**ENVIRONMENTAL COMPLIANCE & AREA COMPLETION PROJECTS (EC&ACP) STANDARD
OPERATING PROCEDURES, VOL. I**
Manual: C3
Procedure: ER-IDS-019-020
Revision: 6
Effective Date: 11/23/2020
Type-Class: Checklist
Page: 1 of 4
**METALLURGICAL LABORATORY HAZARDOUS WASTE MANAGEMENT FACILITY (HWMF) POST
CLOSURE FIELD INSPECTION CHECKLIST**
WORKING COPY

Metallurgical Laboratory Hazardous Waste Management Facility (HWMF) Post Closure Field Inspection Checklist

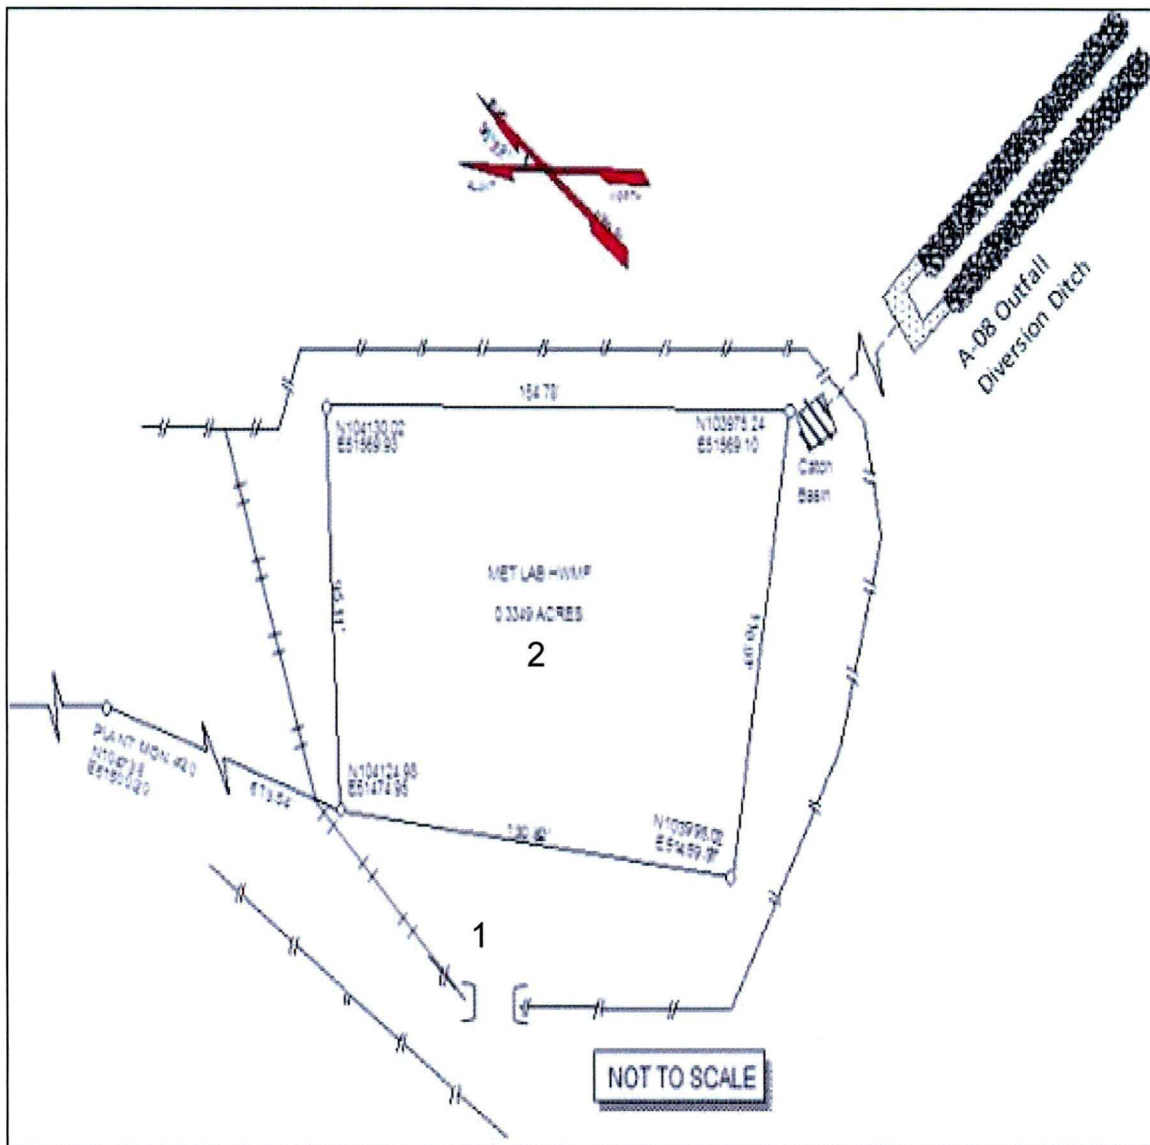
Map of Metallurgical Laboratory HWMF

A = Satisfactory X = Unsatisfactory (Explanation required)		A or X	Observation/Corrective Action Taken
3.	VERIFY fence is in good condition (e.g., shows no signs of serious wear, no vegetative growth) and unattended gates are locked.	X	Carry over item: Bottom piece of frame work tubing on the entry gate is rusted through See Map Note:1 Reference Maintenance Register: PC-2021-00070

4.	CHECK the soil cover and side slopes for signs of erosion, depression (subsidence) and evidence of burrowing animals.	X	Active Ant Mounds on Soil Cover See Map Note: 2 Reference Maintenance Register: PC-2022-00016

NOTES: 1=Carry over item: Bottom piece of frame work tubing on the entry gate is rusted through.

2=Active Ant Mounds on soil cover. Applied 0.25 lb. of extinguish ant bait.

Gate will be repaired with a new piece of frame work tubing.
