**ENVIRONMENTAL COMPLIANCE & AREA COMPLETION PROJECTS (EC&ACP) STANDARD  
OPERATING PROCEDURES, VOL. I**
**Manual:** C3  
**Procedure:** ER-IDS-019-063  
**Revision:** 3  
**Effective Date:** 10/25/2016  
**Type-Class:** Form  
**Page:** 1 of 2

**R-AREA OPERABLE UNIT REACTOR BUILDING AND DISASSEMBLY BASIN FIELD INSPECTION  
CHECKLIST**

R-Area Operable Unit Reactor Building and Disassembly Basin

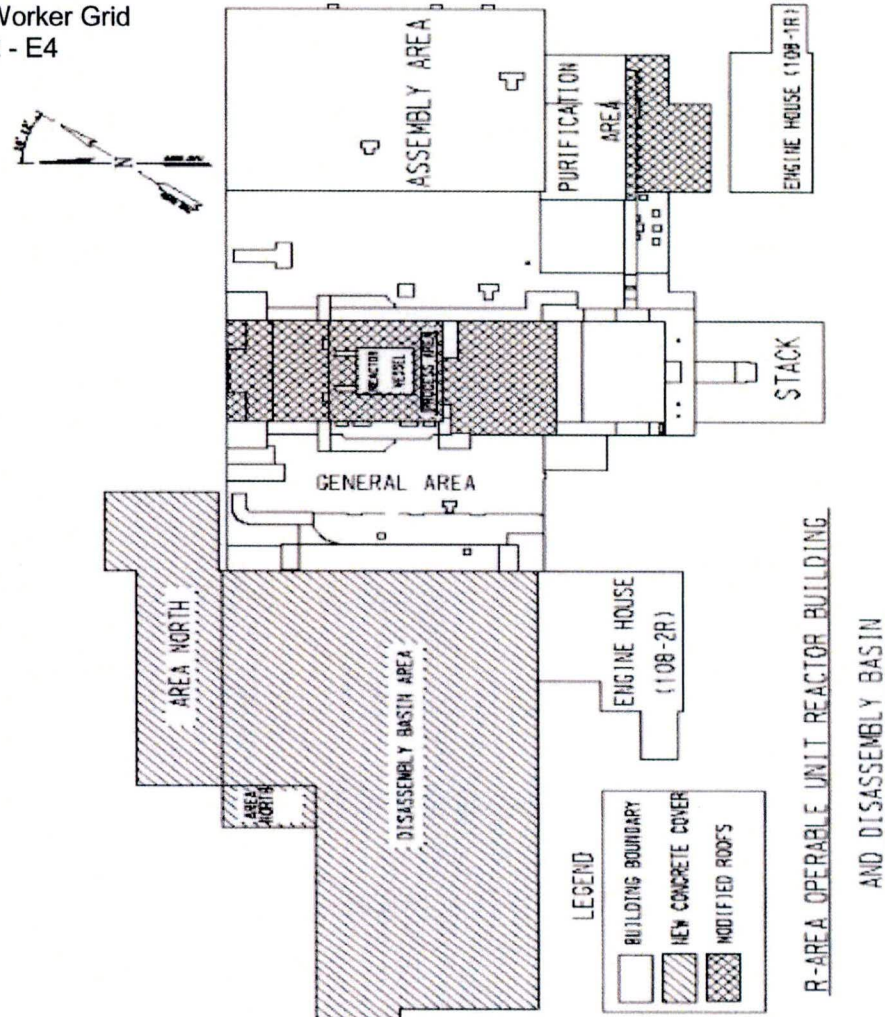
A = Satisfactory	A or X	Observation/Corrective Action Taken
X = Unsatisfactory (Explanation required)		
1. Verify roads are accessible to 105-R Reactor Building and Basin.	A	
2. Verify 105-R Reactor Building Complex roofs are functioning and free of woody vegetation. Submit inspection reports to Cognizant Technical Function to review and evaluate functionality of roofs. (REFER TO Note 3).	X	CARRY OVER ITEM: VEGETATION GROWING ON ROOF SEE MAP NOTE (D). REF MAINT. REGISTER - PL-1015-00105

4. Verify excessive deterioration of disassembly basin cover has not occurred and basin cover is free from debris and woody vegetation.	X	SEVERAL AREAS OF CAULKING IN EXPANSION JOINTS NEED REPAIR. SEE MAP NOTE (2). REF. MAINT. REGISTER PC-2017-00089

6. Verify there are no unauthorized excavations, digging, or construction activities at or in close vicinity of building.	A	
7. Other NOTICED CONCRETE SPALLS ON THE WEST CORNERS OF EL. 88.25. THE SPALLING IS DIRECTLY UNDER THE CONCRETE ROOF CAP.	NOTE	REF. E-MAIL FROM GUY BALDWIN TO WILLIAM GREFFEN. DATED OCTOBER 31, 2019. SEE ATTACHED. ALSO SEE MAP NOTE (3) FOR LOCATION OF SPALLING.

NOTES: (1) CARRY OVER ITEM: VEGETATION GROWING ON ROOFS. ACP WILL DEVELOPE A WORK PACICALE TO REMOVE VEGETATION AS WELL AS REMOVE SILT, SAND AND DEBRIS FROM ROOFS (2) = ACP WILL DEVELOPE A WORK PACKAGE TO REPAIR CAULK JOINTS ON THE DISASSEMBLY BASIN COVER. (3) = AREA OF CONCRETE SPALLING.

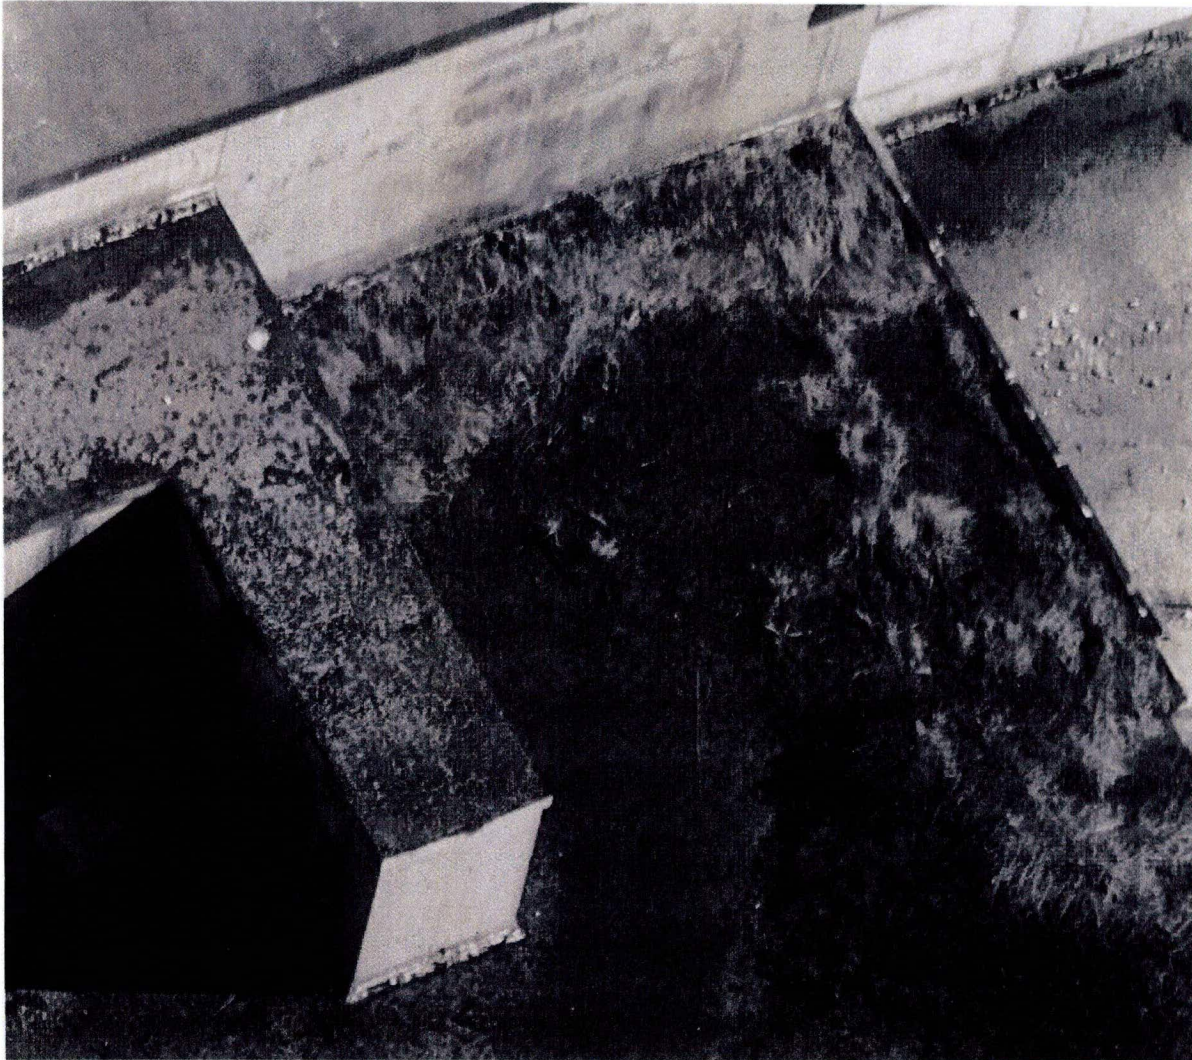
Condition of the roofs remained the same since last inspection. There was no further deterioration at the edge of concrete roof were stack was located. Vegetation growth is present at various areas on the roof. The sediment should be removed to eliminate and prevent vegetation. Some spots exist on the roof that cause the potential for pooling water. Spalled concrete was identified on the west corners of the +88.25 roof, attached is the design engineering report. Please see pictures for further details.

Figure 1: Vegetation

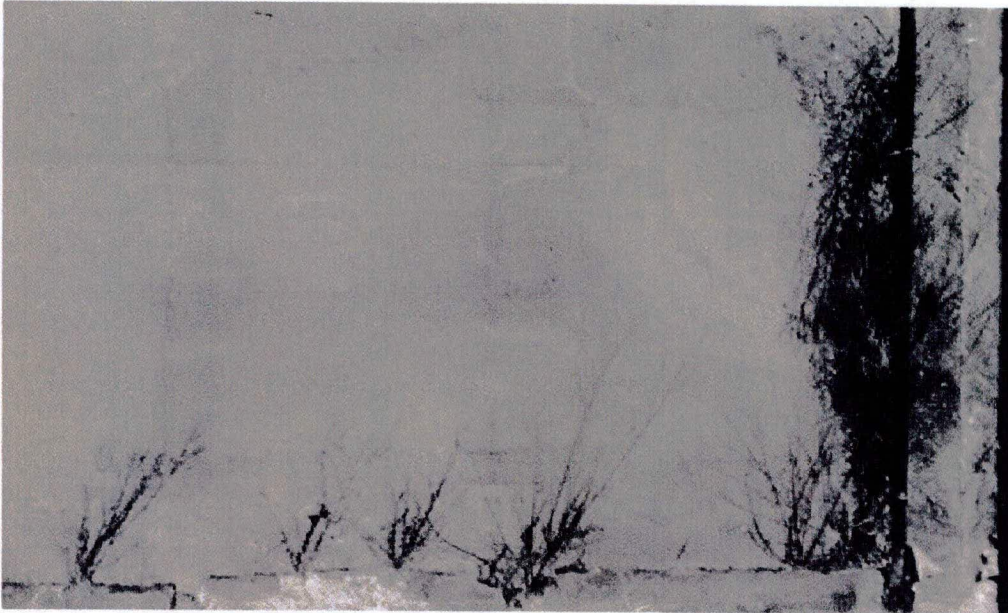
Figure 2: Vegetation

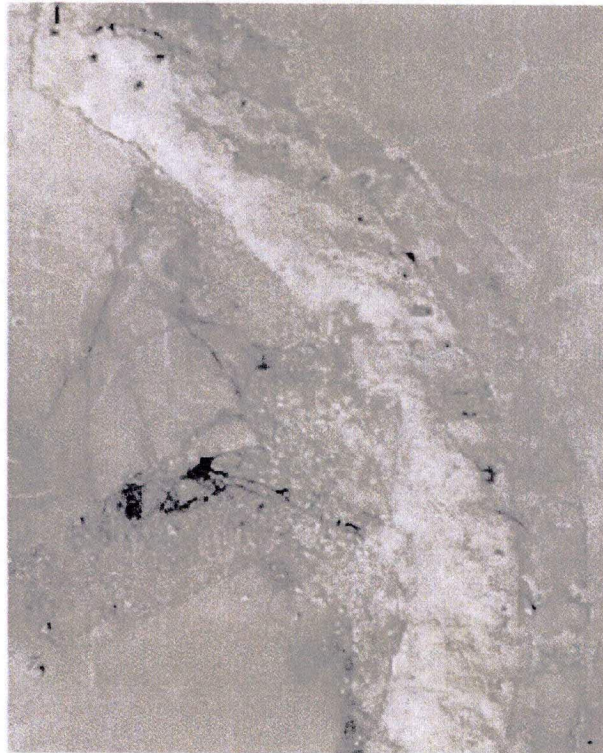
Figure 3: Potential Area for Pooling

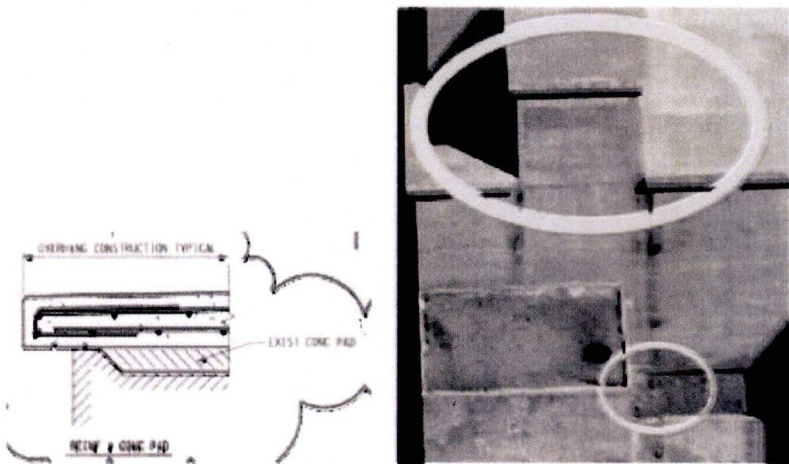
From our conversations, it appears these spalls on the west corners of the El. 88.25 roof happened some time ago for unknown causes, probably soon after or during the activity of stripping the forms in 2011. It is noted from the aerial photo that some of the concrete shards landed harmlessly on the roof below and are still there.

Review of the drawing C-CC-R-00019, Sections F and H show the cap to be well reinforced with #6@18" each way and each face with "U-bars" for the cantilever load which is slightly increased by the spall of the corners below the roof slab. The spalled concrete is from the unreinforced concrete cover at the corner of the non-structural concrete curbs. The curbs are considered non-structural in the sense they do not contribute to the structural strength of the building. Given that the cap slab corner strength is undiminished by the spalls and the unreinforced concrete curb corners do not contribute to the overall strength of the building, this is considered an issue to put on the watch list for future deterioration, but not in need of immediate repair.
