Annual Radioactive Waste Tank Inspection Program – 2022

June 2023

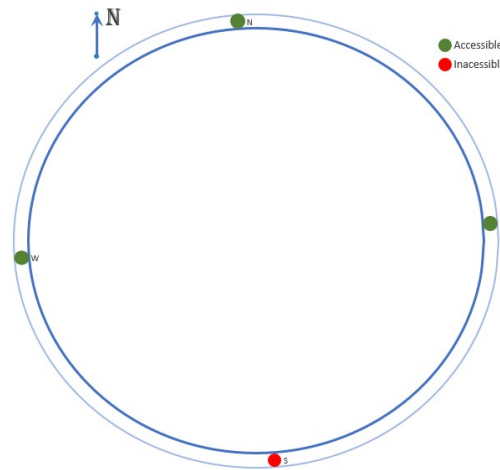
Annulus Inspection Location

Summary of Visual Inspections: No changes were noted since the inspections in 2021.

Conclusions following 2022 Inspections: **No additional leakage, significant surface corrosion, or other anomalies were noted. The 2022 inspection confirmed the structural integrity and waste confinement capability of Tank 1.**

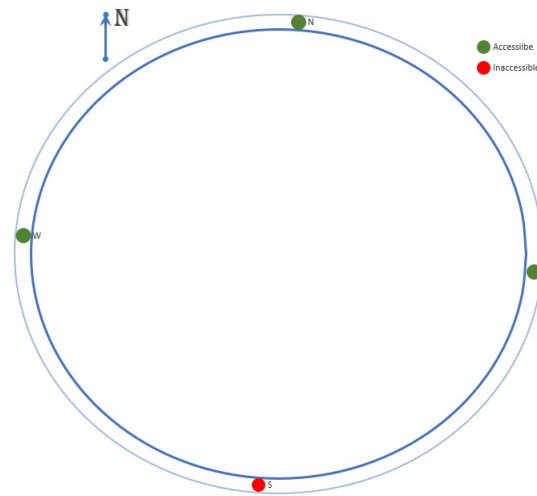
Annulus Inspection Location

Summary of Visual Inspections: Seventeen (17) previously undocumented leak sites were identified in 2022.

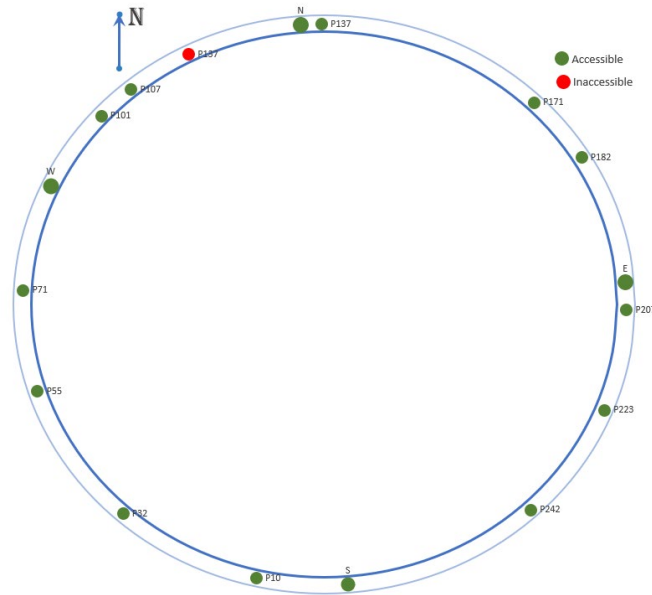
Annulus Inspection Locations

Summary of Visual Inspections: No changes were noted since the inspections in 2021.
