Engineering Survey & Interference Report for Building 484-5D, D-Area Powerhouse Storage Building

This document addresses Building 484-5D, D-Area Powerhouse Storage Building.

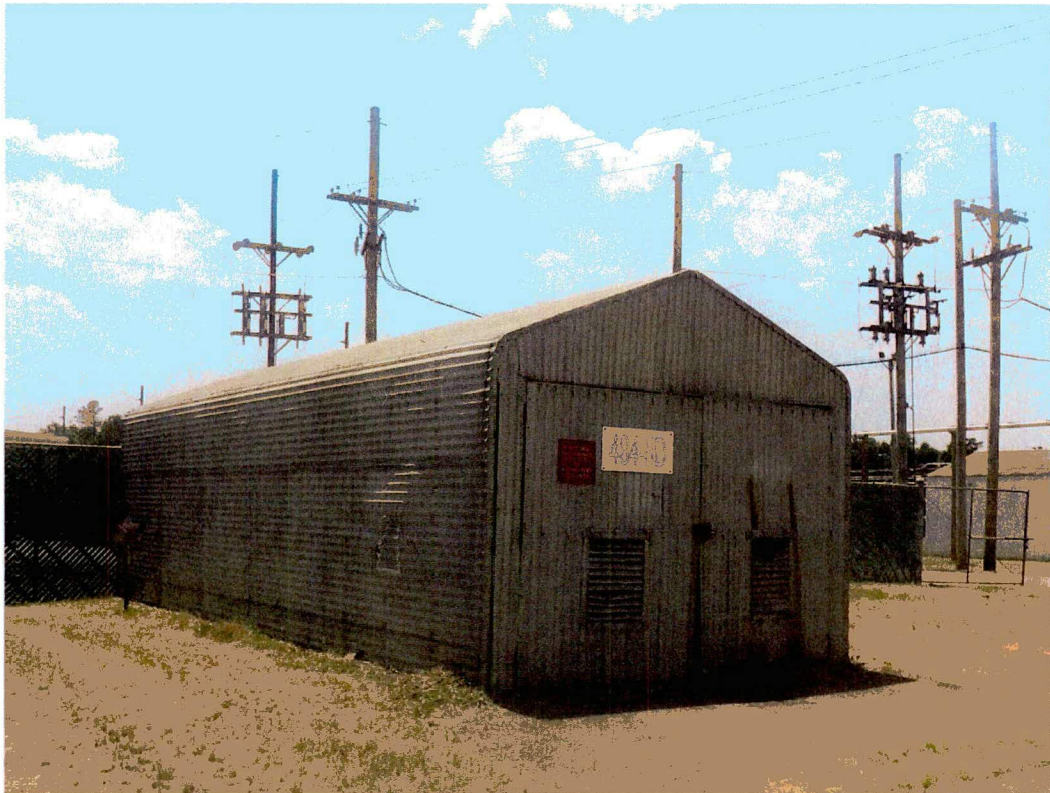
Figure 3: Building 484-5D, Storage Building Photo

The building was erected circa 1980 and is an aluminum tube-frame structure with a corrugated aluminum skin attached to a concrete slab. The structure is approximately 12' wide x 30' long (approximately 360 sq. ft.), with a non-partitioned interior. The structure has double, swinging doors at its front for access.

Based on visual inspection on June 3, 2020, the structure as defined in References 5.1 and 5.2 is in good condition, and there is no potential for an unplanned collapse of the structure either due to forces of nature and/or vibrations created by movement of heavy equipment in proximity to the building.

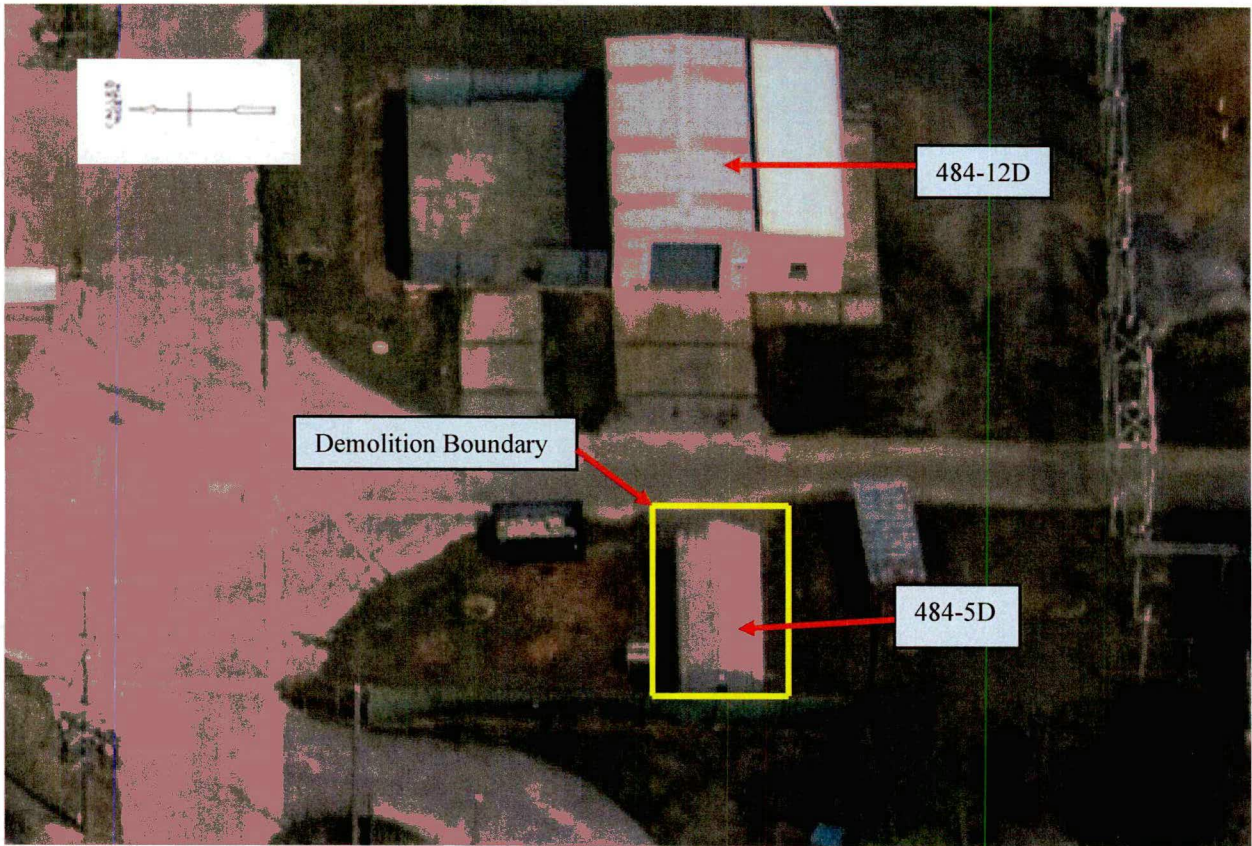
Figure 4: Aerial View of 484-5D and Surrounding Buildings/Facilities

Appendix A, Figures 1-4, provide a general lay-out of the area, interfacing facilities/utilities within proximity and define the demolition boundary. Any underground utilities in the area are buried deep enough that heavy equipment may safely operate over them, and overhead powerlines north of the building are not energized (References 5.4, 5.5 and 5.6).
