ENVIRONMENTAL COMPLIANCE & AREA COMPLETION PROJECTS (EC&ACP) STANDARD OPERATING PROCEDURES, VOL. I

Manual: C3
 Procedure: ER-IDS-019-001
 Revision: 9
 Effective Date: 09/02/2021
 Type-Class: Checklist
 Page: 1 of 3

SILVERTON ROAD WASTE UNIT (BLDG 731-3A) FIELD INSPECTION CHECKLIST

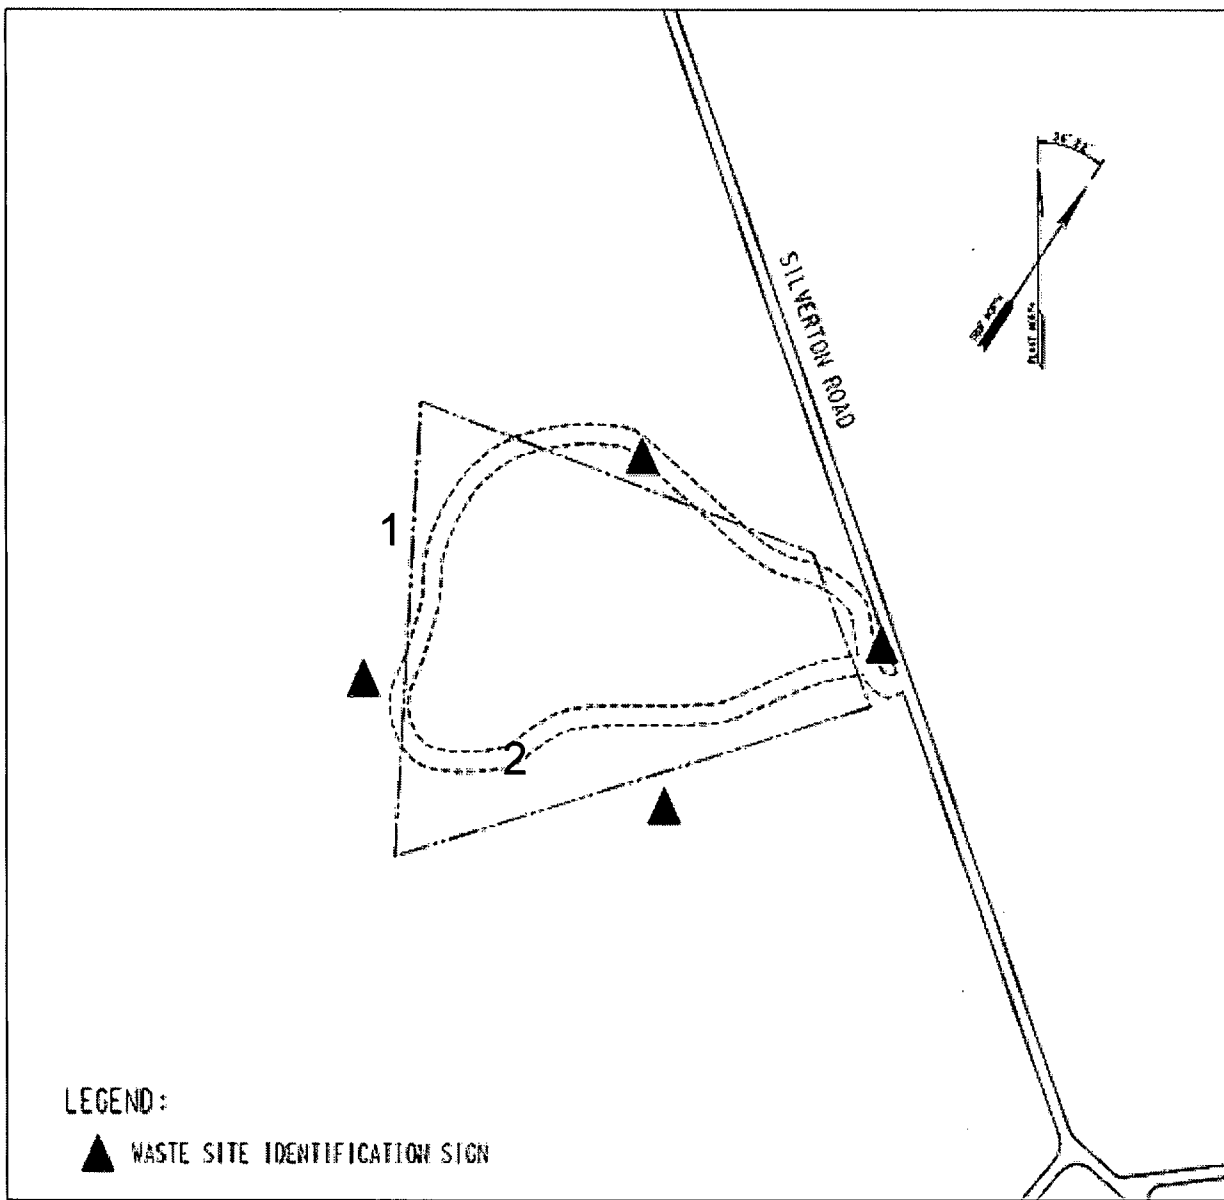
Map of Silverton Road Waste Unit (Bldg. 731-3A)

| A = Satisfactory X = Unsatisfactory (Explanation required) | A or X | Observation/Corrective Action Taken |
|--|---|--|
| 4. CHECK integrity of drainage ditches for the presence of excessive erosion, sediment buildup, and any debris restricting water flow. | X | Carry Over Item: Erosion present in the Southwest drainage ditch See map note: 1 Reference Maintenance Register: PC-2021-00064 |
| 9. Other | X | Dead tree top has fallen down on waste unit See map note: 2 Reference Maintenance Register: PC-2022-00062 |

NOTES: 1=Carry Over Item: Erosion present in the Southwest drainage ditch. USFS will repair with RIP-RAP.

2=Dead tree top has fallen down on waste unit. USFS will remove the tree top.
