**ENVIRONMENTAL COMPLIANCE & AREA COMPLETION PROJECTS (EC&ACP) STANDARD
OPERATING PROCEDURES, VOL. I**
Manual: C3
Procedure: ER-IDS-019-041
Revision: 3
Effective Date: 06/02/2016
Type-Class: Form
Page: 1 of 3
D-AREA ASH BASIN (DAB) (488-D) FIELD INSPECTION CHECKLIST
WORKING COPY

D-Area Ash Basin (DAB) (488-D) Field Inspection Checklist

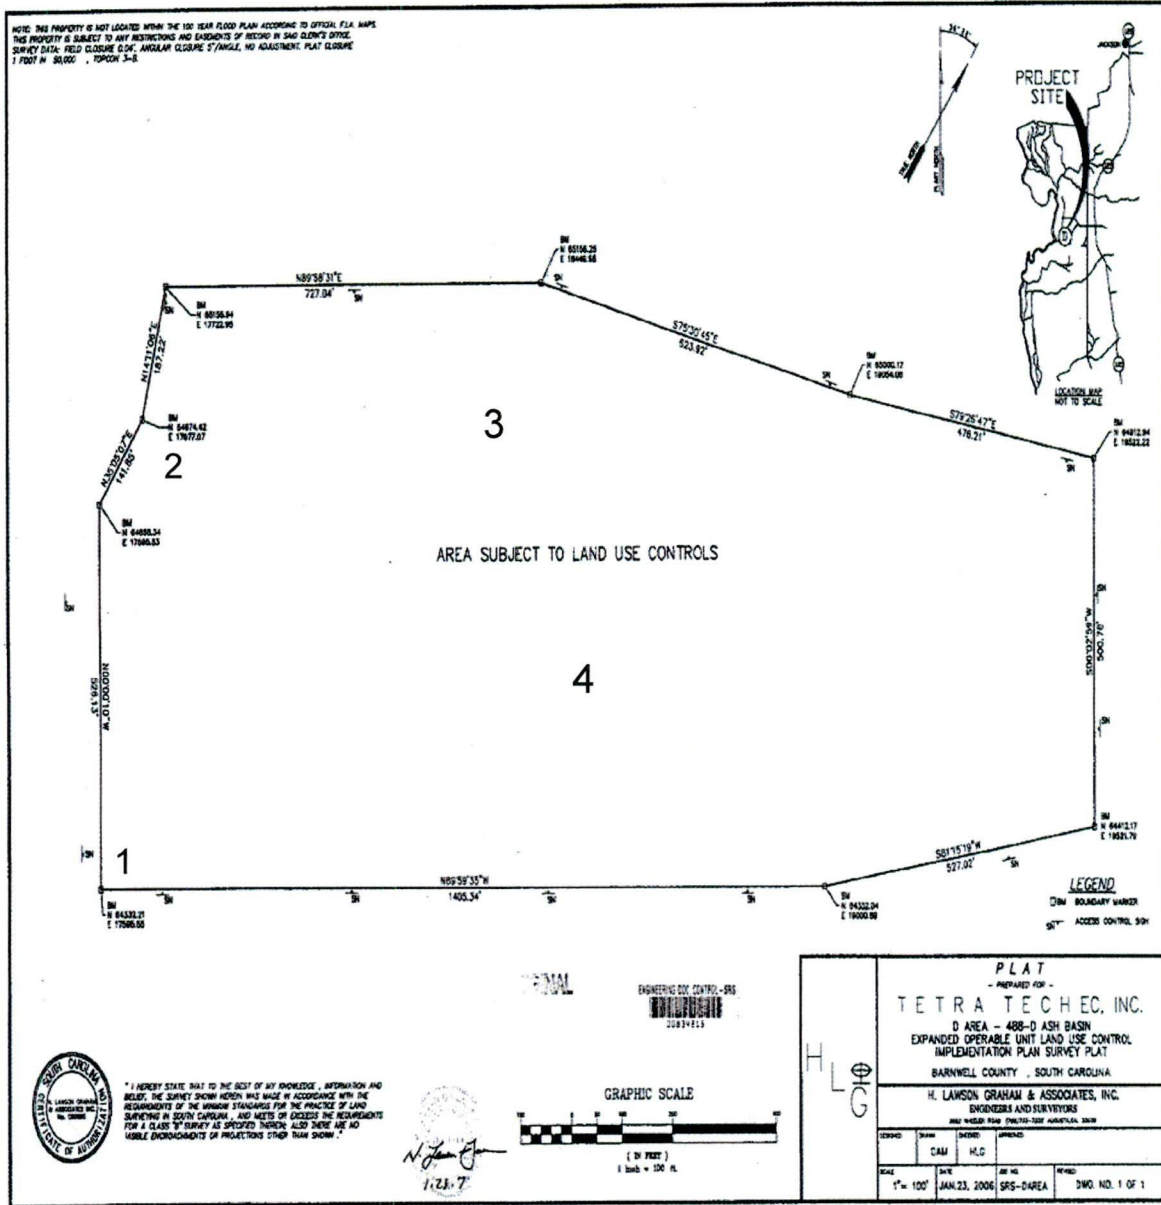
D-AREA ASH BASIN (488-D) MAP

A = Satisfactory X = Unsatisfactory (Explanation required)		A or X	Observation/Corrective Action Taken
4.	Verify that the integrity of drainage systems and required land grading for proper drainage is maintained and that they are free of excessive erosion, sediment buildup and any debris restricting water flow.	X	Build-up of thatch on the storm water grates. See Map Note: 1 Reference Maintenance Register: PC-2021-00118 Broken PVC piping plug on drainage system See Map Note: 2 Reference Maintenance Register: PC-2021-00119

9.	Verify that signs of burrowing animals on the 488-DAB are not present.	X	Carry over item: Excessive hog damage on the North slope and has continued across the entire cap. See map note: 3 Reference Maintenance Register: PC-2017-00118

10.	Other Active Ant Mounds	X	Active ant mounds on soil cover See map note: 4 Reference Maintenance Register: PC-2021-00120

NOTES: 1=Build-up of thatch on the storm water grates. Post Closure Maintenance removed thatch.

2=Broken PVC piping plug on drainage system. Post Closure Maintenance will replace broken PVC pipe plug.

3=Carry over item: Excessive hog damage on the North slope and has continued across the entire cap. USFS will make repairs with topsoil, grass seed and straw.

4=Active ant mounds on soil cover. Applied 1.0 lbs. of Extinguish Ant Bait.
