**ENVIRONMENTAL COMPLIANCE & AREA COMPLETION PROJECTS (EC&ACP) STANDARD
OPERATING PROCEDURES, VOL. I**
Manual: C3
Procedure: ER-IDS-019-048
Revision: 5
Effective Date: 06/01/2016
Type-Class: Form
Page: 1 of 3
**R-REACTOR SEEPAGE BASINS 904-57G, 904-58G, 904-59G, 904-60G, 904-103G AND 904-104G
FIELD INSPECTION CHECKLIST**
WORKING COPY

R-Reactor Seepage Basins 904-57G, 904-58G, 904-59G, 904-60G, 904-103G And 904-104G Field Inspection Checklist

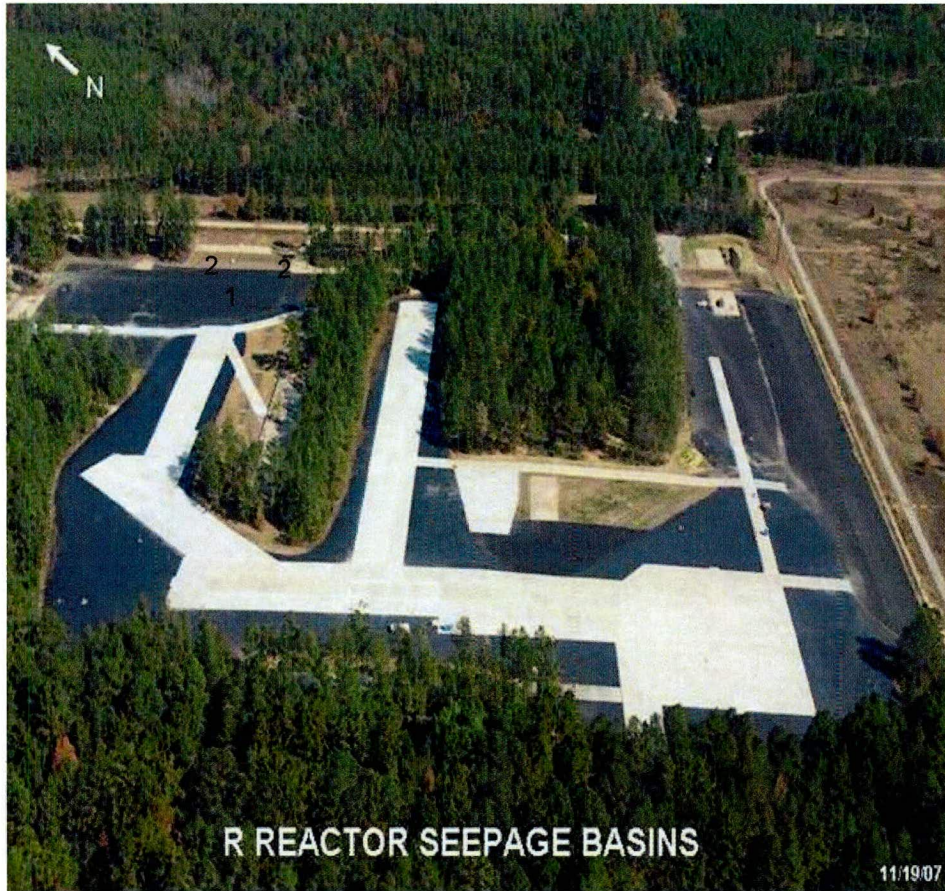
4.	Check asphalt cover for signs excessive cracking, depressions (subsidence), and burrowing animals.	X	Approximately a 1/2"x 90' crack in the asphalt on the Northeast side. The crack is large enough for surface water to pass through. See map note: 1 Ref. Maint. Register PC-2019-00079

7.	Check integrity of sediment basins (2) and drainage ditches for presence of excessive erosion, sediment build-up, and debris restricting water flow.	X	Erosion on the side slope of the North sediment basin. See map note: 2 Ref. Maint. Register: PC-2019-00080

NOTES: 1=Approximately a 1/2"x 90' crack in the asphalt on the Northeast side. The crack is large enough for surface water to pass through. The crack will be repaired during the asphalt recoating process, which is to be scheduled in FY 20.

2=Erosion on the side slope of the North sediment basin. Post Closure Maintenance will repair the eroded areas by installing a layer of rock/ Rip-Rap.

Post Closure Maintenance repaired the eroded areas by installing a layer of rock/ Rip-Rap.

Subcontractor cleaned and filled crack with sealant
