**Metallurgical Laboratory Hazardous Waste Management Facility (HWMF) Post Closure Field
Inspection Checklist**

Manual: C3
 Procedure: ER-IDS-019-020
 Revision: 5
 Page: 2 of 5

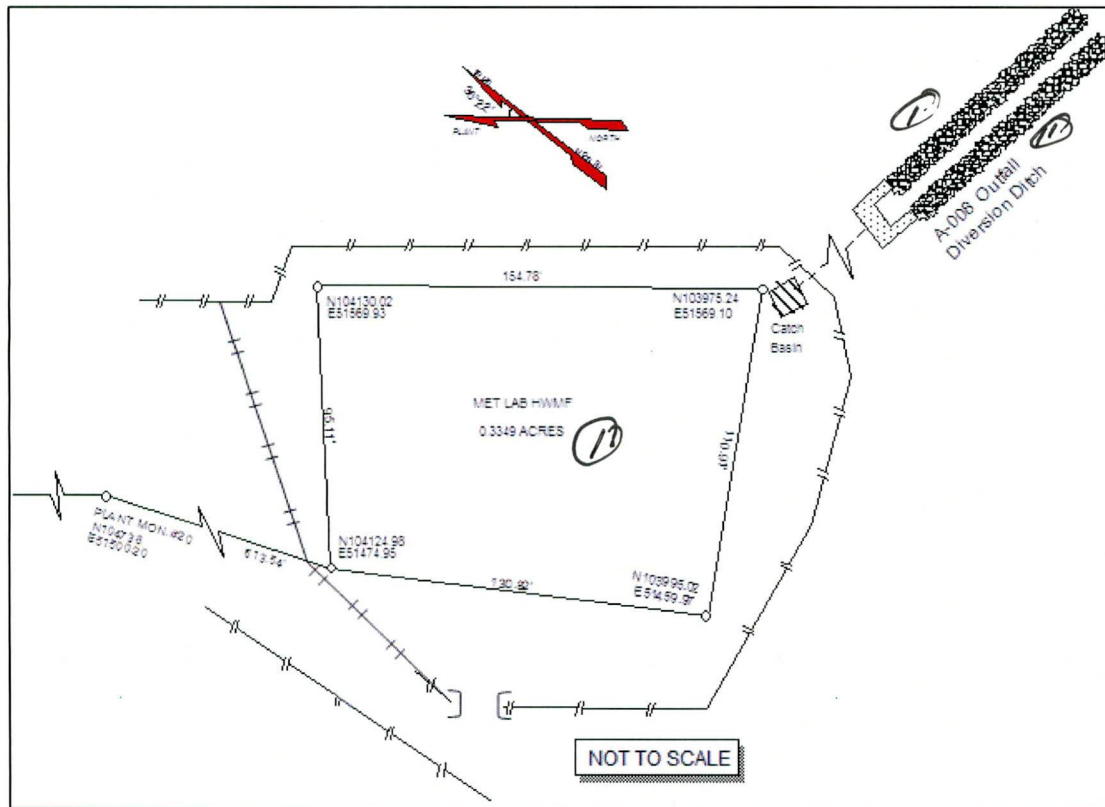
Map of Metallurgical Laboratory HWMF

4. Check for excessive vegetation growing over fences, which may obstruct warning signs or visibility of closure cover.	A	
5. Walk across the closure cover and check for erosion, abnormal soil cracks and evidence of burrowing animals.	X	Active Ant Mounds on Soil Cover. See Map Note ① Res. Maint. Register. No PC-2018-00012

NOTES: See Map Note ⑩ = Active Ant Mounds on soil cover
Applied 3.0 lbs of Extinguish Ant Bait.
~~No Further Entries 2/20/18~~

Active ant mounds on waste unit

Applied Extinguish pesticide
