**ENVIRONMENTAL COMPLIANCE & AREA COMPLETION PROJECTS (EC&ACP) STANDARD  
OPERATING PROCEDURES, VOL. I**
**Manual: C3**  
**Procedure: ER-IDS-019-048**  
**Revision: 6**  
**Effective Date: 01/27/2022**  
**Type-Class: Checklist**  
**Page: 1 of 3**
**R-REACTOR SEEPAGE BASINS 904-57G, 904-58G, 904-59G, 904-60G, 904-103G AND 904-104G  
FIELD INSPECTION CHECKLIST**
**WORKING COPY**

R-Reactor Seepage Basins 904-57G, 904-58G, 904-59G, 904-60G, 904-103G and 904-104G Field Inspection Checklist

R-REACTOR SEEPAGE BASINS

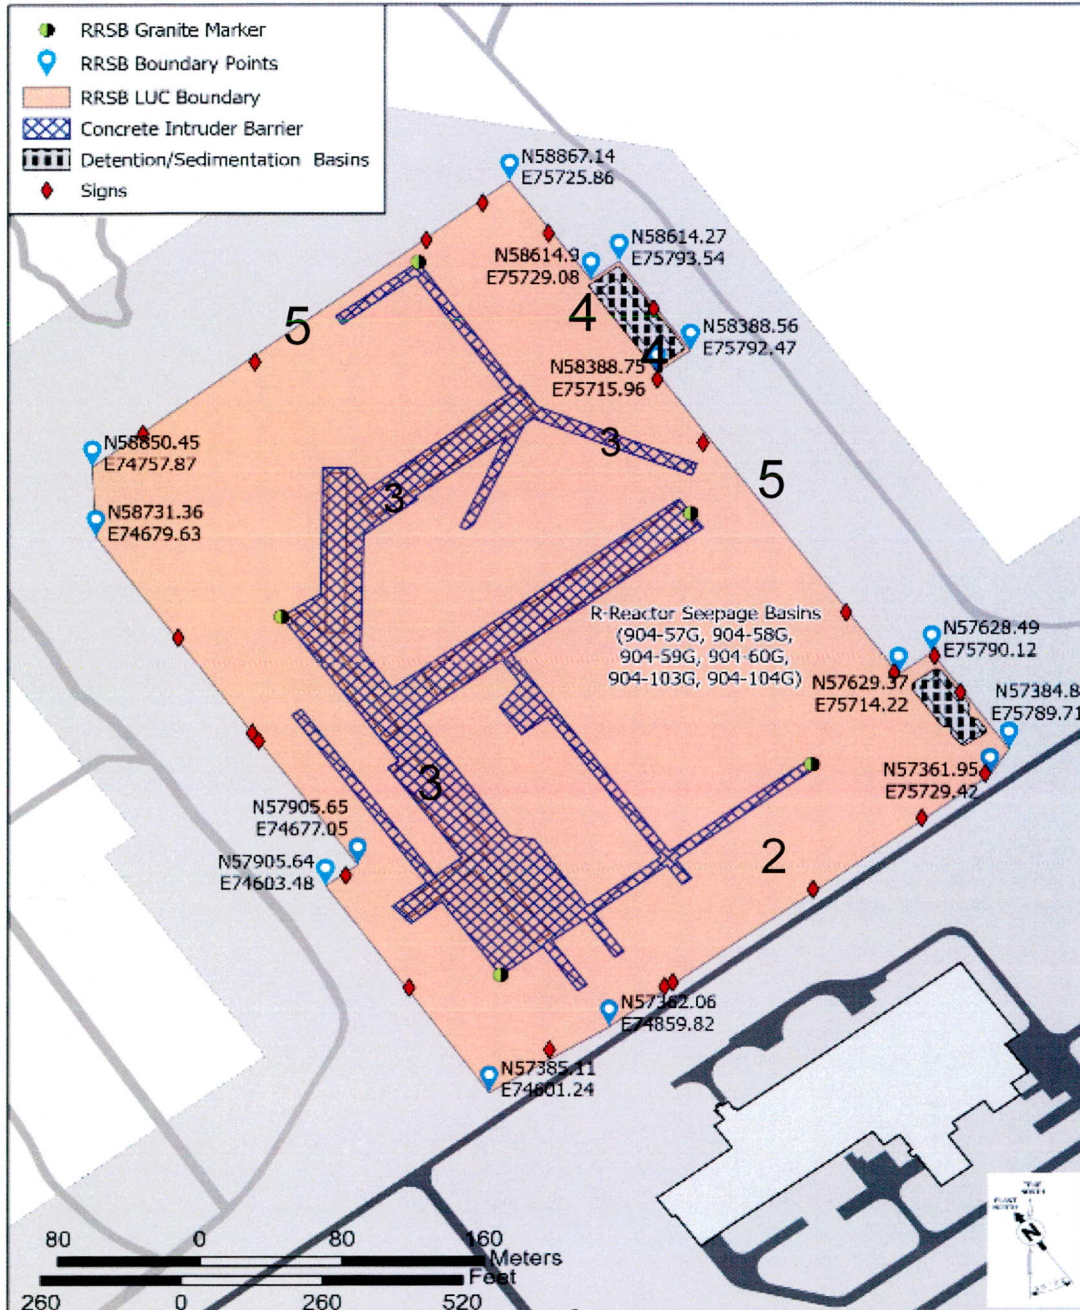
4.	CHECK asphalt cover for signs excessive cracking, depressions (subsidence), and burrowing animals.	X	Two cracks on the south side. See Map Note:2 Reference Maintenance Register: PC-2022-00096

5.	VERIFY no woody vegetation is growing through asphalt bioturbation barrier. REMOVE OR IDENTIFY as needed.	A	
6.	VERIFY there has not occurred excessive deterioration of concrete cover.	X	Concrete cover has areas of cracking and sealant in control joints is deteriorated See Map Note: 3 Reference Maintenance Register: PC-2022-00097 Note: Zone 4 concrete repairs were completed in FY23, zones 1,2 and 3 have been completed in FY24. All cracks need to be repaired again.

7.	CHECK integrity of sediment basins (2) and drainage ditches for presence of excessive erosion, sediment build-up, and debris restricting water flow.	X	Minor Erosion is present at the inlets to the North sediment basin See Map Note:4 Reference Maintenance Register: PC-2023-00071

9.	VERIFY there are no unauthorized excavation, digging, or construction activities in R-Reactor Seepage Basin (RRSB) Operable Unit.	A	
10.	Other. Two fallen trees across fence	X	Two trees fell across perimeter fence on the East and West sides. USFS removed the trees and temporarily repaired the fence to prevent access until permanent repairs can be made. See Map Note: 5 Reference Maintenance Register: PC-2023-00072

- NOTES:** 2=Two cracks in the asphalt cover. The cracks will be filled with a repair sealant that engineering will specify.
- 3=Concrete cover has areas of cracking and sealant in control joints is deteriorated. Construction will repair concrete and replace sealant in the control joints.
- Note: Zone 4 concrete repairs were completed in FY23. Zones 1,2 & 3 have been completed in FY 24. All cracks need to be repaired again.
- 4=Minor Erosion is present at the inlets to the North sediment basin. Minor areas of erosion will be repaired with rock.
- 5=Two trees fell across perimeter fence on the East and West sides. USFS removed the trees and temporarily repaired the fence to prevent access until permanent repairs can be made. USFS will make permanent repairs.
