Engineering Survey & Interference Report for Building 484-9D, D-Area Valve House

Prepared by: W.B. Griffin Date: 11/3/2020
W.B. Griffin
EC&ACP Engineering
Environmental Compliance & Area Completion Projects

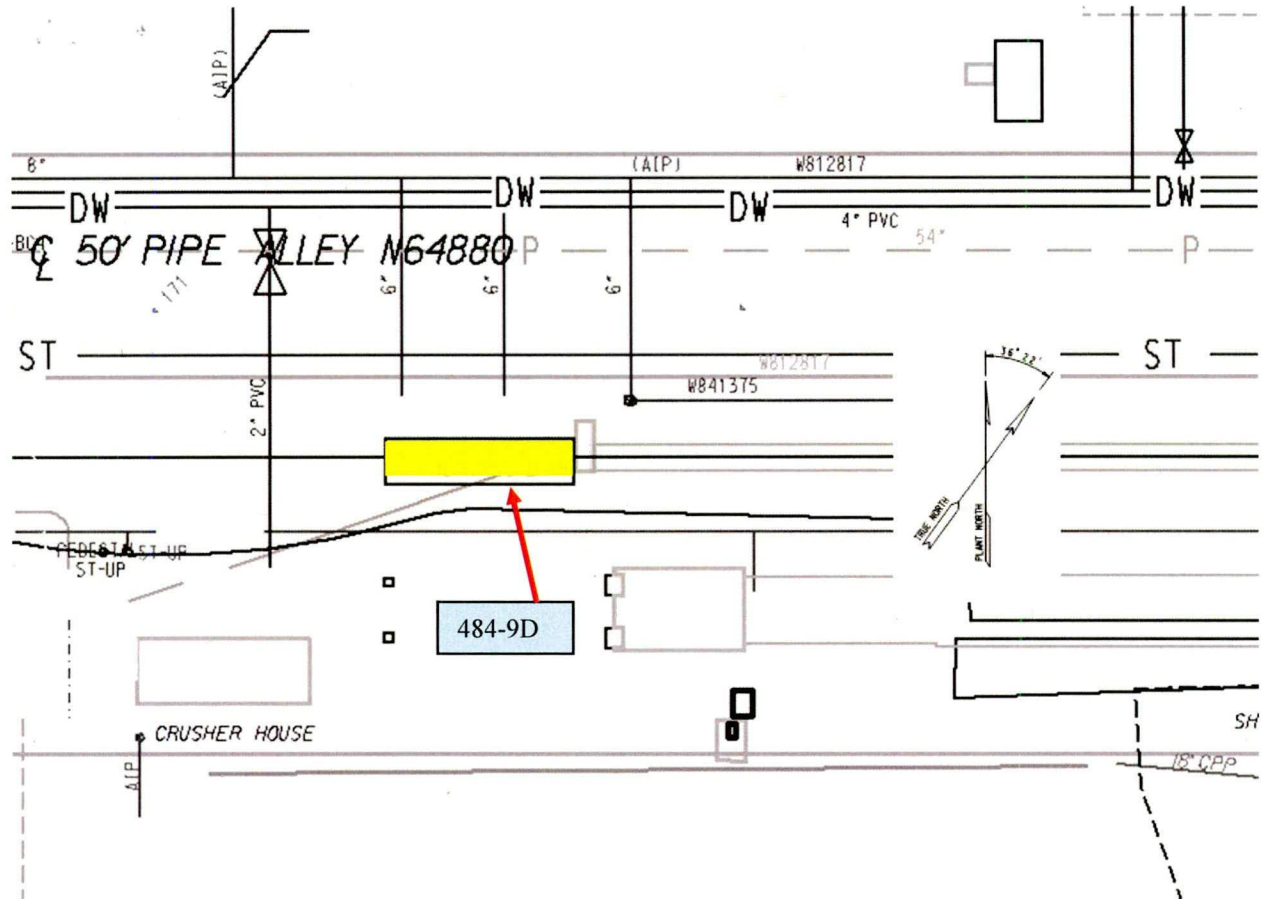
Figure 2: Building 484-9D and Surrounding Facilities/Utilities

Appendix A provides a general lay-out of the area, interfacing facilities/utilities within close proximity and defines the demolition boundary. All underground utilities are buried deep enough that the equipment may safely operate over them.
