**ENVIRONMENTAL COMPLIANCE & AREA COMPLETION PROJECTS (EC&ACP) STANDARD
OPERATING PROCEDURES, VOL. I**
Manual: C3
Procedure: ER-IDS-019-065
Revision: 4
Effective Date: 1/08/2020
Type-Class: Checklist
Page: 1 of 3

**P-AREA OPERABLE UNIT REACTOR BUILDING AND DISASSEMBLY BASIN FIELD INSPECTION
CHECKLIST**
WORKING COPY

P-Area Operable Unit Reactor Building and Disassembly Basin Field Inspection Checklist

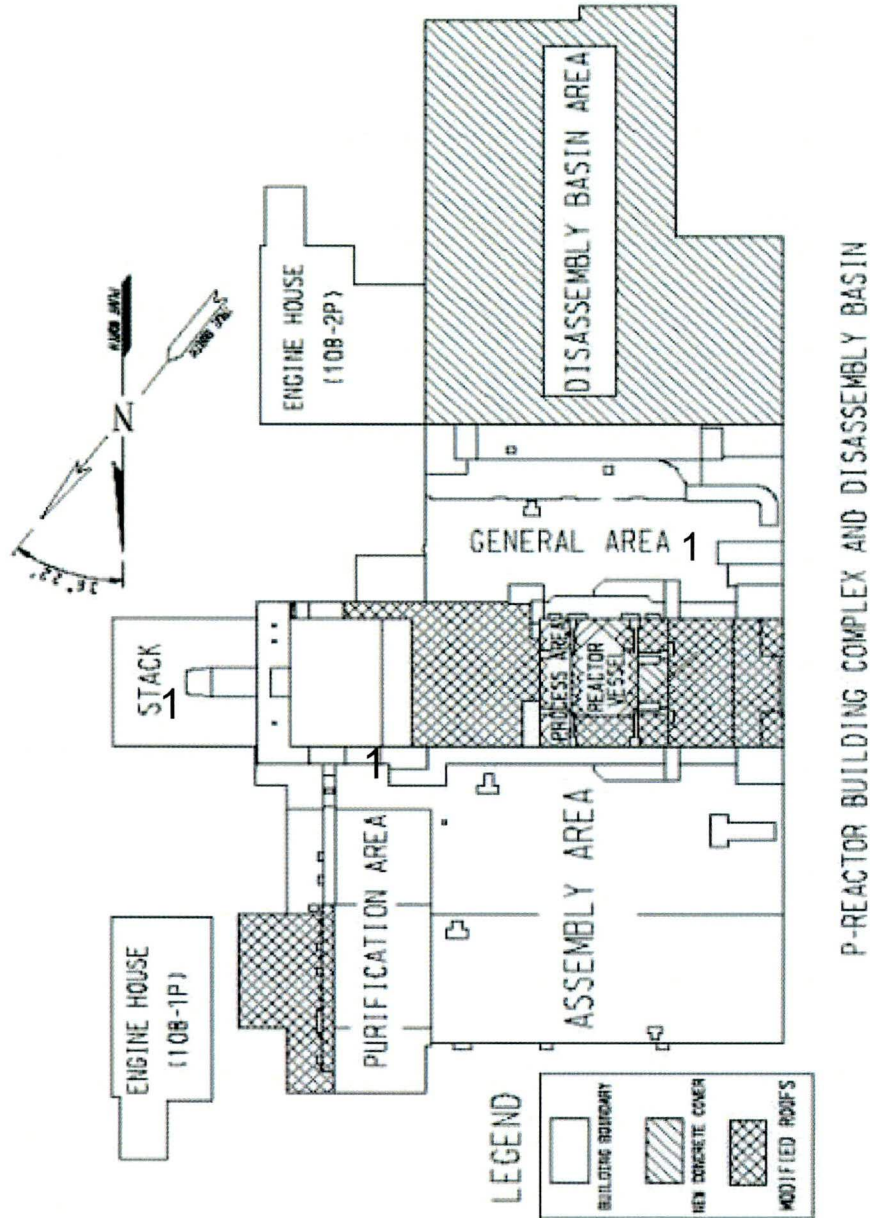
Map of P-Area Operable Unit Reactor Building and Disassembly Basin

NOTES: 1=Carry over item: Roofs are functioning as intended. Non-woody vegetation exist and hinders drainage. Efforts will be made remove vegetation. During the roof inspection via Drone footage/photos in Oct 2020 some woody vegetation was also noticed. Herbicide will be applied in the late spring of 2021 to kill the vegetation.
