MIXED WASTE MANAGEMENT FACILITY POST CLOSURE INSPECTION, BLDG. 643-28E AND LOW-LEVEL RADIOACTIVE WASTE DISPOSAL FACILITY FIELD INSPECTION CHECKLIST

Mixed Waste Management Facility Post Closure Inspection, Bldg. 643-28E and Low-Level
Radioactive Waste Disposal Facility Field Inspection Checklist

Map of Mixed Waste Management Facility, Bldg. 643-28E and Low-Level Radioactive Waste
Disposal Facility

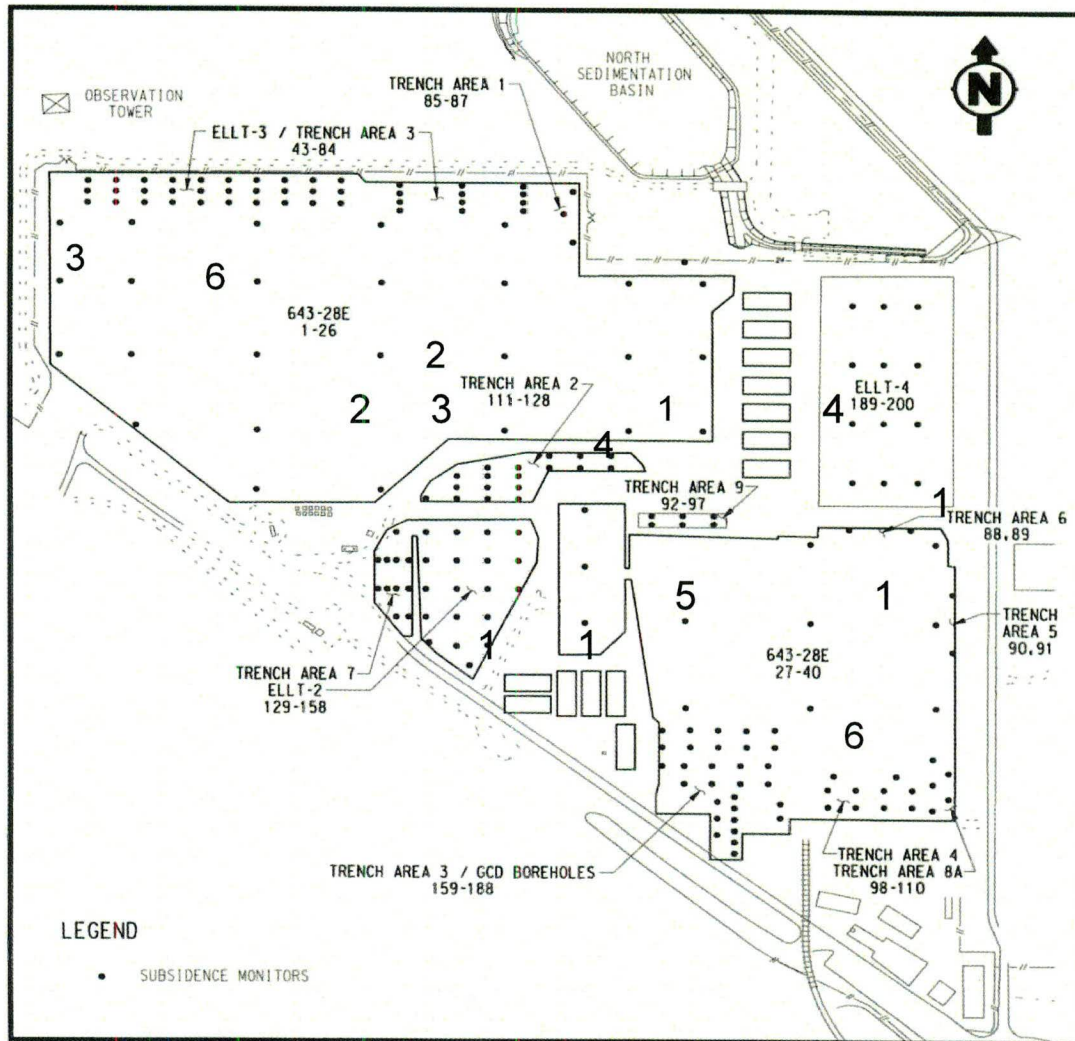
4.	Check for excessive vegetation growing over fences which may obstruct warning signs or visibility of the closure cover.	A	
5.	Inspect closure cover and check for erosion, uncovered buried waste, abnormal soil cracks, and presence of burrowing animals.	X	Active ant mounds on soil cover. See map note: 1 Ref. maint. register PC-2019-00053

6.	Check integrity of concrete-lined drainage channels inside and outside fenced areas for the presence of erosion or debris restricting water flow. Build-up of debris/sedimentation in drainage ditches is not to exceed 2 inches. Ditches are designed to collect run-off and divert run-on. Standing water in the ditches or on the cover is not to exceed defined limits.	X	Carry over item: Concrete joint sealant needs repair. See map note: 2 Ref. maint. register PC-2017-00066. Carry over item: Concrete lined channels has areas of spalling/flaking. See map note: 3 Ref. maint. register PC-2019-00023

9.	Visually check vegetative cover for grass density with no bare spots more than 3 feet in diameter. There should be no woody vegetation or shrubs growing on the closure covers. The height of vegetative cover should not impair visual inspection of closure. This will be determined by the EC&ACP Post Closure Inspector.	X	Carry over item: Rutting caused by mowing equipment during wet times. See map note: 5 Ref. maint. register PC-2018-00136

10.	Visually check subsidence monitors for damage and visibility.	X	Worn and faded subsidence monitor marker flags need replacing See map note: 6 Ref. maint. register: PC-2019-0054

15.	Check gas vents for signs of damage or obstructions.	A	
16.	Other Subsidence on Trench 2. Carry over item: See map note: 4 Ref. maint. register PC-2019-00022	X	Subsidence noticed on Trench 2. This area of subsidence was also noticed on July 10, 2014 and repaired with topsoil, grass seed and straw on July 29, 2015 The area is currently under engineering evaluation for repair.

NOTES: 1=Active ant mounds on soil cover. Applied 2.5 lbs. of Extinguish ant bait. 2=Carry over item: concrete joint sealant in concrete channels needs repair. ACP will prepare a work package for repairs. 3=Carry over item: Concrete lined channels have areas of spalling The areas of spalling are currently under engineering evaluation for repair. Carry over item: 4=Subsidence noticed on Trench 2. Engineering is performing an evaluation for repair. 5=Carry over item: Rutting caused by mowing equipment during wet times. USFS will make repairs with topsoil, grass seed and straw. 6=Worn and faded subsidence monitor marker flags need replacing. The USFS will replace.
