Manual: C3
Procedure: ER-IDS-019-063
Revision: 4
Effective Date: 1/08/2020
Type-Class: Checklist
Page: 1 of 3

R-AREA OPERABLE UNIT REACTOR BUILDING AND DISASSEMBLY BASIN FIELD INSPECTION CHECKLIST

R-Area Operable Unit Reactor Building and Disassembly Basin Field Inspection Checklist

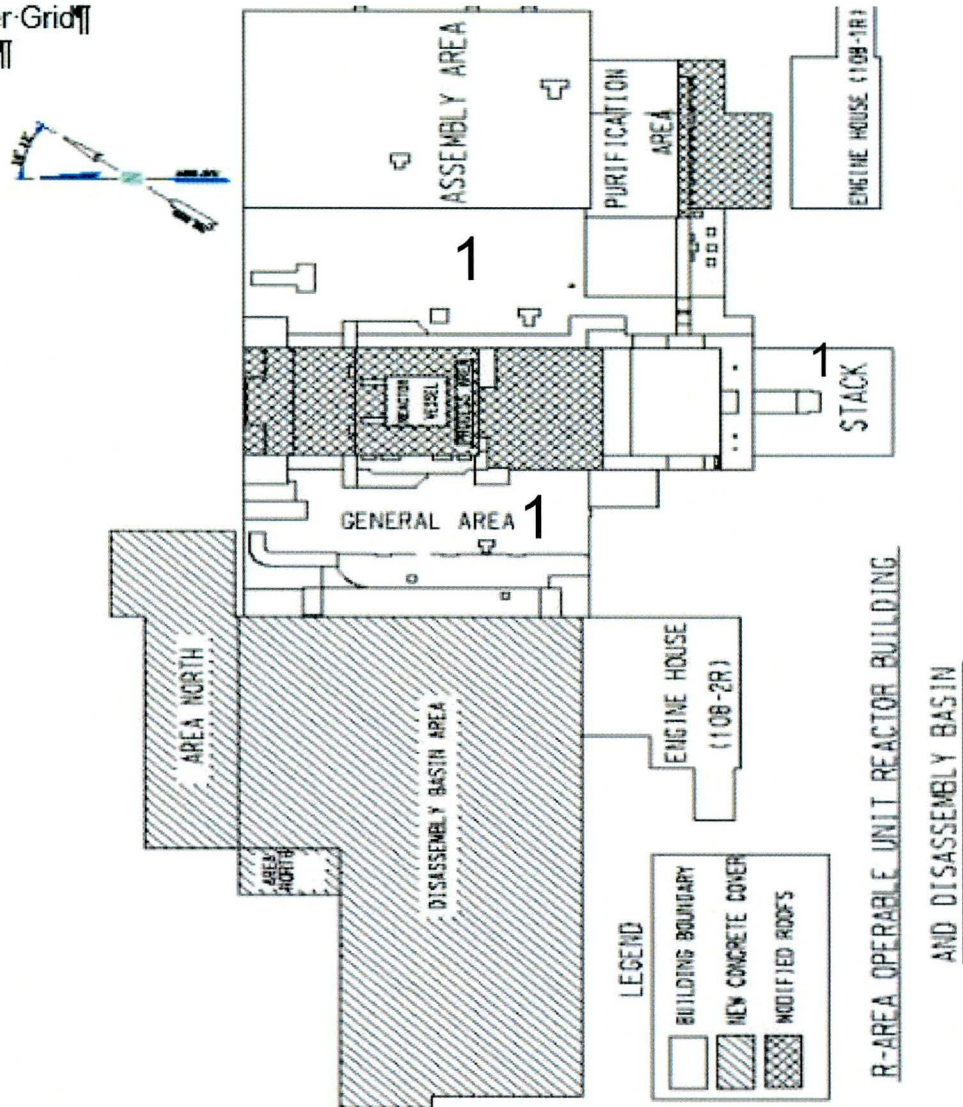
Map of R-Area Operable Unit Reactor Building and Disassembly Basin

NOTES: 1=Carry over item: Roofs are functioning as intended. Non-woody vegetation exist and hinders drainage. Efforts will be made remove vegetation. During the roof inspection via Drone footage/photos in Oct 2020 some woody vegetation was also noticed. Herbicide will be applied in the late spring of 2021 to kill the vegetation.
