**ENVIRONMENTAL COMPLIANCE & AREA COMPLETION PROJECTS (EC&ACP) STANDARD
OPERATING PROCEDURES, VOL. I**
Manual: C3
Procedure: ER-IDS-019-071
Revision: 2
Effective Date: 06/01/2016
Type-Class: Form
Page: 1 of 3
D-AREA BUBBLE TOWER COVER FIELD INSPECTION CHECKLIST
WORKING COPY

D-area Bubble Tower Cover Field Inspection Checklist

D-Area Bubble Tower Cover

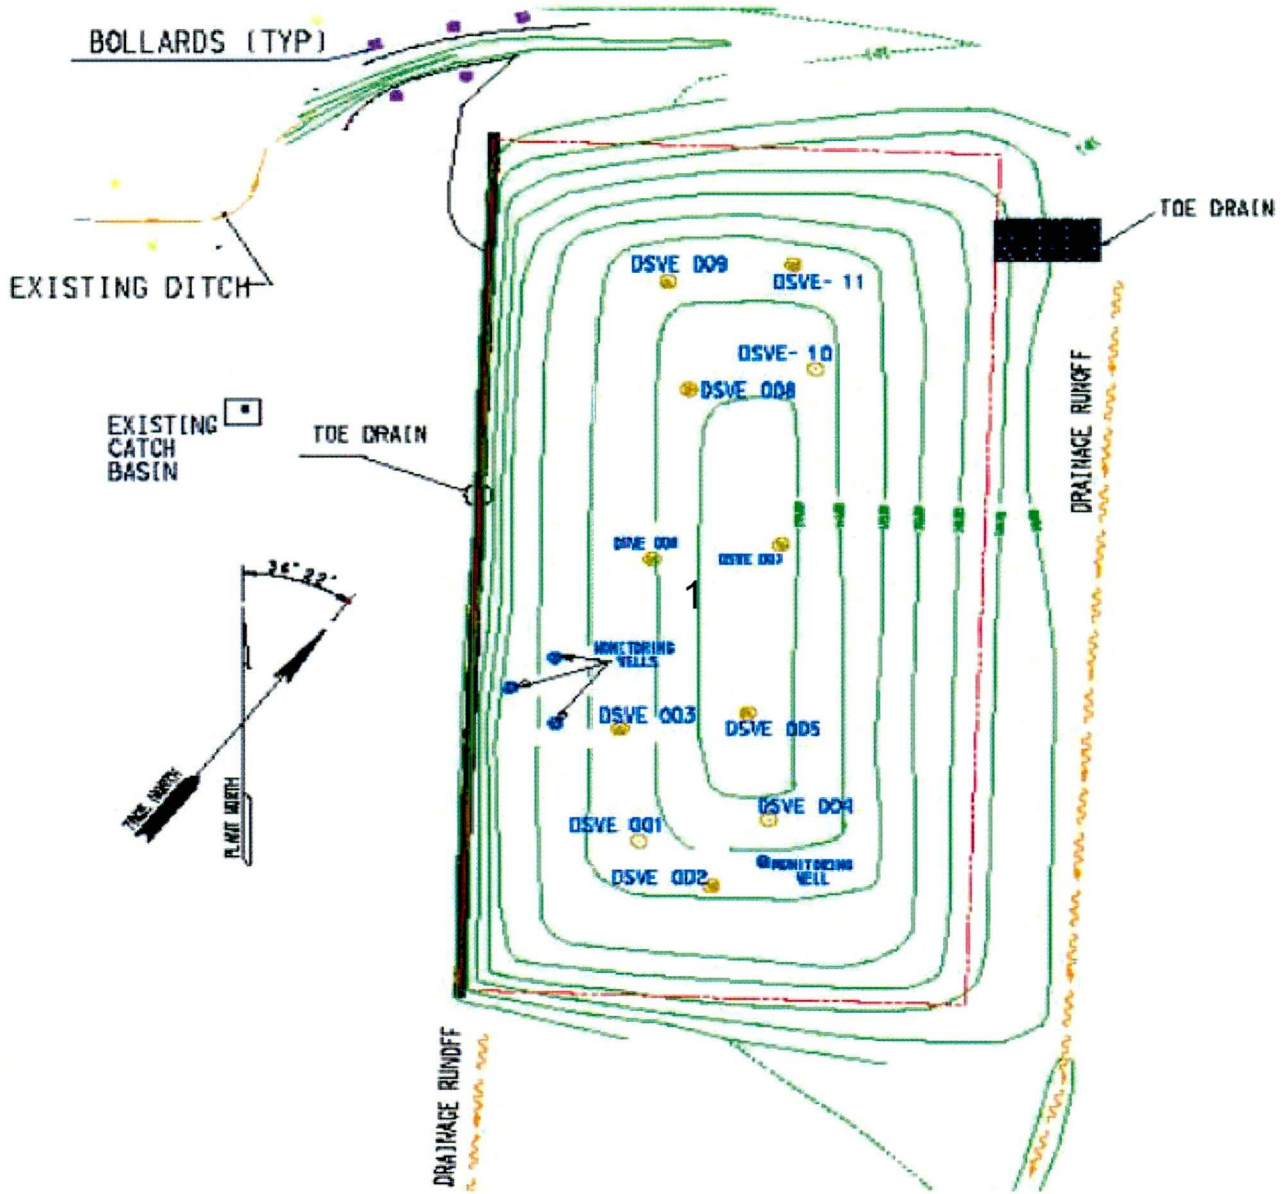
NOTES: 1=Active ant mounds on soil cover. Applied 0.25 lbs. of extinguish ant bait.

Description Of Maintenance Item
Active ant mounds on waste unit

Maintenance Item Corrected
Applied Extinguish pesticide
