**ENVIRONMENTAL COMPLIANCE & AREA COMPLETION PROJECTS (EC&ACP) STANDARD  
OPERATING PROCEDURES, VOL. I**

**Manual:** C3  
**Procedure:** ER-IDS-019-048  
**Revision:** 6  
**Effective Date:** 01/27/2022  
**Type-Class:** Checklist  
**Page:** 1 of 3

**R-REACTOR SEEPAGE BASINS 904-57G, 904-58G, 904-59G, 904-60G, 904-103G AND 904-104G  
FIELD INSPECTION CHECKLIST**

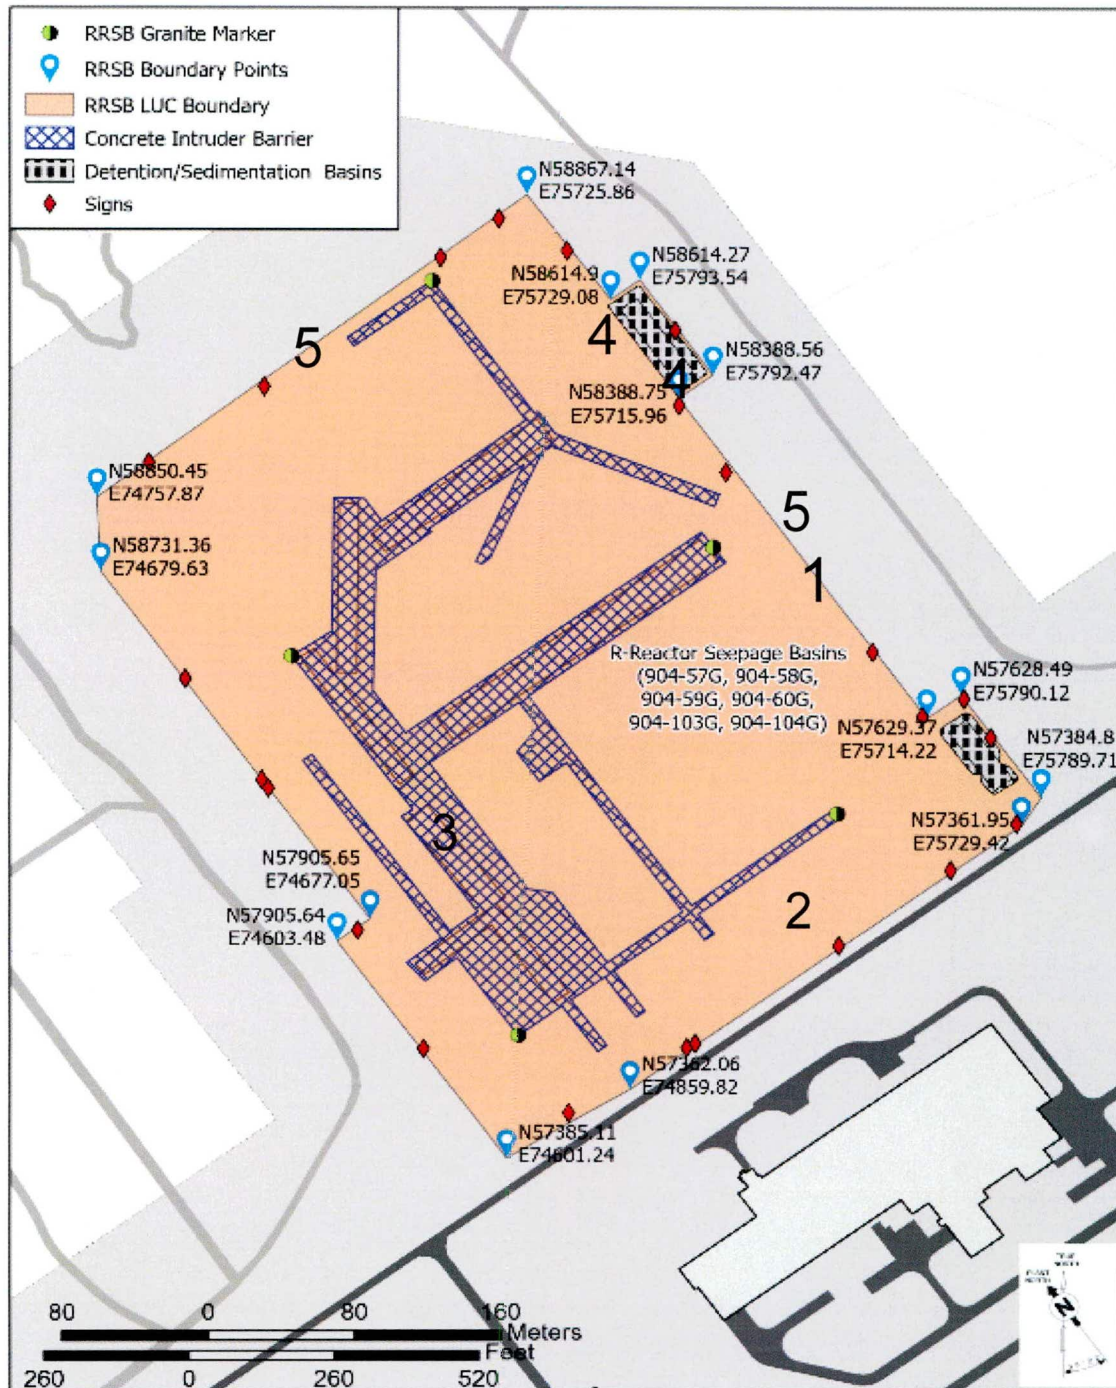
R-REACTOR SEEPAGE BASINS

A = Satisfactory X = Unsatisfactory (Explanation required)		A or X	Observation/Corrective Action Taken
3.	VERIFY fence is in good condition and locked (five locations).	X	Standing dead trees and vines at fence on the East fence line need removal See Map Note: 1 Reference Maintenance Register: PC-2022-00095

4.	CHECK asphalt cover for signs excessive cracking, depressions (subsidence), and burrowing animals.	X	Two cracks on the south side. See Map Note:2 Reference Maintenance Register: PC-2022-00096

5.	VERIFY no woody vegetation is growing through asphalt bioturbation barrier. REMOVE OR IDENTIFY as needed.	A	
6.	VERIFY there has not occurred excessive deterioration of concrete cover.	X	Concrete cover has areas of cracking and sealant in control joints is deteriorated See Map Note: 3 Reference Maintenance Register: PC-2022-00097 Note: Zone 4 concrete repairs were completed in FY23, zones 1,2 and 3 will be completed in FY24. Please see map of zones on page 3A.

7.	CHECK integrity of sediment basins (2) and drainage ditches for presence of excessive erosion, sediment build-up, and debris restricting water flow.	X	Minor Erosion is present at the inlets to the North sediment basin See Map Note:4 Reference Maintenance Register: PC-2023-00071

9.	VERIFY there are no unauthorized excavation, digging, or construction activities in R-Reactor Seepage Basin (RRSB) Operable Unit.	A	
10.	Other. Two fallen trees across fence	X	Two trees fell across perimeter fence on the East and West sides. USFS removed the trees and temporarily repaired the fence to prevent access until permanent repairs can be made. See Map Note: 5 Reference Maintenance Register: PC-2023-00072

- NOTES:**
- 1=Standing dead trees and vines at fence on the East fence line need removal. USFS will cut and remove dead trees and clear vines from fence.

- 2=Two cracks in the asphalt cover. The cracks will be filled with a repair sealant that engineering will specify.
  - 3=Concrete cover has areas of cracking and sealant in control joints is deteriorated. Construction will repair concrete and replace sealant in the control joints.

- Note: Zone 4 concrete repairs were completed in FY23. Zones 1,2 & 3 will be completed in FY 24. Please see map of zones on page 3A.
- 4=Minor Erosion is present at the inlets to the North sediment basin. Minor areas of erosion will be repaired with rock.

- 5=Two trees fell across perimeter fence on the East and West sides. USFS removed the trees and temporarily repaired the fence to prevent access until permanent repairs can be made. USFS will make permanent repairs.
