ENVIRONMENTAL COMPLIANCE & AREA COMPLETION PROJECTS (EC&ACP) STANDARD OPERATING PROCEDURES, VOL. I

Manual: C3
 Procedure: ER-IDS-019-020
 Revision: 6
 Effective Date: 11/23/2020
 Type-Class: Checklist
 Page: 1 of 4

METALLURGICAL LABORATORY HAZARDOUS WASTE MANAGEMENT FACILITY (HWMF) POST CLOSURE FIELD INSPECTION CHECKLIST

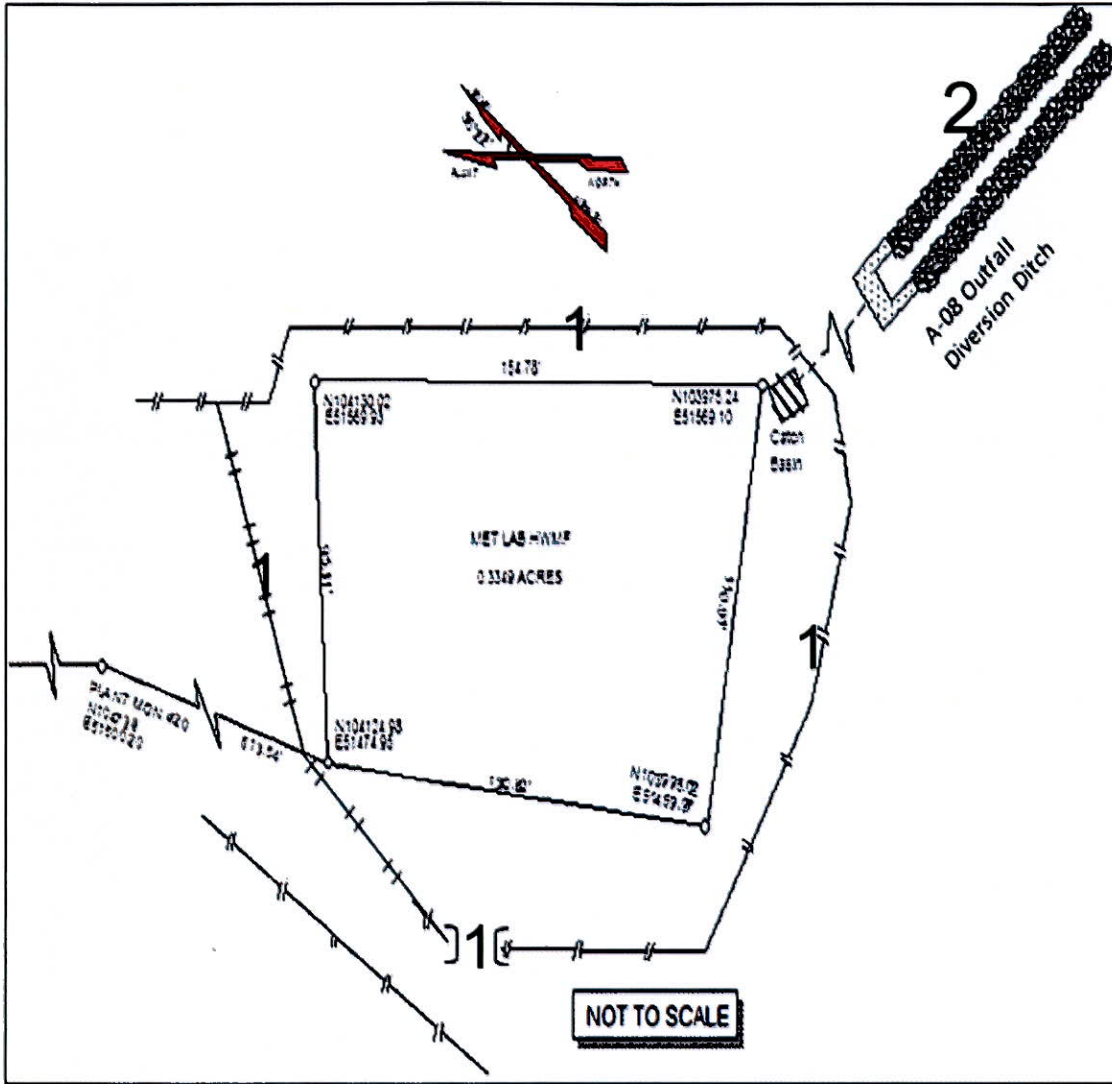
Map of Metallurgical Laboratory HWMF

A = Satisfactory X = Unsatisfactory (Explanation required)	A or X	Observation/Corrective Action Taken
1. VERIFY roads to waste unit are accessible.	A	
2. VERIFY signs on the fence are in acceptable condition and are legible from a distance of 25 feet. Signs must include "Danger Unauthorized Personnel Keep Out" and include Post Closure Manager and Savannah River Site Operations Center contact information.	X	New signs have been ordered with Post Closure Manager info on them. SEE Map note 1: Reference Maintenance Register: PC-2024-00030

A = Satisfactory X = Unsatisfactory (Explanation required)		A or X	Observation/Corrective Action Taken
10.	INSPECT A-08 Outfall Diversion Ditch for the presence of erosion and debris restricting water flow.	X	Vegetation needs herbicide applied in A-008 Diversion Ditch. See map note:2 reference maintenance register:PC-2024-00083
11.	Other None	A

Note 2: Vegetation needs herbicide applied in A-008 Diversion Ditch. Maintenance register: PC-2024-00083

NOTES: NOTE 1: Ordered new Waste site signs with proper info on it. Maintenance register PC-2024-00030
