**ENVIRONMENTAL COMPLIANCE & AREA COMPLETION PROJECTS (EC&ACP) STANDARD
OPERATING PROCEDURES, VOL. I**
**R-AREA OPERABLE UNIT REACTOR BUILDING AND DISASSEMBLY BASIN FIELD INSPECTION
CHECKLIST**
Manual: C3
Procedure: ER-IDS-019-063
Revision: 4
Effective Date: 1/08/2020
Type-Class: Checklist
Page: 1 of 3
WORKING COPY

R-Area Operable Unit Reactor Building and Disassembly Basin Field Inspection Checklist

Map of R-Area Operable Unit Reactor Building and Disassembly Basin

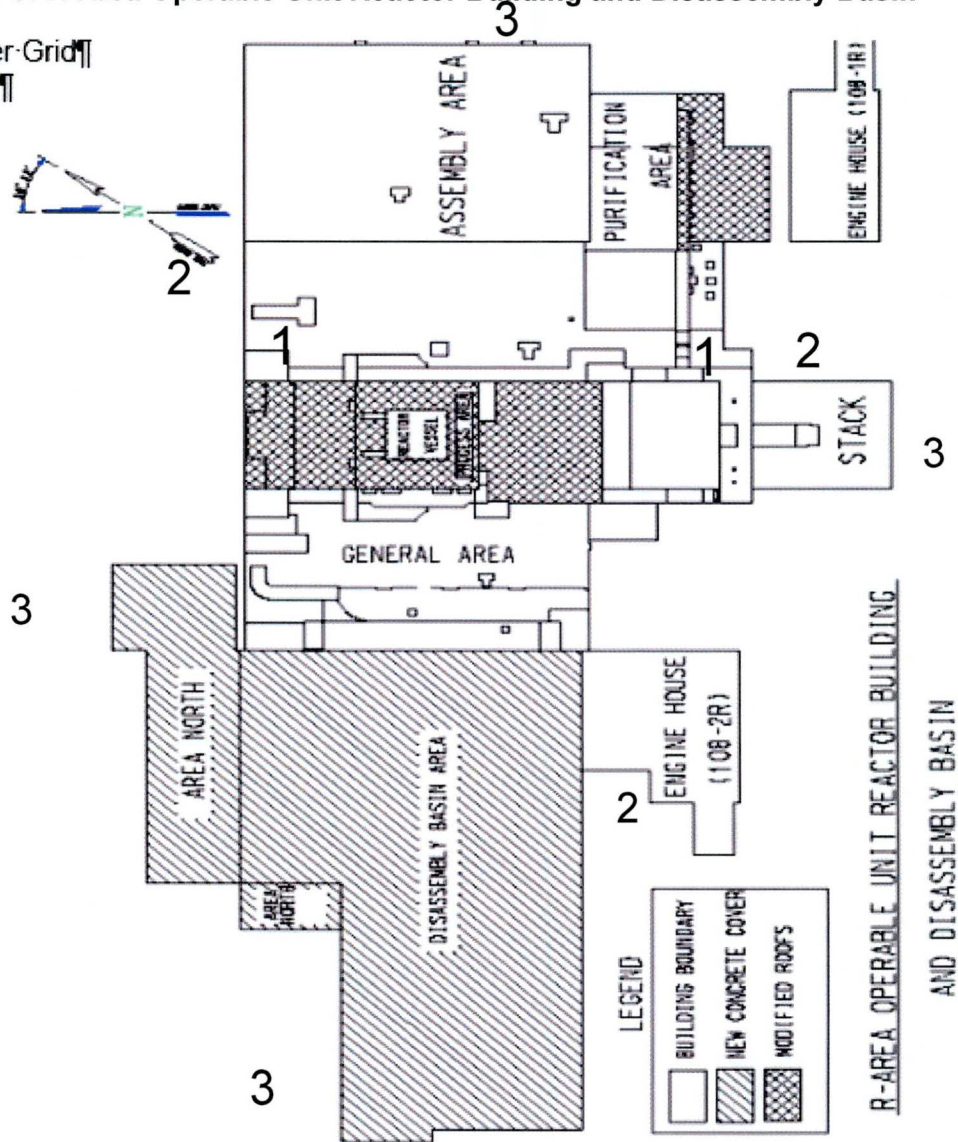
- 1=Roofs are functioning as intended and are free of woody vegetation with the exception of two small woody plants that we will apply herbicide to in the spring of 2024.
- 2=Carry over item: Hog damage (rooting) next to the 105 Reactor building, on the North and South sides. There is also damage next to 108-2R
- 3=Active Ant Mounds around the perimeter of building. Applied 2 lbs. of Extinguish ant bait.
