**ENVIRONMENTAL COMPLIANCE & AREA COMPLETION PROJECTS (EC&ACP) STANDARD
OPERATING PROCEDURES, VOL. I**
**R-AREA OPERABLE UNIT REACTOR BUILDING AND DISASSEMBLY BASIN FIELD INSPECTION
CHECKLIST**
Manual: C3
Procedure: ER-IDS-019-063
Revision: 4
Effective Date: 1/08/2020
Type-Class: Checklist
Page: 1 of 3
WORKING COPY

R-Area Operable Unit Reactor Building and Disassembly Basin Field Inspection Checklist

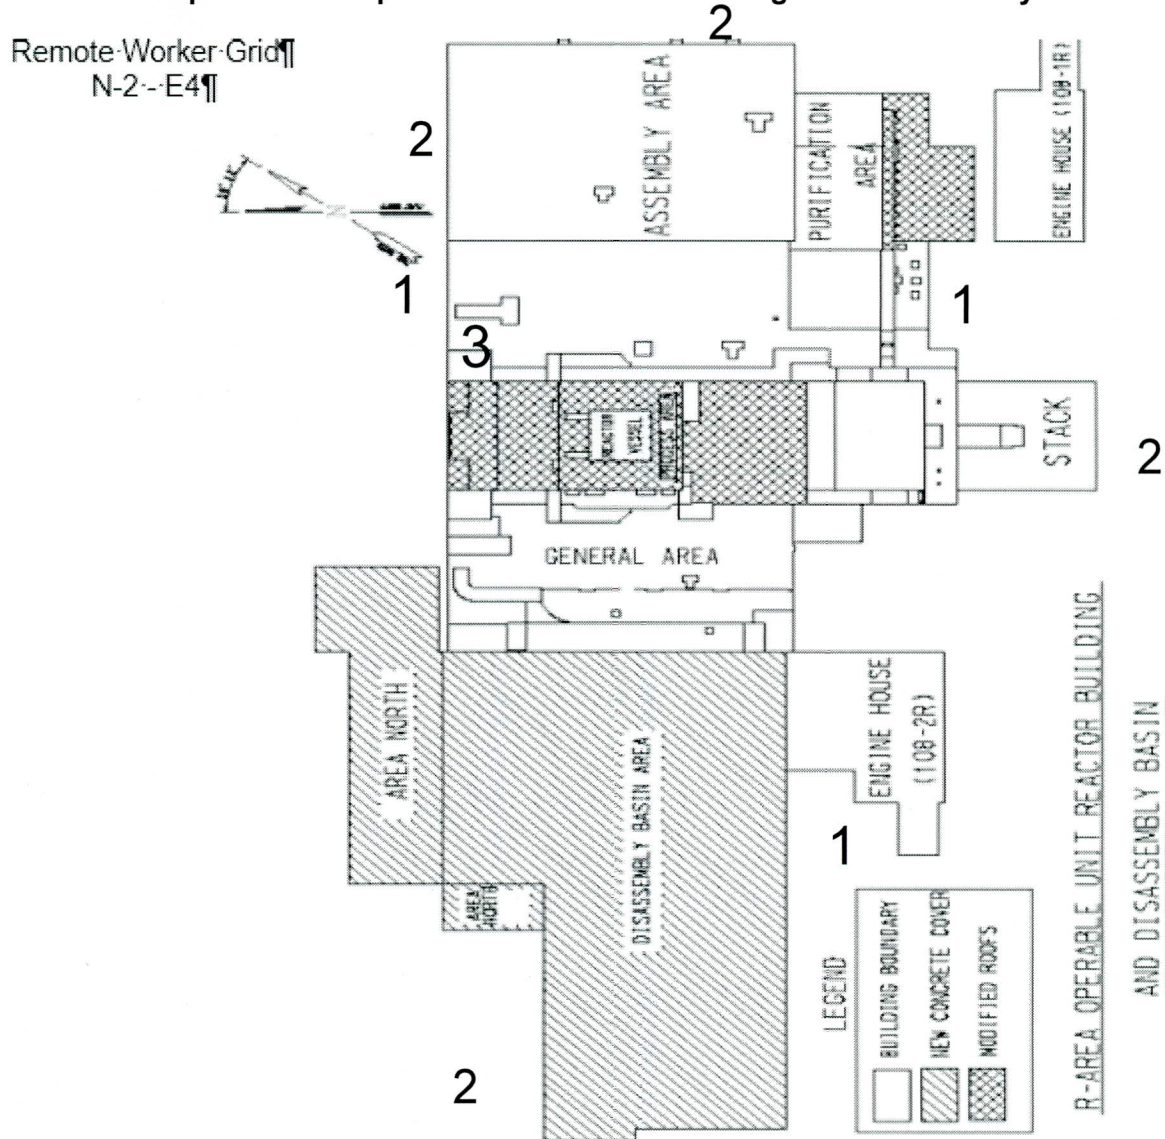
Map of R-Area Operable Unit Reactor Building and Disassembly Basin

6.	Verify there are no unauthorized excavations, digging, or construction activities at or in close vicinity of building.	A	
7.	Other Hog Damage Active Ant Mounds	X	Hog damage (rooting) next to the 105 Reactor building, on the North and South sides. There is also damage next to 108-2R. See Map Note: 1 Reference Maintenance Register PC-2022-000106 Active Ant Mounds around the building. See Map Note: 2. Ref. Maint. Reg: PC-2022-00107

NOTES: 1=Hog damage (rooting) next to the 105 Reactor building, on the North and South sides. There is also damage next to 108-2R
 2=Active Ant Mounds around the perimeter of building. Applied 2 lbs. of Extinguish ant bait.
 3=Roofs are functioning as intended and are free of woody vegetation with the exception of one small woody plant that we will apply herbicide to in the spring of 2023.

Applied Extinguish ant bait
