ENVIRONMENTAL COMPLIANCE & AREA COMPLETION PROJECTS (EC&ACP) STANDARD OPERATING PROCEDURES, VOL. I

Manual: C3
Procedure: ER-IDS-019-018
Revision: 3
Effective Date: 11/26/2018
Type-Class: Checklist
Page: 1 of 4

MIXED WASTE MANAGEMENT FACILITY POST CLOSURE INSPECTION, BLDG. 643-28E AND LOW-LEVEL RADIOACTIVE WASTE DISPOSAL FACILITY FIELD INSPECTION CHECKLIST

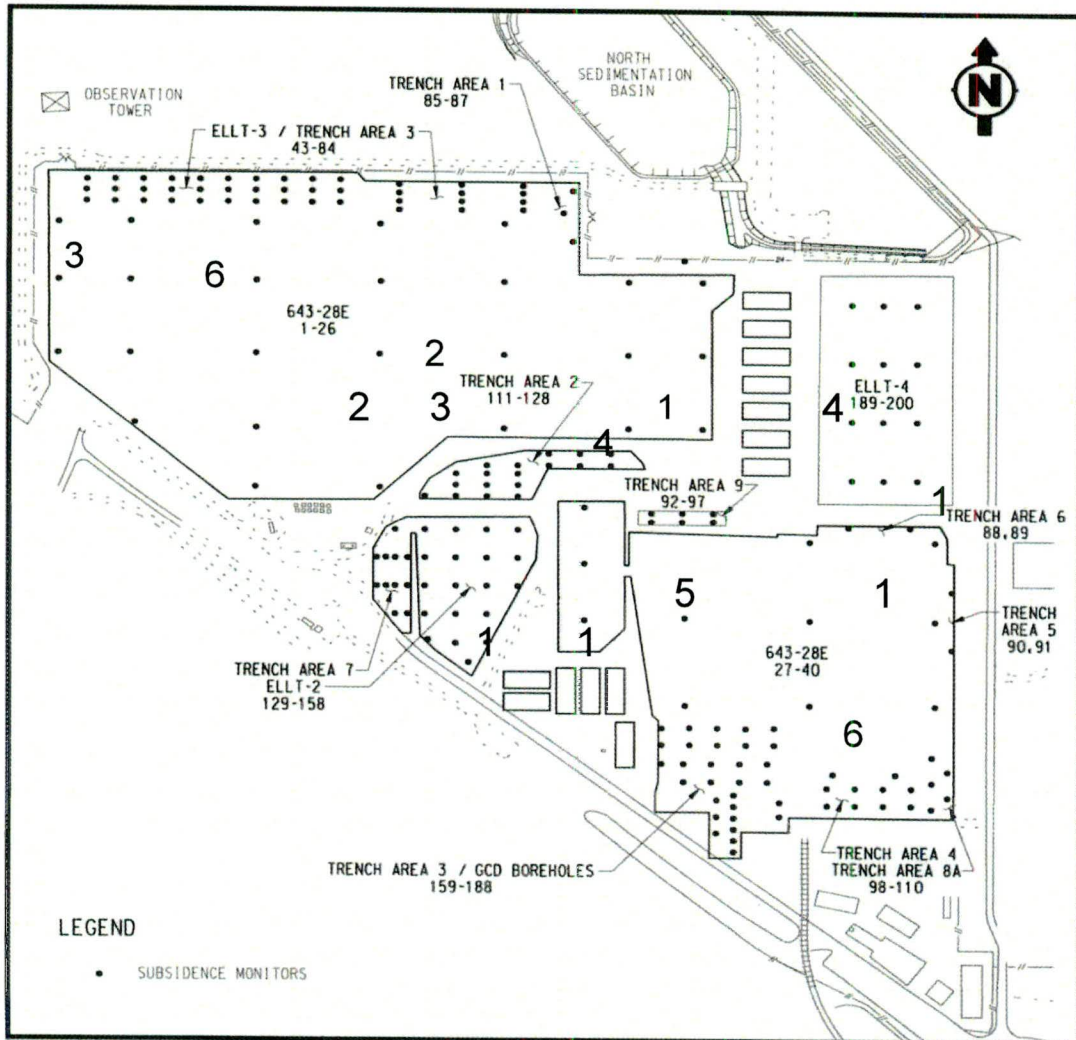
Map of Mixed Waste Management Facility, Bldg. 643-28E and Low-Level Radioactive Waste Disposal Facility

4.	Check for excessive vegetation growing over fences which may obstruct warning signs or visibility of the closure cover.	A	
5.	Inspect closure cover and check for erosion, uncovered buried waste, abnormal soil cracks, and presence of burrowing animals.	X	Active ant mounds on soil cover. See map note: 1 Ref. maint. register PC-2019-00078

6.	Check integrity of concrete-lined drainage channels inside and outside fenced areas for the presence of erosion or debris restricting water flow. Build-up of debris/sedimentation in drainage ditches is not to exceed 2 inches. Ditches are designed to collect run-off and divert run-on. Standing water in the ditches or on the cover is not to exceed defined limits.	X	Carry over item: Concrete joint sealant needs repair. See map note: 2 Ref. maint. register PC-2017-00066. Carry over item: Concrete lined channels has areas of spalling/flaking. See map note: 3 Ref. maint. register PC-2019-00023

9.	Visually check vegetative cover for grass density with no bare spots more than 3 feet in diameter. There should be no woody vegetation or shrubs growing on the closure covers. The height of vegetative cover should not impair visual inspection of closure. This will be determined by the EC&ACP Post Closure Inspector.	X	Carry over item: Rutting caused by mowing equipment during wet times. See map note: 5 Ref. maint. register PC-2018-00136

15.	Check gas vents for signs of damage or obstructions.	A	
16.	Other Subsidence on Trench 2. Carry over item: See map note: 4 Ref. maint. register PC-2019-00022	X	Subsidence noticed on Trench 2. This area of subsidence was also noticed on July 10, 2014 and repaired with topsoil, grass seed and straw on July 29, 2015 The area is currently under engineering evaluation for repair.

NOTES: 1=Active ant mounds on soil cover. Applied 0.5 lbs. of Extinguish ant bait. 2=Carry over item: concrete joint sealant in concrete channels needs repair. ACP will prepare a work package for repairs. 3=Carry over item: Concrete lined channels have areas of spalling The areas of spalling are currently under engineering evaluation for repair. Carry over item: 4=Subsidence noticed on Trench 2. Engineering is performing an evaluation for repair. 5=Carry over item: Rutting caused by mowing equipment during wet times. USFS will make repairs with topsoil, grass seed and straw.
