**ENVIRONMENTAL COMPLIANCE & AREA COMPLETION PROJECTS (EC&ACP) STANDARD
OPERATING PROCEDURES, VOL. I**
**P-AREA OPERABLE UNIT REACTOR BUILDING AND DISASSEMBLY BASIN FIELD INSPECTION
CHECKLIST**
Manual: C3
Procedure: ER-IDS-019-065
Revision: 4
Effective Date: 1/08/2020
Type-Class: Checklist
Page: 1 of 3
WORKING COPY

P-Area Operable Unit Reactor Building and Disassembly Basin Field Inspection Checklist

1902 P-AREA OPERABLE UNIT, REACTOR BUILDING AND DISASSEMBLY BASIN (105-P)

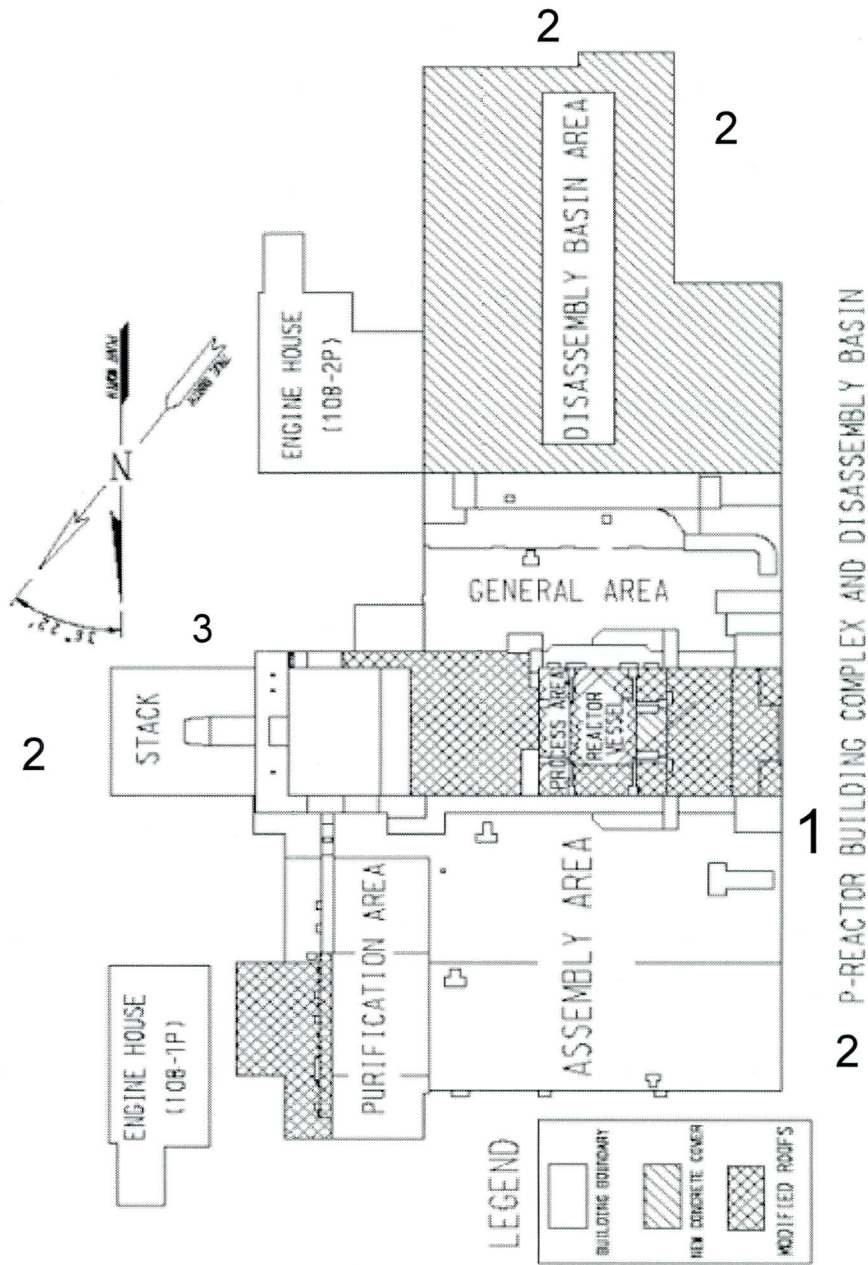
Map of P-Area Operable Unit Reactor Building and Disassembly Basin

4.	Verify excessive deterioration of disassembly basin cover has not occurred, basin cover is free from debris, and woody vegetation.	A	
5.	Check integrity of stone armament for presence of excessive erosion. Maintain area surrounding the building up to and including perimeter roads for vegetation.	X	Minor erosion at the toe of the stone armament located on the West side of building See Map Note: 1 Reference Maintenance Register PC-2022-00102

6.	Verify there are no unauthorized excavations, digging, or construction activities at or close vicinity of the building.	A	
7.	Other Active Ant Mounds Sink Hole	X	Active Ant Mounds around the building. See Map Note: 2. Ref. Maint. Reg: PC-2022-00103 Small sink hole. See Map Note:3. Ref. Maint. Reg: PC-2022-104

NOTES: 1=Minor erosion at the toe of the stone armament located on the West side of building. The erosion was caused by rain water discharge from the roof. Post Closure Maintenance filled the small eroded area with Riprap/rock. 2=Active Ant Mounds around the building. Applied 1.5 lbs. of Extinguish ant bait. 3=A small sink hole was found on 09/28/2022. The approx. 2x2x2 hole is located approximately 30 feet South of the 105-P Stack Area. The Rad Protection Department was notified and rad survey was performed. No detectable contamination was found. Reference Survey DDSG-M-20220928-1 for survey results. Engineering is evaluating the sink hole for cause and repair.

Engineering performed a field walkdown of the sink hole, reviewed P Reactor drawings, which revealed no evidence of anything below that would have caused it. The hole was repaired with compacted fill dirt per engineering direction.
