SRMC-STI-2022-00154
Revision 0

Annual Radioactive Waste Tank Inspection Program – 2021

June 2022

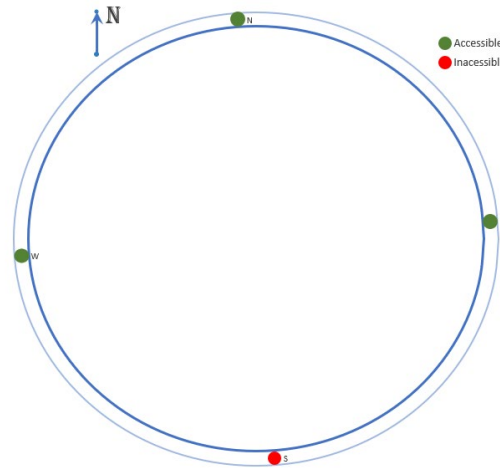
Annulus Inspection Location

Number of Known Leak Sites	Date of Discovery	Waste on Annulus Floor	Location	Elevation from Tank Bottom
≥ 1	Feb 1969	Small deposits on floor	Unknown	Unknown

Summary of Visual Inspections: No changes were noted since the inspections in 2020.

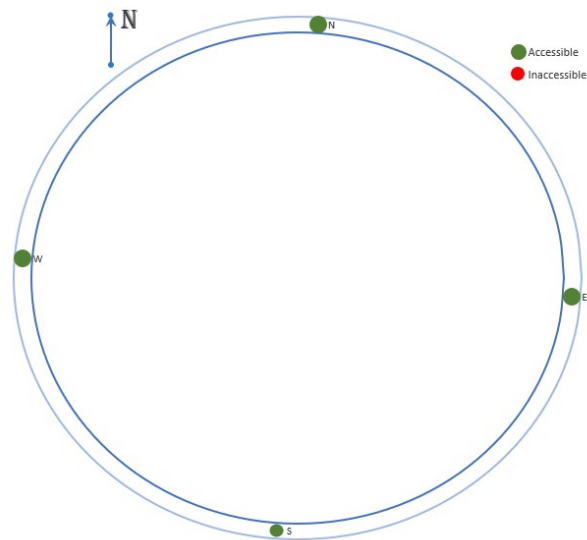
Annulus Inspection Location

Summary of Visual Inspections: No changes were noted since the inspections in 2020.

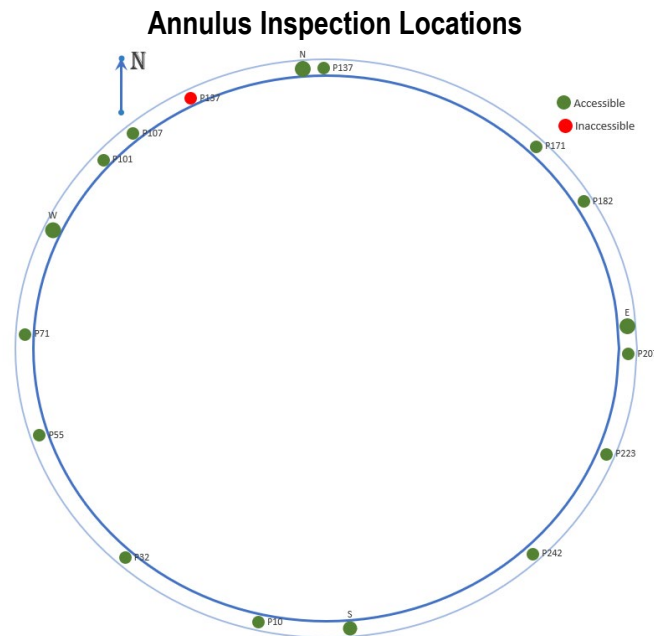
Conclusions following 2021 Inspections: **No significant surface corrosion or other anomalies were noted. The 2021 inspection confirmed the structural integrity and waste confinement capability of Tank 15.**
