ENVIRONMENTAL COMPLIANCE & AREA COMPLETION PROJECTS (EC&ACP) STANDARD OPERATING PROCEDURES, VOL. I

Manual: C3
Procedure: ER-IDS-019-018
Revision: 3
Effective Date: 11/26/2018
Type-Class: Checklist
Page: 1 of 4

MIXED WASTE MANAGEMENT FACILITY POST CLOSURE INSPECTION, BLDG. 643-28E AND LOW-LEVEL RADIOACTIVE WASTE DISPOSAL FACILITY FIELD INSPECTION CHECKLIST

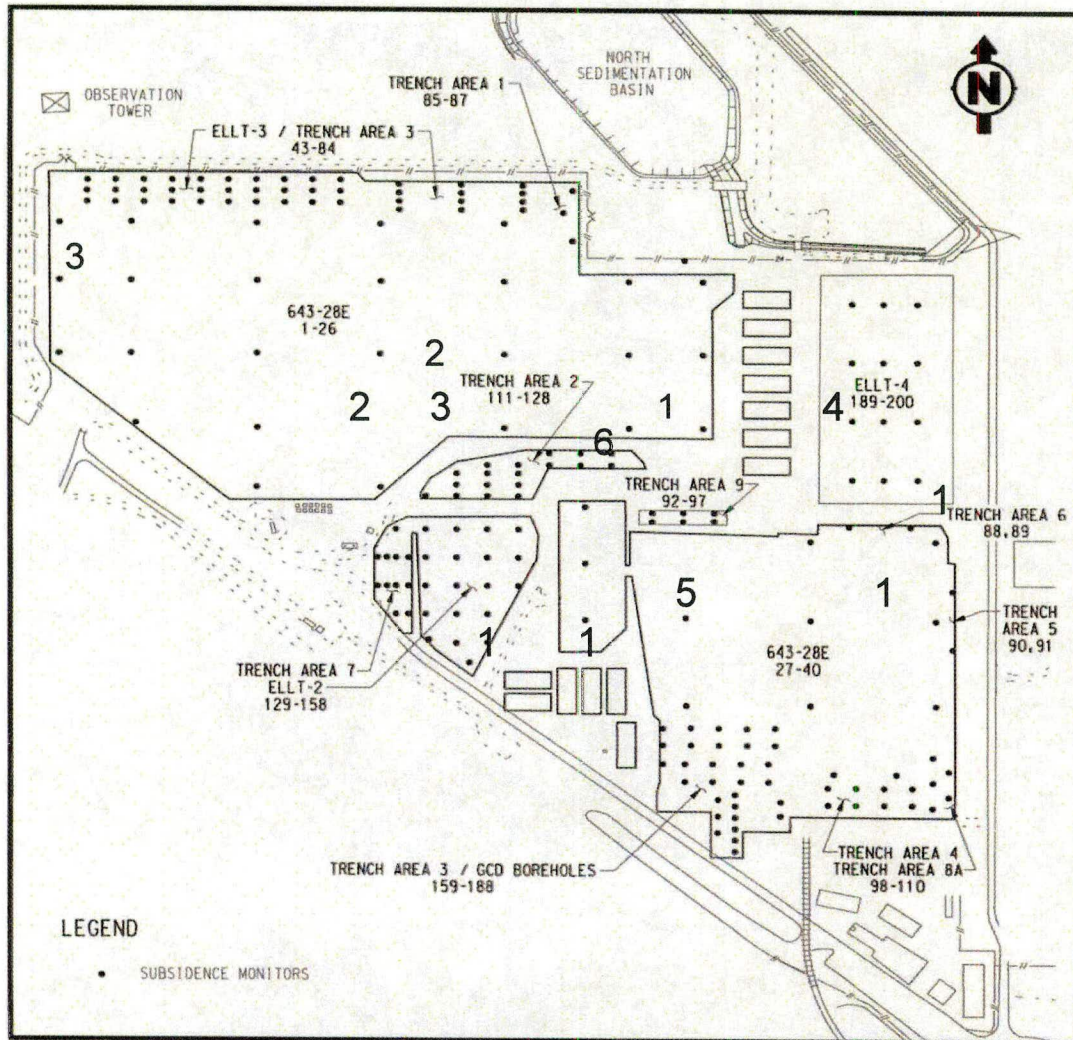
Map of Mixed Waste Management Facility, Bldg. 643-28E and Low-Level Radioactive Waste Disposal Facility

4.	Check for excessive vegetation growing over fences which may obstruct warning signs or visibility of the closure cover.	A	
5.	Inspect closure cover and check for erosion, uncovered buried waste, abnormal soil cracks, and presence of burrowing animals.	X	Active ant mounds on soil cover. See map note: 1 Ref. maint. register PC-2019-00021

6.	Check integrity of concrete-lined drainage channels inside and outside fenced areas for the presence of erosion or debris restricting water flow. Build-up of debris/sedimentation in drainage ditches is not to exceed 2 inches. Ditches are designed to collect run-off and divert run-on. Standing water in the ditches or on the cover is not to exceed defined limits.	X	Carry over item: Concrete joint sealant needs repair. See map note: 2 Ref. maint. register PC-2017-00066. Concrete lined channels has areas of spalling/flaking. See map note: 3 Ref. maint. register PC-2019-00023

7.	Visually verify weep holes in the concrete-lined drainage channels are not plugged.	A	
8.	Visually check the cover and side slopes for signs of ponding, slumping, excessive erosion, and any observable depressions indicating subsidence.	X	Carry over item: Small erosion on the West side slope of the Northeast cap. See map note: 4 Ref. maint register PC-2018-00135 See step 16

9.	Visually check vegetative cover for grass density with no bare spots more than 3 feet in diameter. There should be no woody vegetation or shrubs growing on the closure covers. The height of vegetative cover should not impair visual inspection of closure. This will be determined by the EC&ACP Post Closure Inspector.	X	Carry over item: Rutting caused by mowing equipment during wet times. See map note: 5 Ref. maint. register PC-2018-00136

15.	Check gas vents for signs of damage or obstructions.	A	
16.	Other Subsidence on Trench 2 See map note: 6 Ref. maint. register PC-2019-00022	X	Subsidence noticed on Trench 2. This area of subsidence was also noticed on July 10, 2014 and repaired with topsoil, grass seed and straw on July 29, 2015 The area is currently under engineering evaluation for repair.

NOTES: 1=Active ant mounds on soil cover. Applied 3 lbs. of Extinguish ant bait. 2=Carry over item: concrete joint sealant in concrete channels needs repair. ACP will prepare a work package for repairs. 3=Concrete lined channels have areas of spalling/flaking. The areas of spalling are currently under engineering evaluation for repair. 4=Small area of erosion on the West slope of the Northeast cap. USFS will make repairs with topsoil, grass seed and straw. 5=Carry over item: Rutting caused by mowing equipment during wet times. USFS will make repairs with topsoil, grass seed and straw. 6=Subsidence noticed on Trench 2. Engineering is performing an evaluation for repair.
