**ENVIRONMENTAL COMPLIANCE & AREA COMPLETION PROJECTS (EC&ACP) STANDARD
OPERATING PROCEDURES, VOL. I**
Manual: C3
Procedure: ER-IDS-019-071
Revision: 2
Effective Date: 06/01/2016
Type-Class: Form
Page: 1 of 3
D-AREA BUBBLE TOWER COVER FIELD INSPECTION CHECKLIST
WORKING COPY

D-area Bubble Tower Cover Field Inspection Checklist

D-Area Bubble Tower Cover

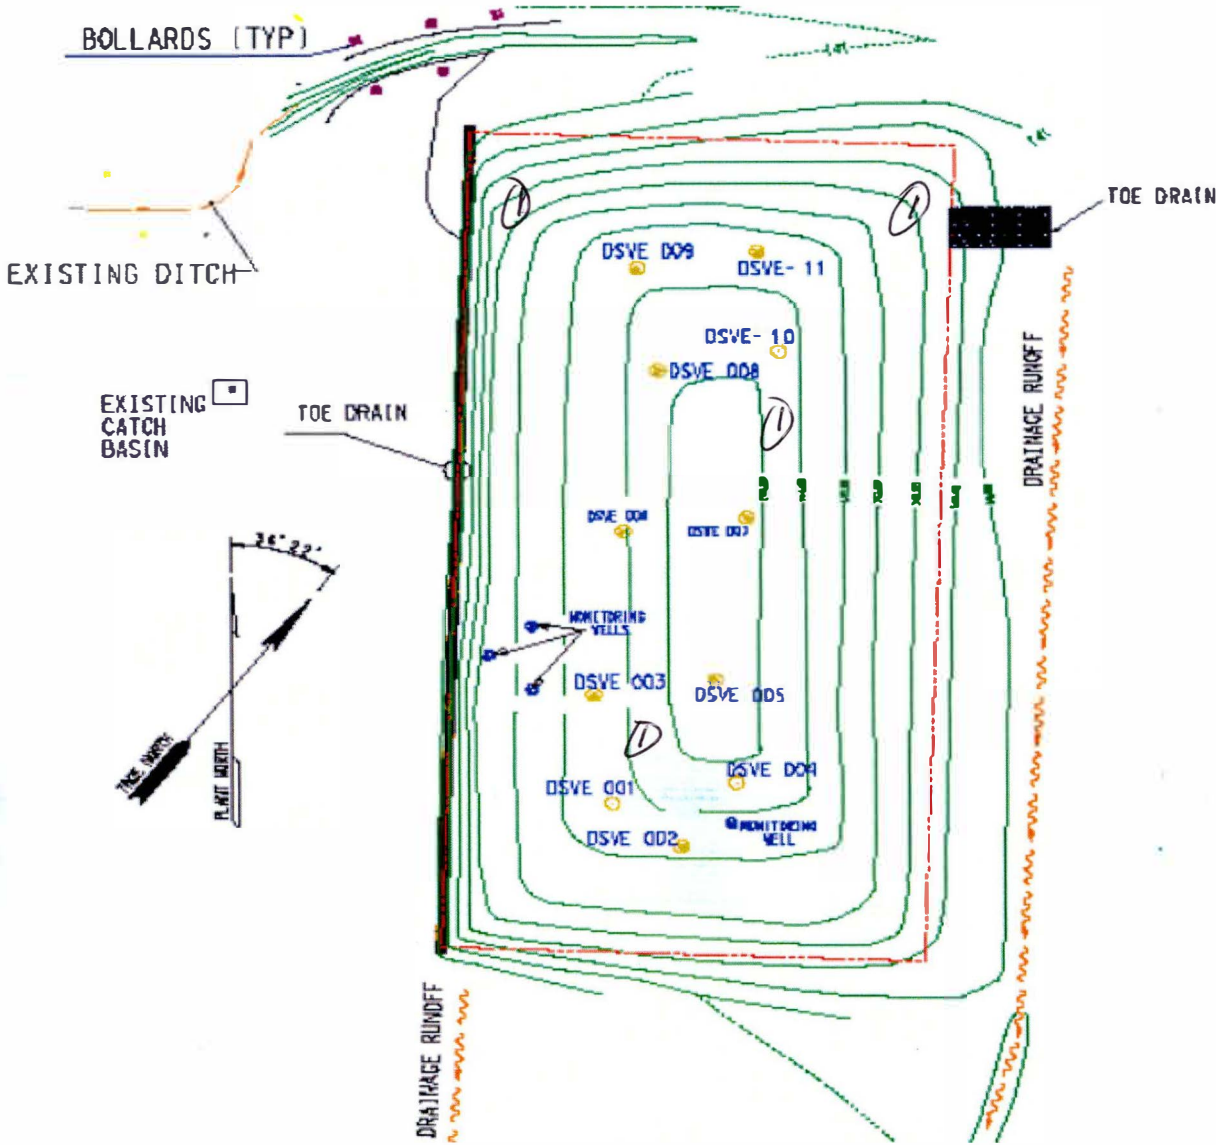
NOTES: (D) = ACTIVE ANT MOUNDS ON SOIL COVER. Applied 2.0 lbs. DF EXTINGUISH ANT BAIT.

Description Of Maintenance Item
Active ant mounds on waste unit

Maintenance Item Corrected
Applied Extinguish pesticide
