**Title: MONITORING OF CLOSED WASTE TANKS FOR HTF
AND FTF**

Facility	FTF	F-TANK FARM
Unit		Project
Work Order Type	PM	Priority 3B
WO Discipline	A	Written To MONITORING OF CLOSED WASTE TANKS
WO Planner	N9895	WO Planner Name HOCHSTETLER W
Task Planner	N9895	Task Planner Name HOCHSTETLER W
Work Order Title	MONITORING OF CLOSED WASTE TANKS FOR HTF AND FTF	Task Title MONITORING OF CLOSED WASTE TANKS FOR HTF AND FTF

Closed Waste Tank Annual Inspection Checklist Cover Sheet

Inspection Year: 2021

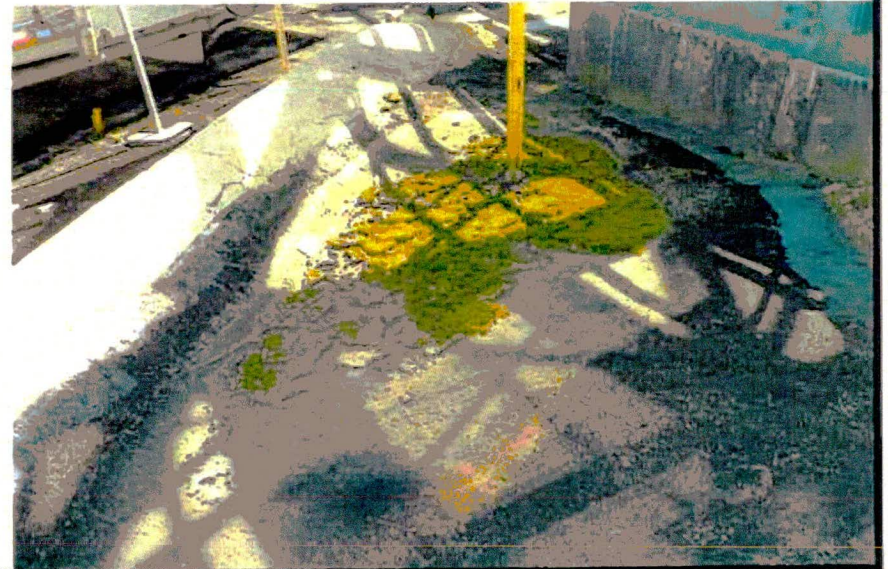
Tank 18, Depression North of East Riser

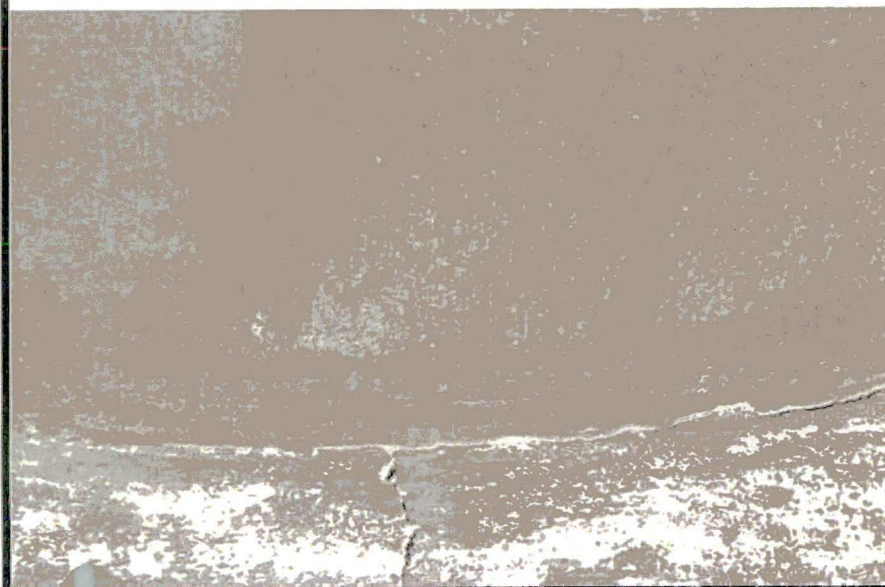
Tank 19, Northwest Riser (Crack on South Side)
