**ENVIRONMENTAL COMPLIANCE & AREA COMPLETION PROJECTS (EC&ACP) STANDARD
OPERATING PROCEDURES, VOL. I**
Manual: C3
Procedure: ER-IDS-019-020
Revision: 6
Effective Date: 11/23/2020
Type-Class: Checklist
Page: 1 of 4
**METALLURGICAL LABORATORY HAZARDOUS WASTE MANAGEMENT FACILITY (HWMF) POST
CLOSURE FIELD INSPECTION CHECKLIST**
WORKING COPY

Metallurgical Laboratory Hazardous Waste Management Facility (HWMF) Post Closure Field Inspection Checklist

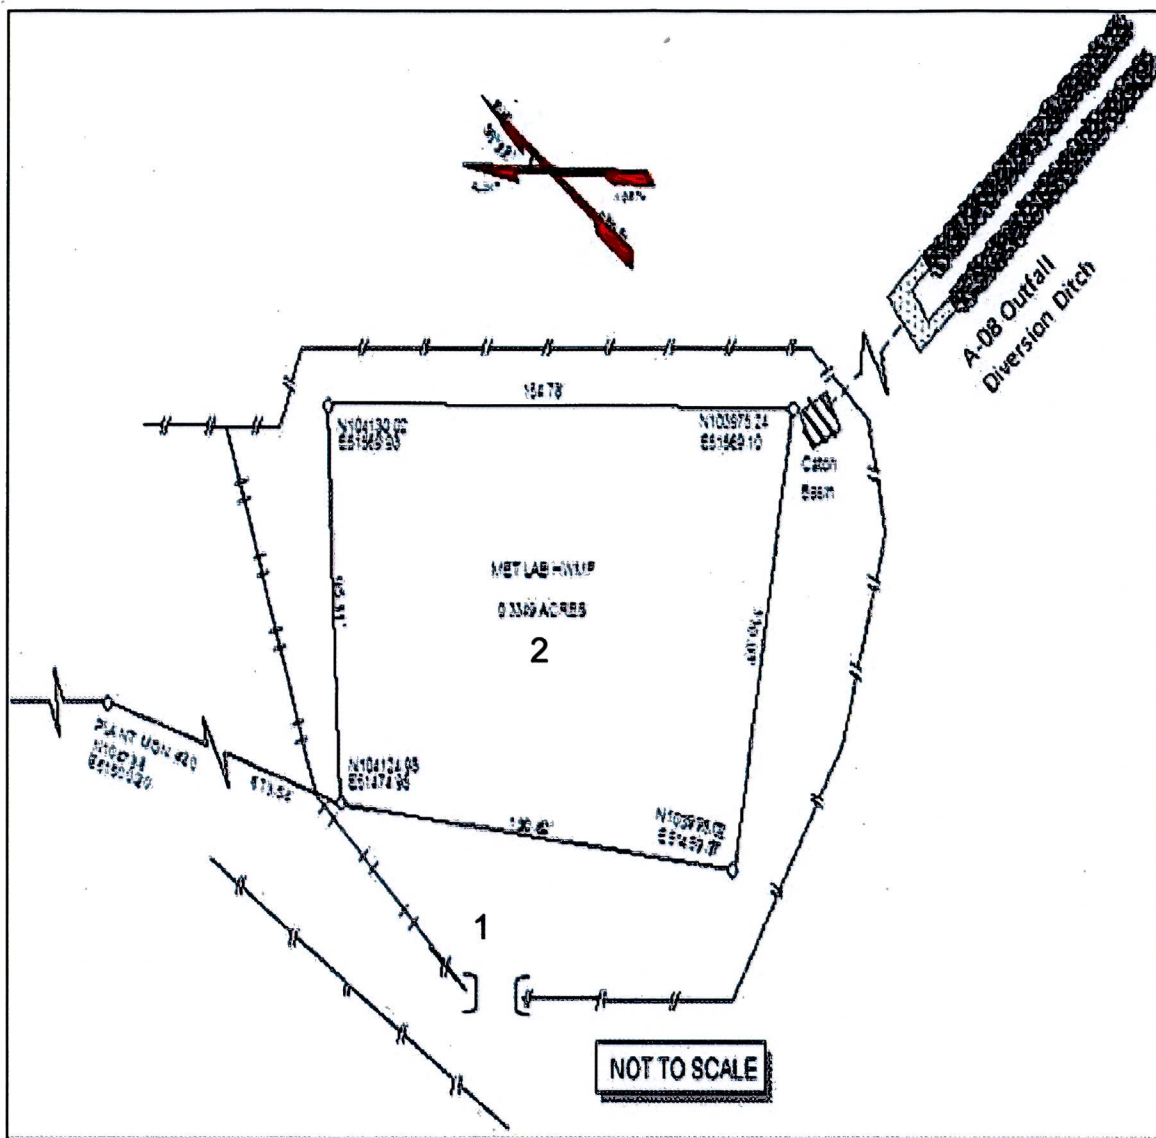
Map of Metallurgical Laboratory HWMF

A = Satisfactory X = Unsatisfactory (Explanation required)	A or X	Observation/Corrective Action Taken
3. VERIFY fence is in good condition (e.g., shows no signs of serious wear, no vegetative growth) and unattended gates are locked.	X	Carry over item: Bottom piece of frame work tubing on the entry gate is rusted through See Map Note:1 Reference Maintenance Register: PC-2021-00070

4. CHECK the soil cover and side slopes for signs of erosion, depression (subsidence) and evidence of burrowing animals.	X	Active Ant Mounds on Soil Cover See Map Note: 2 Reference Maintenance Register: PC-2021-00109

NOTES: 1=Carry over item: Bottom piece of frame work tubing on the entry gate is rusted through.

2=Active Ant Mounds on soil cover. Applied 1.0 lb. of extinguish ant bait.

Gate will be repaired with a new piece of frame work tubing.
