**ENVIRONMENTAL COMPLIANCE & AREA COMPLETION PROJECTS (EC&ACP) STANDARD
OPERATING PROCEDURES, VOL. I**
Manual: C3
Procedure: ER-IDS-019-065
Revision: 4
Effective Date: 1/08/2020
Type-Class: Checklist
Page: 1 of 3
**P-AREA OPERABLE UNIT REACTOR BUILDING AND DISASSEMBLY BASIN FIELD INSPECTION
CHECKLIST**
WORKING COPY

P-Area Operable Unit Reactor Building and Disassembly Basin Field Inspection Checklist

1902 P-AREA OPERABLE UNIT, REACTOR BUILDING AND DISASSEMBLY BASIN (105-P)

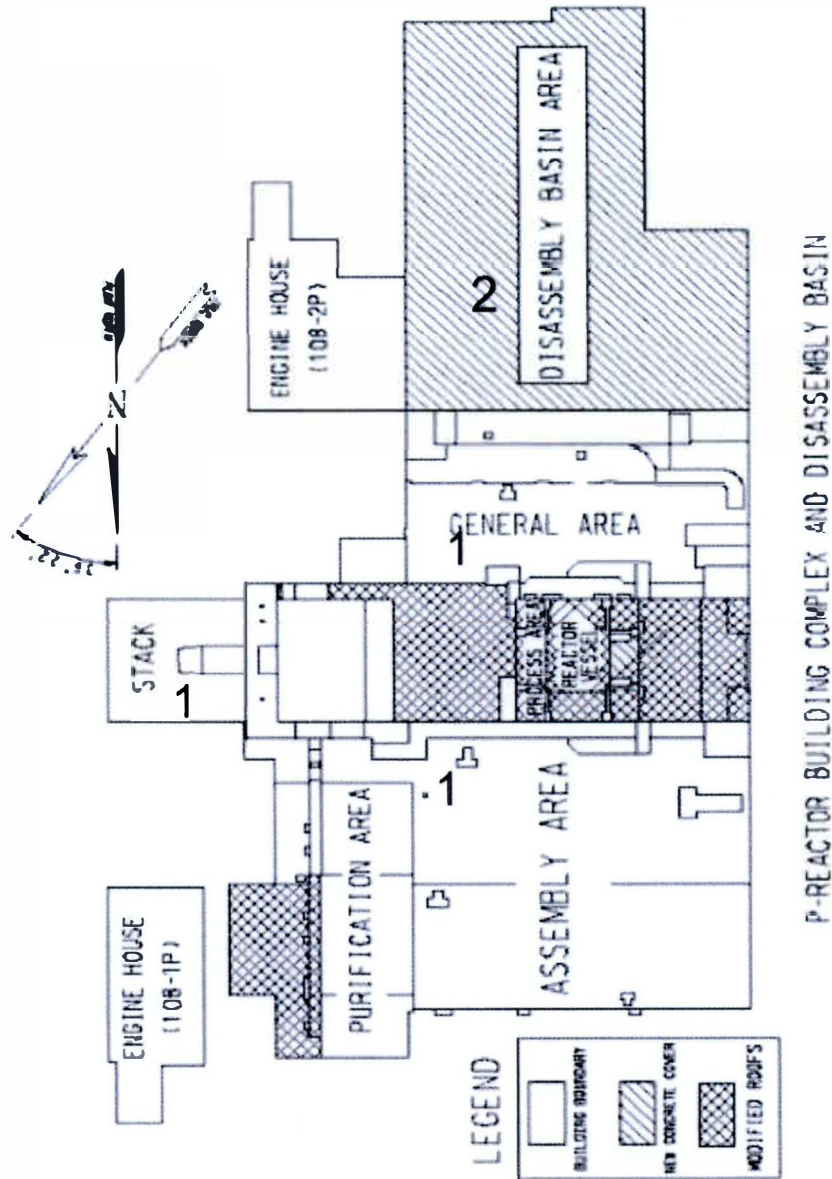
Map of P-Area Operable Unit Reactor Building and Disassembly Basin

NOTES: 1=Carry over item: Roofs are functioning as intended. Non-woody vegetation exist and hinders drainage. Efforts will be made to remove vegetation. 2=Carry over item: Several areas of caulking in expansion joints need repair. Work package for repair is in development
