P-Area Operable Unit Reactor Building and Disassembly Basin Field Inspection Checklist

P-Area Operable Unit Reactor Building and Disassembly Basin

2017, 105-P Inspection

FROM: GUY R. BALDWIN 730-2B/2175 *ARB***105-P ACTUATOR TOWER ROOF SLAB FLAW AT THE SOUTHEAST CORNER**

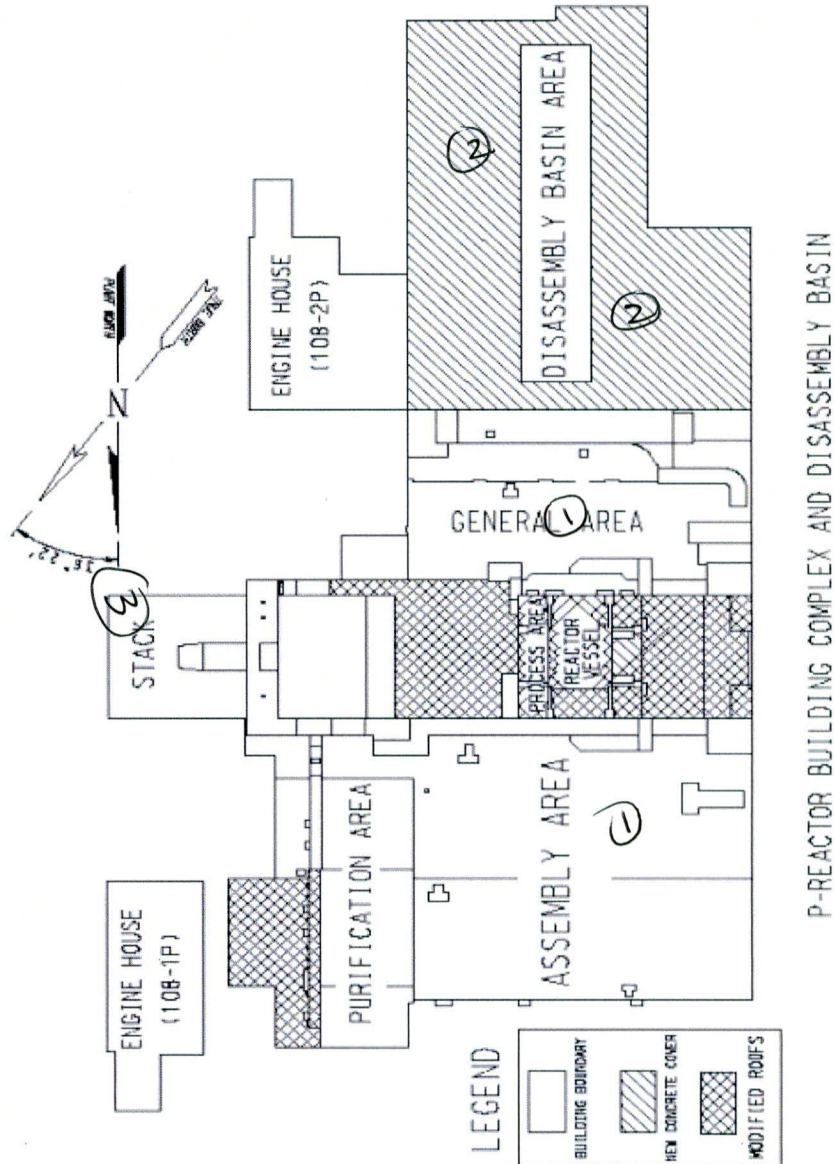
NOTES: ①: VEGETATION GROWING ON ROOF. ACP IS CURRENTLY DEVELOPING A WORK PACKAGE TO CLEAN SILT, SAND, DEBRIS AND REMOVE VEGETATION.
 ② SEVERAL AREAS OF CAULKING IN EXPANSION JOINTS NEED REPAIR. ACP WILL DEVELOP A WORK PACKAGE TO REPAIR CAULKING JOINTS ON THE DISASSEMBLY BASIN COVER
 SEE ATTACHED CTF REVIEW COMMENTS

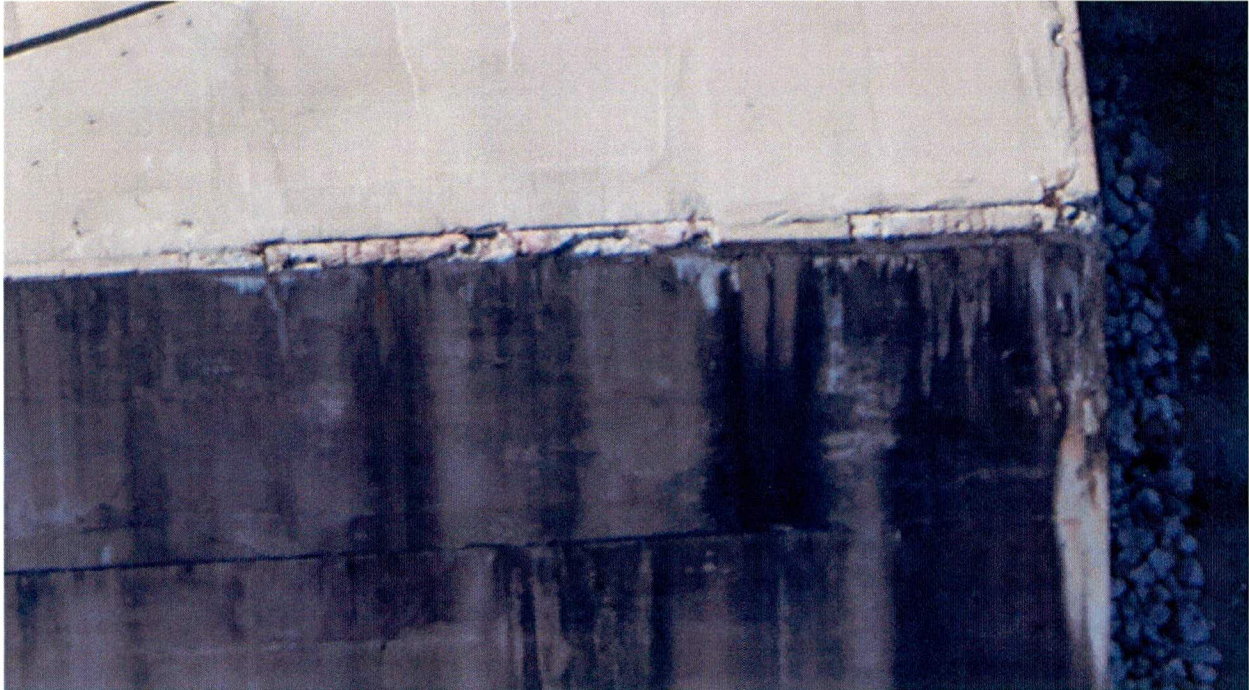
Photo 1: Concrete Edge Degradation

Condition of the roofs remained the same since last inspection. There was no further deterioration at the edge of concrete roof where stack was located and the flaw on the high hat (See Attached Memo). Vegetation growth is present at various areas on the roof. The sediment should be removed to eliminate and prevent vegetation. Some spots exist on the roof that cause the potential for pooling water. A crack on the process room cap appears to be widening and should continue to be monitored. The crack on the north face below the actuator has no change. Please see pictures for further details.

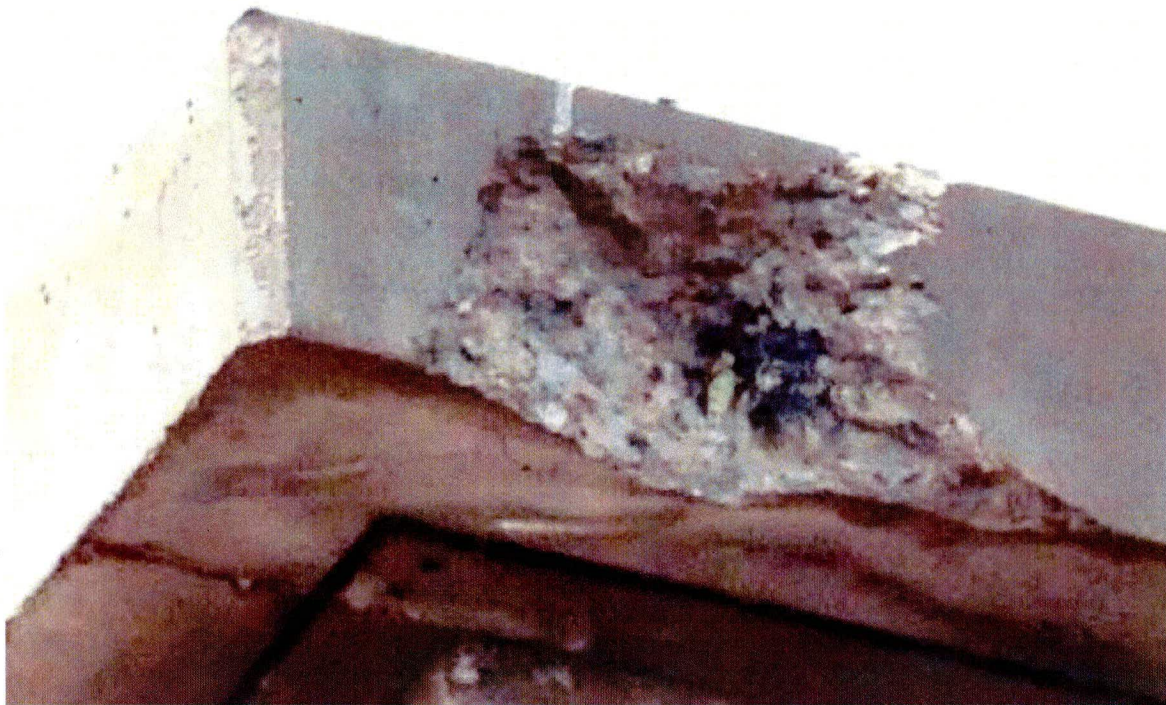
Image DSC 0009

6. The surface of the flaw appears to vary. The upper right portion in Photo DSC 0009 (attached) is clearly a break. The aggregate is fully exposed or split. The flaw near the exposed bar has a coating of cement paste over the aggregate; however there is no paste visible on the exposed bar.

The observations of the surface texture indicate the flaw is a void in the concrete that had a thin veneer on the surface. The thin veneer was likely stripped away when the forms were removed, leaving the void exposed. Thus, the flaw is deemed a product of construction, which is corroborated by the attached "105-P Aerial Taken 9-14-12", showing the flaw was present a year after the slab was constructed.

The crack across the corner is an indication the corner was subjected to an impact, perhaps during removal of the scaffolding and forms used during installation. Given the bars embedded in the projecting portion of the corner, it is not likely the corner will fall off. This is further assured by the presence of effervescence on the bottom of the slab along the crack. The slab has Integral Crystalline Waterproofing (ICW) in the concrete mix to seal cracks should they form after the slab has hardened. Thus, it is thought the cracks are annealing over time.

The presence of this flaw in the edge of the overhang does not threaten the underlying Actuator Tower. There is no indication the flaw will allow water to get into the building. The exposed rebar would be vulnerable to corrosion without the epoxy coating; however, the coating protects the bar for a time.

Note the cracking across the underside of the overhang corner, exposed epoxy coated bar (depth 3"), aggregate exposed near the surface but not near the bar and the foreign material near the top of the exposed bar..

Continue to surveille the flaw on an annual basis for signs of degradation. If it is seen the exposed bar is corroding, or if the corner is degrading further it would be prudent to consider applying a repair mortar with corrosion inhibitor.

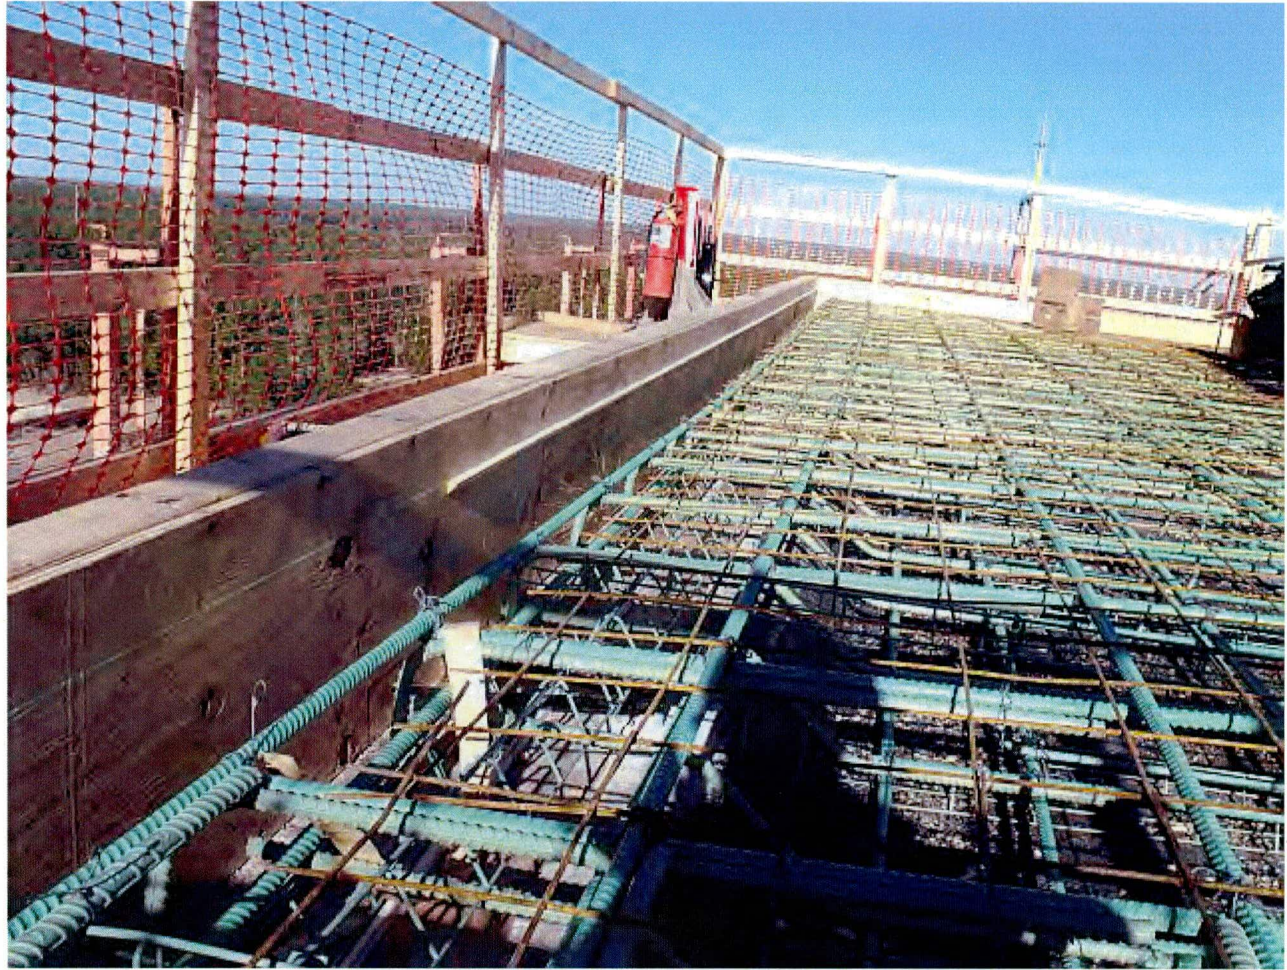
105-P Actuator Tower Roof Prep

Note the clear distance between the edge bars and the form is approximately 3" and the bars are coated with epoxy. No explanation for the welded wire mesh on top of the reinforcing grid.

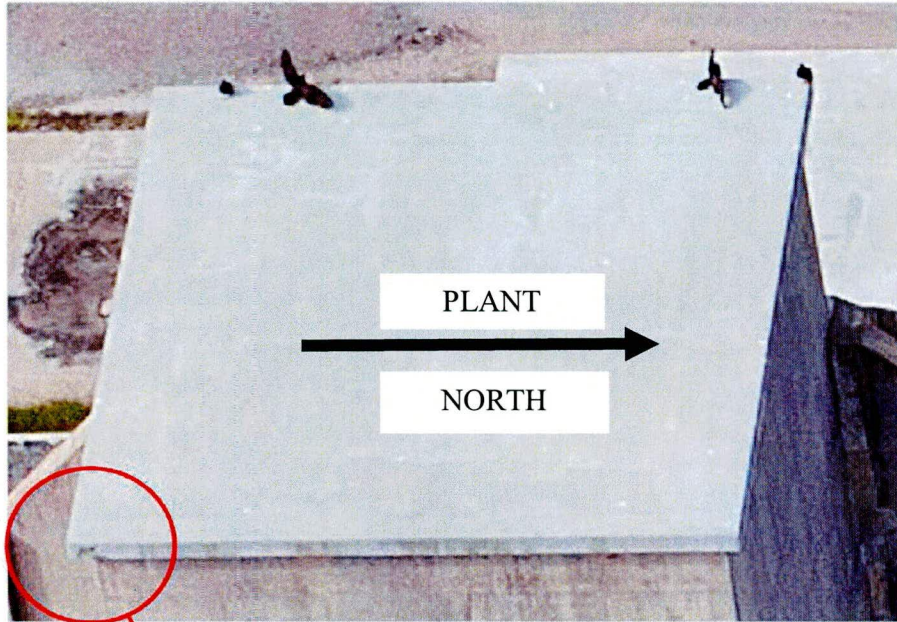
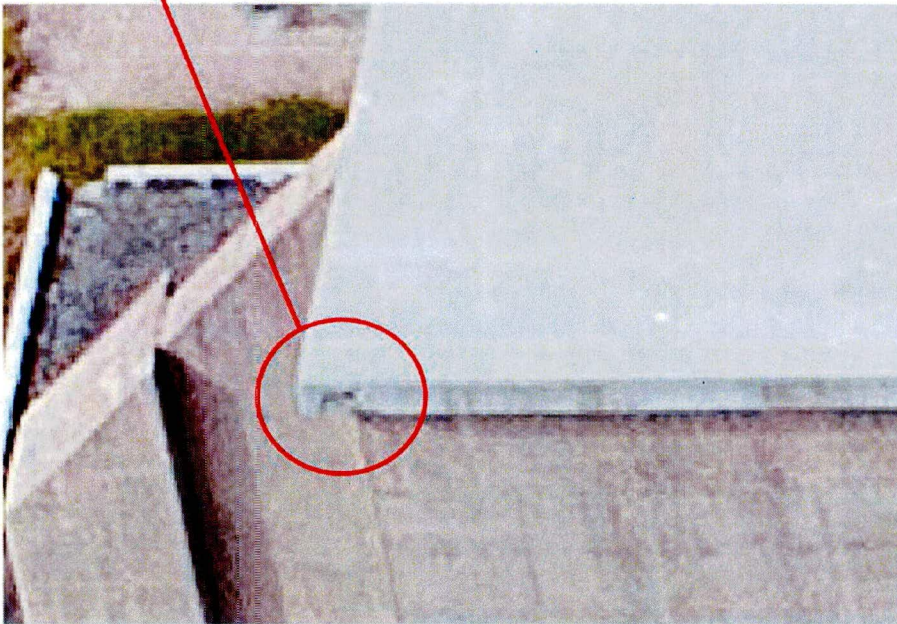
7. The "105-P Aerial Taken 9-14-12" (attached) shows this flaw was visible one year after the slab placement in 2011.

Aerial taken September 14, 2012 showing flaw was present one year after construction
