## Baseline Asbestos Inspection Report of Building 482-2D

Q-APG-D-00006  
October 30, 2019

**BASELINE ASBESTOS INSPECTION REPORT OF BUILDING 482-2D**

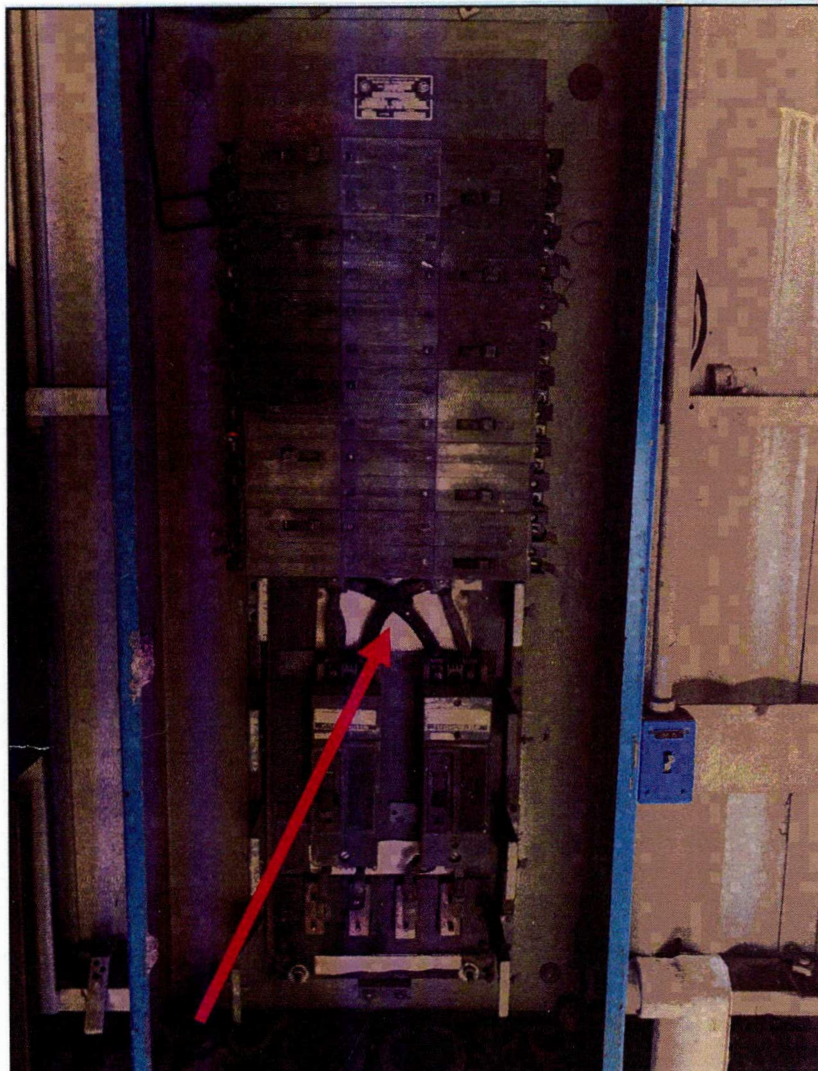
<b>Location: Observed at seams of exterior corrugated cementitious panels.</b>					
H04	Miscellaneous	<b>Description:</b> Cloth electrical wire jacketing (braided) <b>Sample Numbers:</b> N/A, inaccessible for sample collection.	Approximately 1 Linear Foot	<b>PACM</b>	Non-friable Good Condition
<b>Location: Observed inside panel box located on interior northeast side wall (See Photo 1).</b>					
H04	Miscellaneous	<b>Description:</b> Black colored arc shoot plates <b>Sample Numbers:</b> N/A, inaccessible for sample collection.	Approximately 1 Square Foot	<b>PACM</b>	Non-friable Good Condition
<b>Location: Observed inside panel box located on interior northeast side wall (See Photo 2).</b>

Photo 1. View of electrical wire jacking (facing northeast).

Although building 482-2D has been deactivated and placed in shutdown condition, the inspector could not verify that the building was de-energized. Therefore, all suspect materials visually identified inside the electrical panel boxes must be considered PACM until sampled by a licensed asbestos inspector. In addition, all gaskets (if any) must be considered PACM. Gaskets in unbroken flanges are determined to be encased in a hardened substance therefore not subject to regulatory requirements if undisturbed.

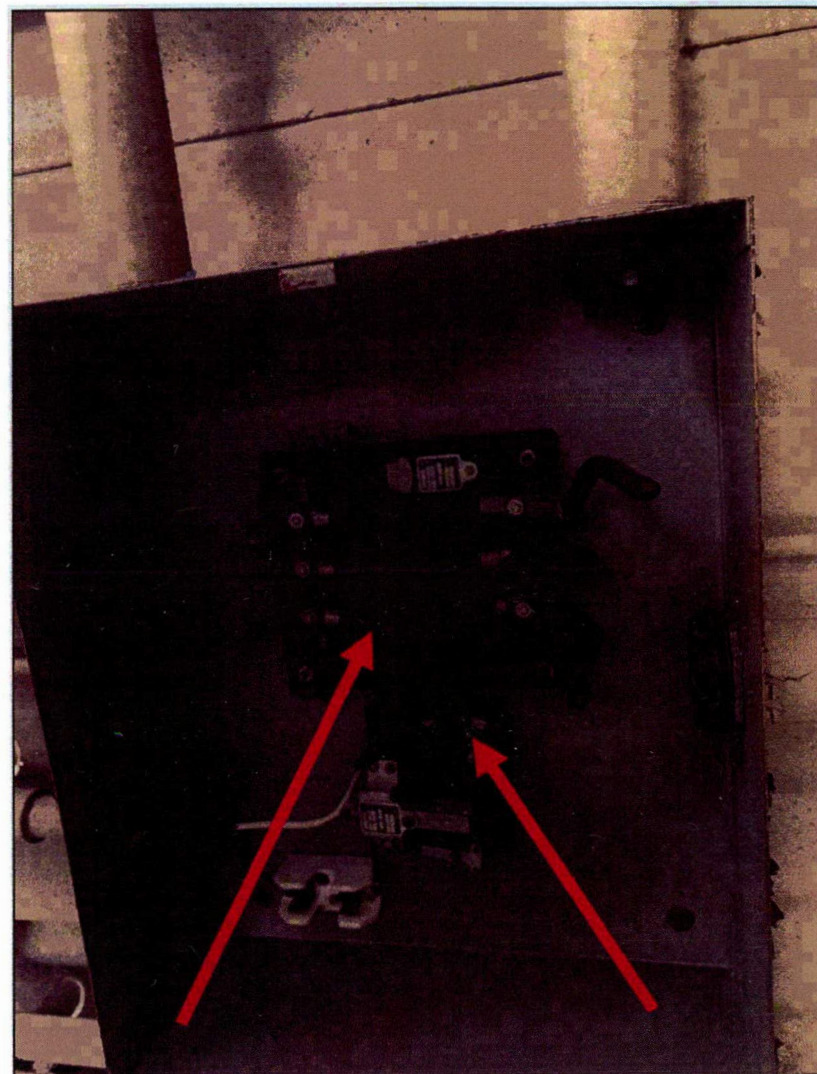
Photo 2. View of arc shoot plates (facing northeast).
