Engineering Survey & Interference Report for Building 483-3D, Electrical Control Building

Prepared by: W.B. Griffin Date: 11/3/2020
W.B. Griffin
EC&ACP Engineering
Environmental Compliance & Area Completion Projects

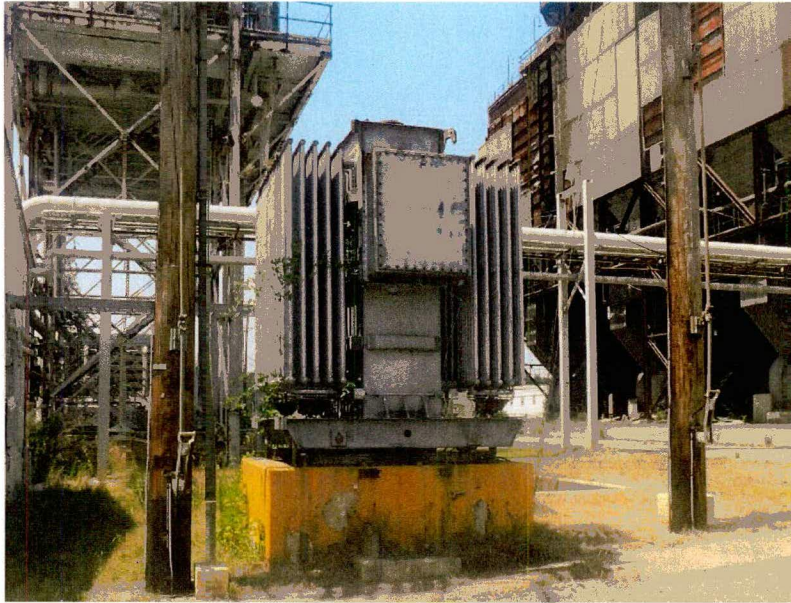
- On the east side of the structure is one transformer, AT2W (southeast) (Figure 3), which is outside the decommissioning scope of this project.

Figure 3: Transformer AT2W (Not in Scope)

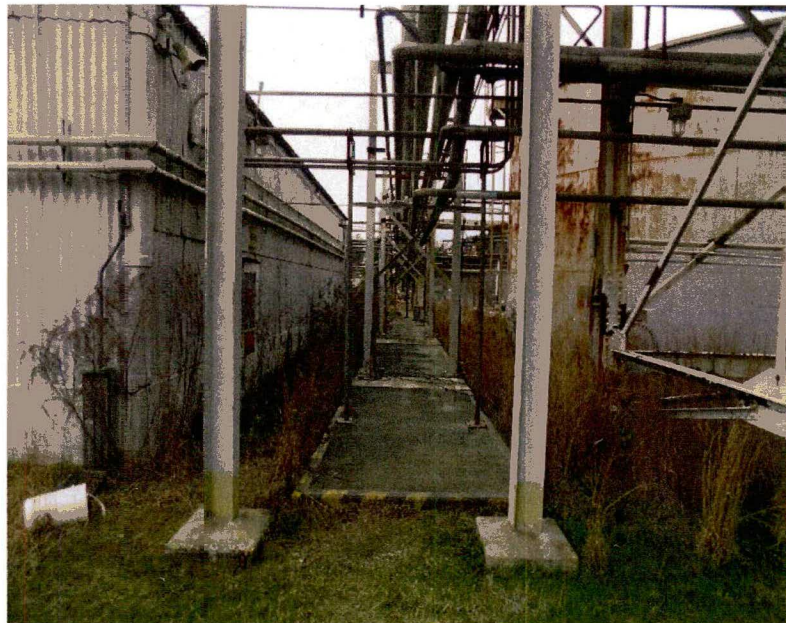
- The northeast (AT1W) transformer pad has an empty cable tray that goes overhead to the west and enters Building 483-3D.
- The scope of this decommissioning ends at the end of the north cable trench concrete slab. This is also the boundary for the conduit bridge that is mounted above the cable trench.

Figure 4: Building 483-3D Ancillary Cable Trench and Pipe/Conduit Bridge

The proposed end-state for this facility which has no defined or anticipated future missions, is decommissioning of the above grade structure(s) to the top of the concrete slab(s). The end-state also includes removal of the pipe bridge and piping on the north side of the building along with “In-Situ” decommissioning of the north side pipe trench with an appropriate cementitious fill material.
