**R-AREA OPERABLE UNIT REACTOR BUILDING AND DISASSEMBLY BASIN FIELD INSPECTION
CHECKLIST**

R-Area Operable Unit Reactor Building and Disassembly Basin Field Inspection Checklist

R-Area Operable Unit Reactor Building and Disassembly Basin

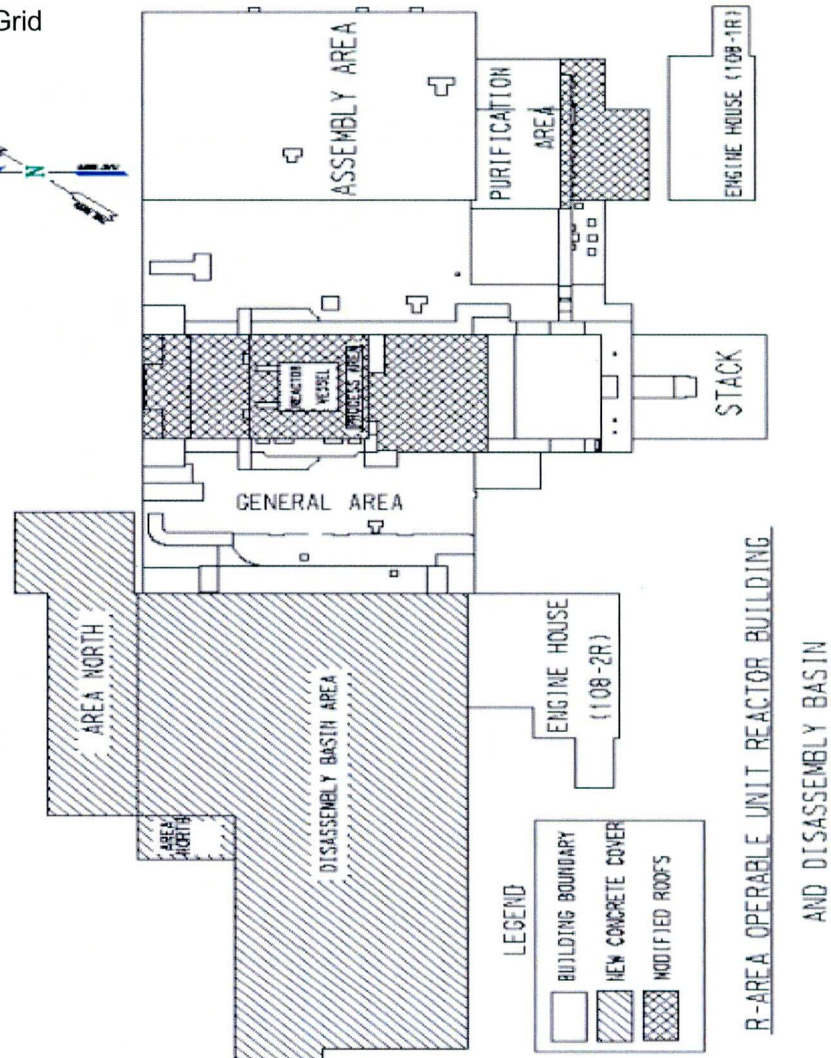
NOTES: (1) CARRY OVER ITEM: Vegetation growing on roofs. ACP will develop a work package to remove vegetation as well as remove silt, sand and debris from roofs. (2) = ACP will develop a work package to repair caulk joints on the disassembly basin cover. (3) = Area of concrete spalling.
 SEE ATTACHED FOR CTF REVIEW & COMMENTS

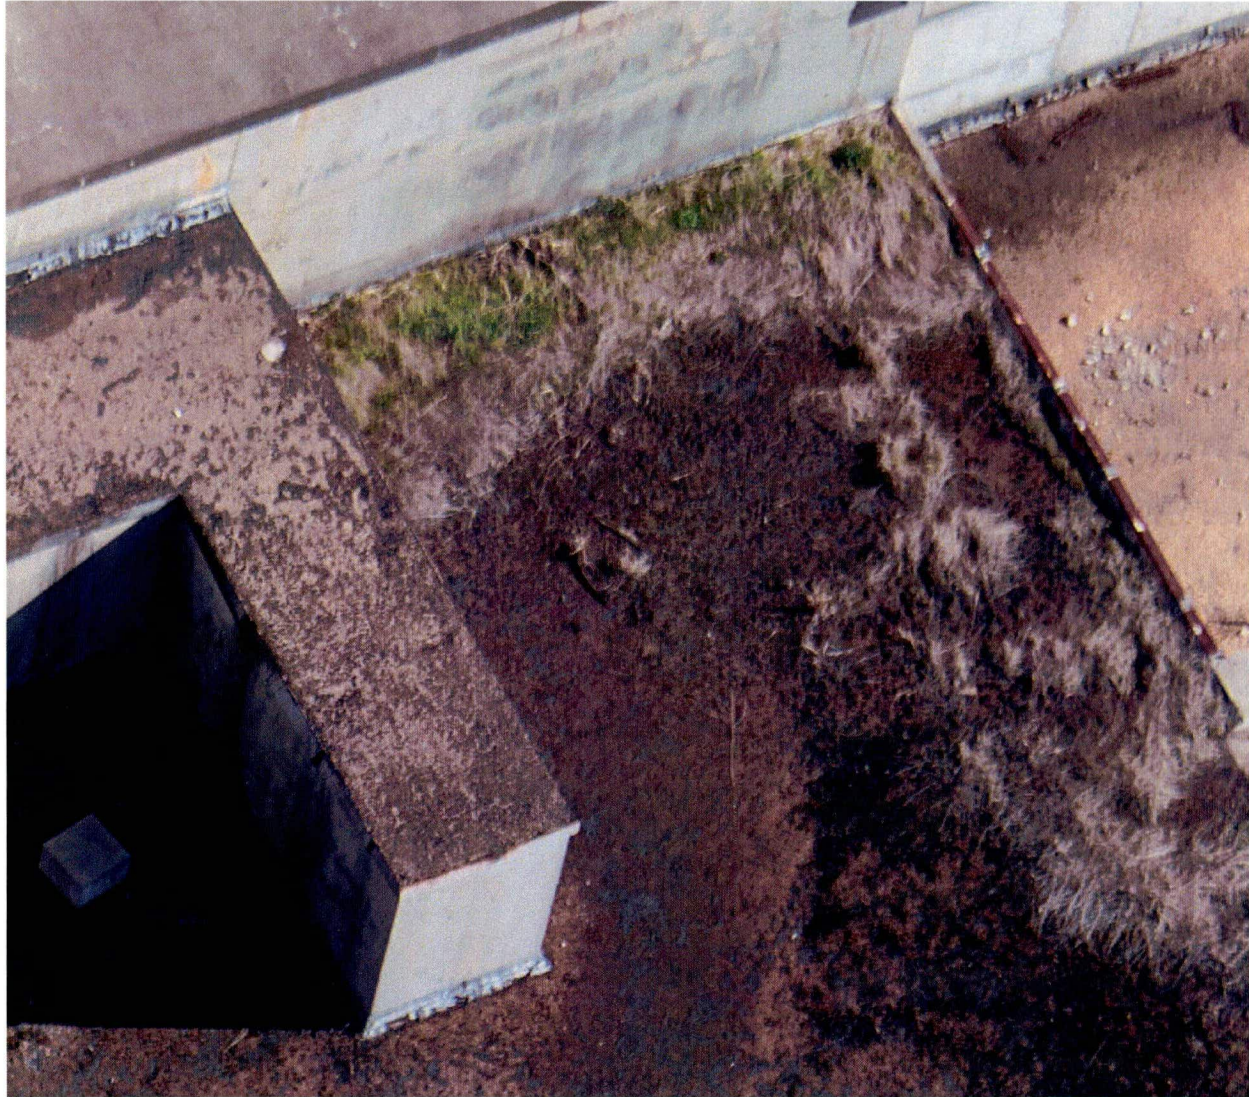
Condition of the roofs remained the same since last inspection. There was no further deterioration at the edge of concrete roof were stack was located. Vegetation growth is present at various areas on the roof. The sediment should be removed to eliminate and prevent vegetation. Some spots exist on the roof that cause the potential for pooling water. Spalled concrete was identified on the west corners of the +88.25 roof, attached is the design engineering report. Please see pictures for further details.

Figure 1: Vegetation

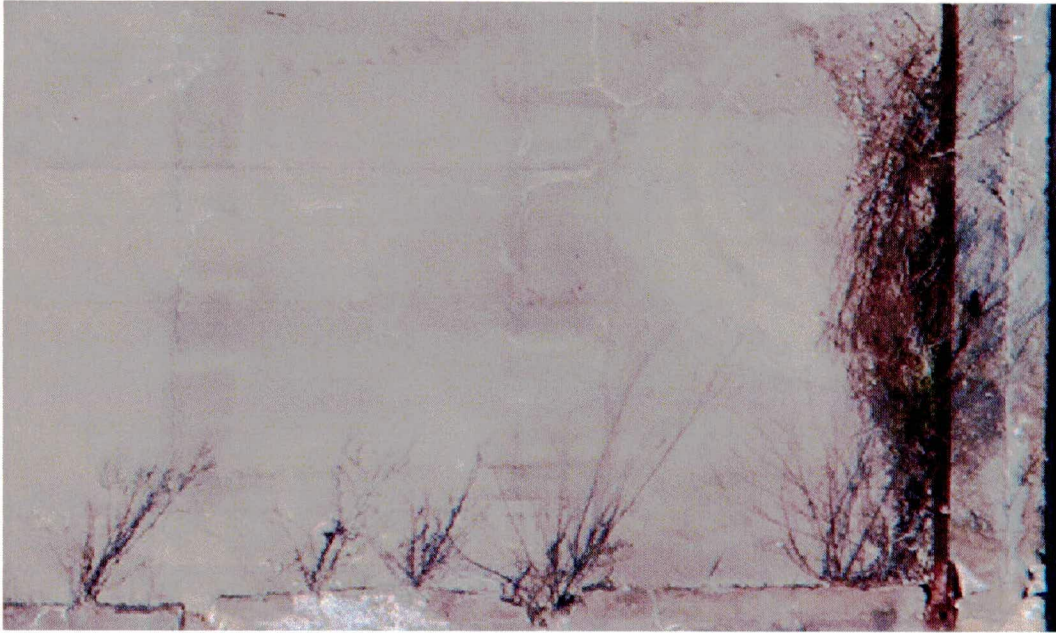
Figure 2: Vegetation

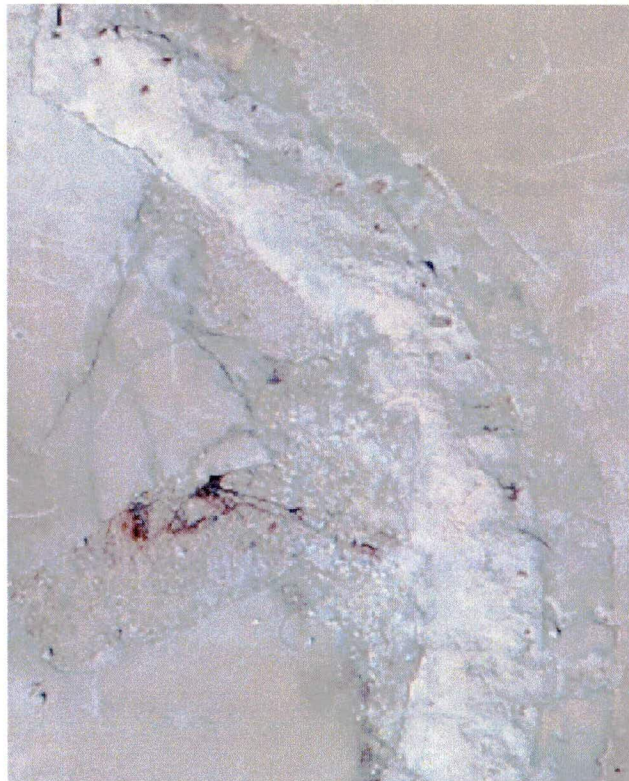
Figure 3: Potential Area for Pooling

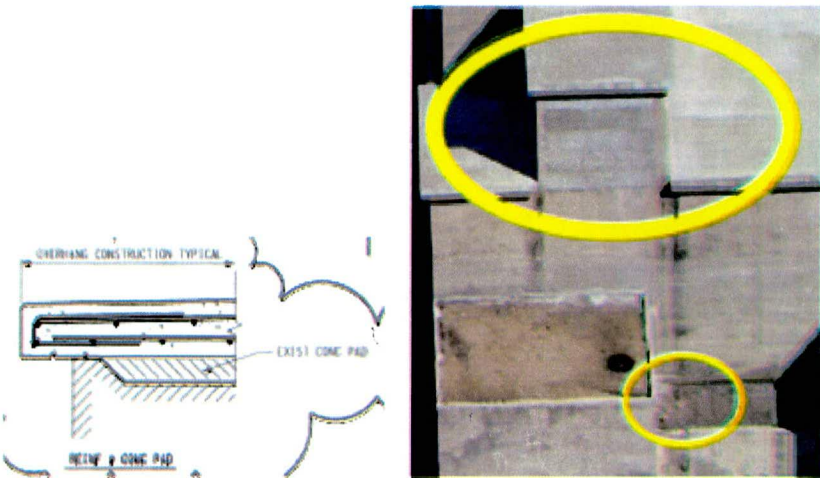
Bill,
From our conversations, it appears these spalls on the west corners of the El. 88.25 roof happened some time ago for unknown causes, probably soon after or during the activity of stripping the forms in 2011. It is noted from the aerial photo that some of the concrete shards landed harmlessly on the roof below and are still there.

Review of the drawing C-CC-R-00019, Sections F and H show the cap to be well reinforced with #6@18" each way and each face with "U-bars" for the cantilever load which is slightly increased by the spall of the corners below the roof slab. The spalled concrete is from the unreinforced concrete cover at the corner of the non-structural concrete curbs. The curbs are considered non-structural in the sense they do not contribute to the structural strength of the building. Given that the cap slab corner strength is undiminished by the spalls and the unreinforced concrete curb corners do not contribute to the overall strength of the building, this is considered an issue to put on the watch list for future deterioration, but not in need of immediate repair.

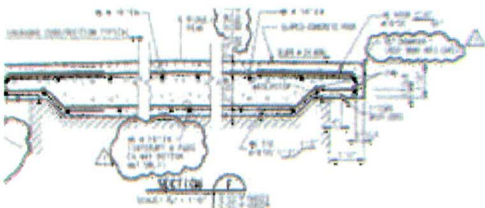
Was the roof slab supposed to be like the section below from the 105P Building?
