**ENVIRONMENTAL COMPLIANCE & AREA COMPLETION PROJECTS (EC&ACP) STANDARD
OPERATING PROCEDURES, VOL. I**
Manual: C3
Procedure: ER-IDS-019-065
Revision: 4
Effective Date: 1/08/2020
Type-Class: Checklist
Page: 1 of 3
**P-AREA OPERABLE UNIT REACTOR BUILDING AND DISASSEMBLY BASIN FIELD INSPECTION
CHECKLIST**
WORKING COPY

P-Area Operable Unit Reactor Building and Disassembly Basin Field Inspection Checklist

Map of P-Area Operable Unit Reactor Building and Disassembly Basin

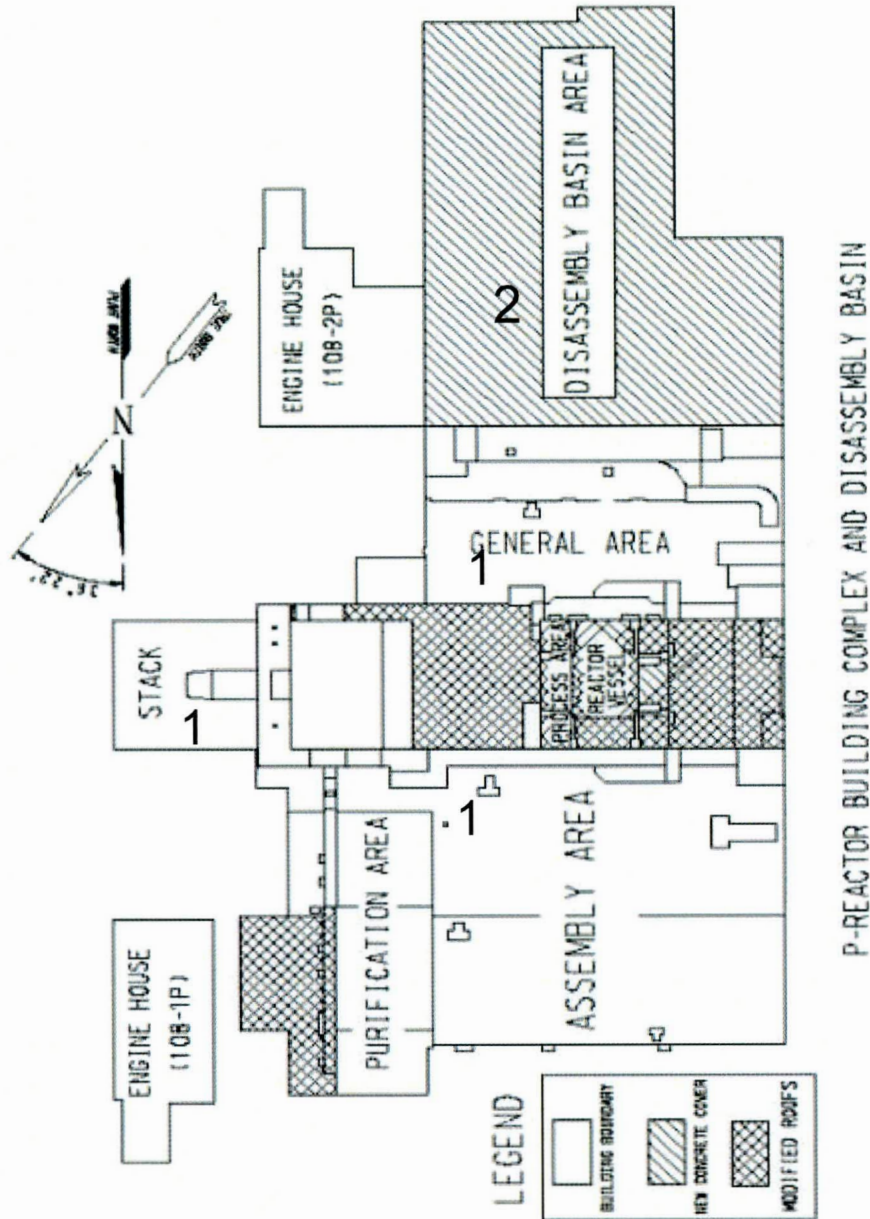
NOTES: 1=Carry over item: Roofs are functioning as intended. Non-woody vegetation exist and hinders drainage. Efforts will be made to remove vegetation. 2=Carry over item: Several areas of caulking in expansion joints need repair. Work package for repair is in development
