Manual: C3
 Procedure: ER-IDS-019-065
 Revision: 3
 Effective Date: 10/25/2016
 Type-Class: Form
 Page: 1 of 37 ^{cal} 10-23-18

P-AREA OPERABLE UNIT REACTOR BUILDING AND DISASSEMBLY BASIN FIELD INSPECTION CHECKLIST

P-REACTOR BUILDING COMPLEX AND DISASSEMBLY BASIN

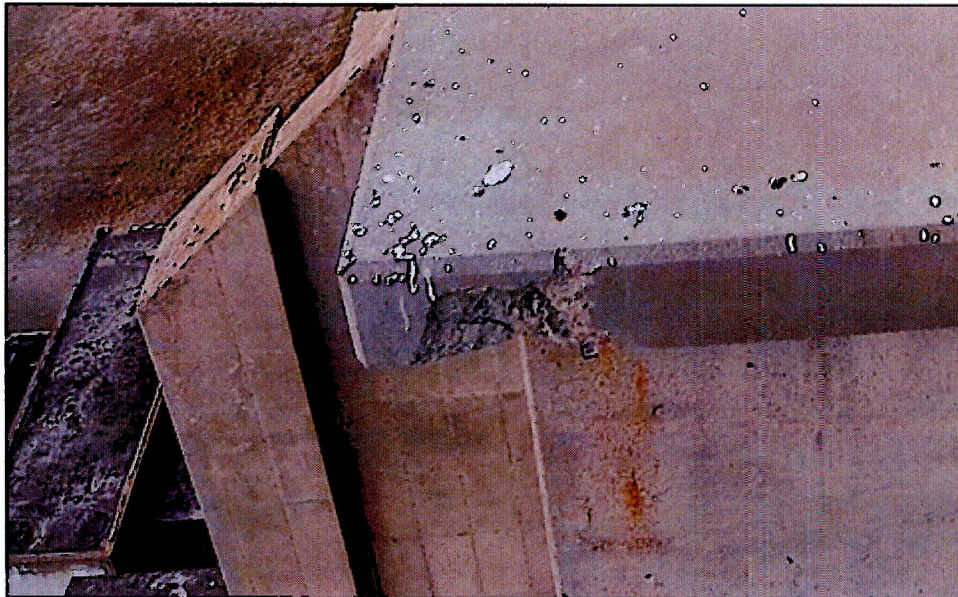
High-hat Flaw

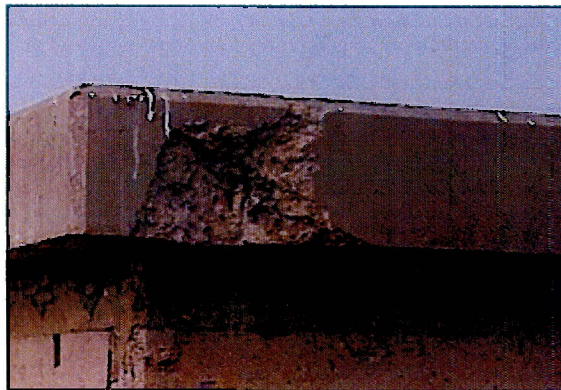
High-hat Flaw

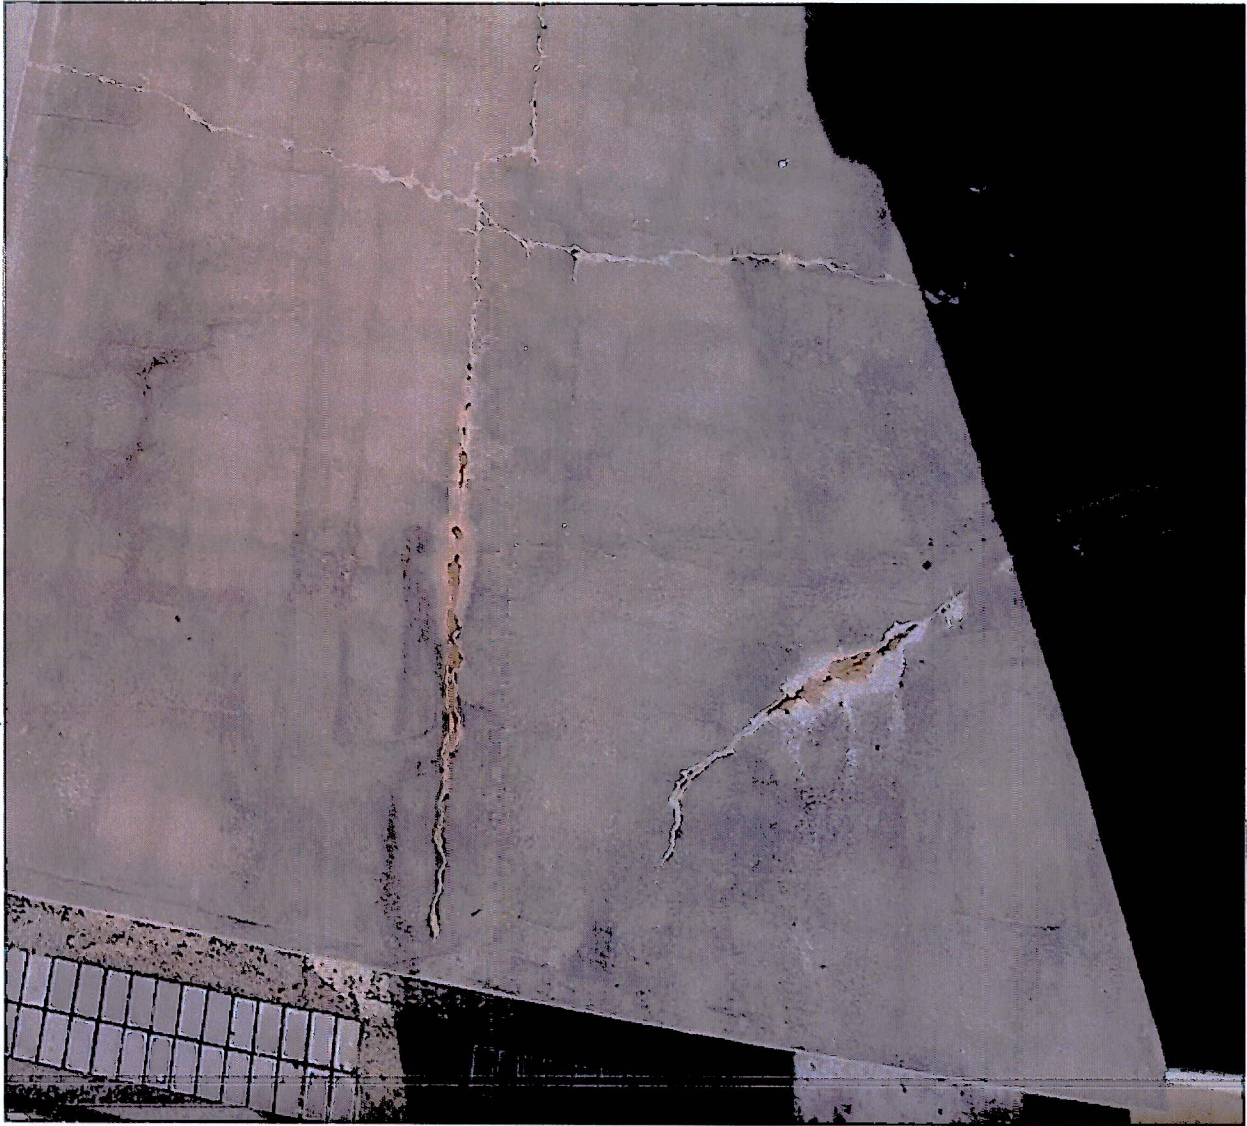
Cracking on Roof, North of High-hat

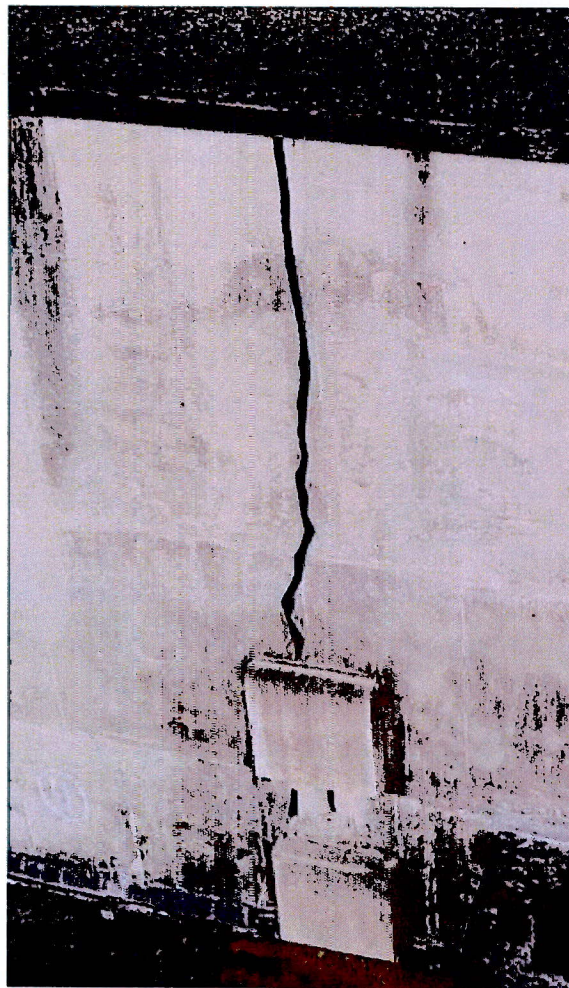
Crack, North Face

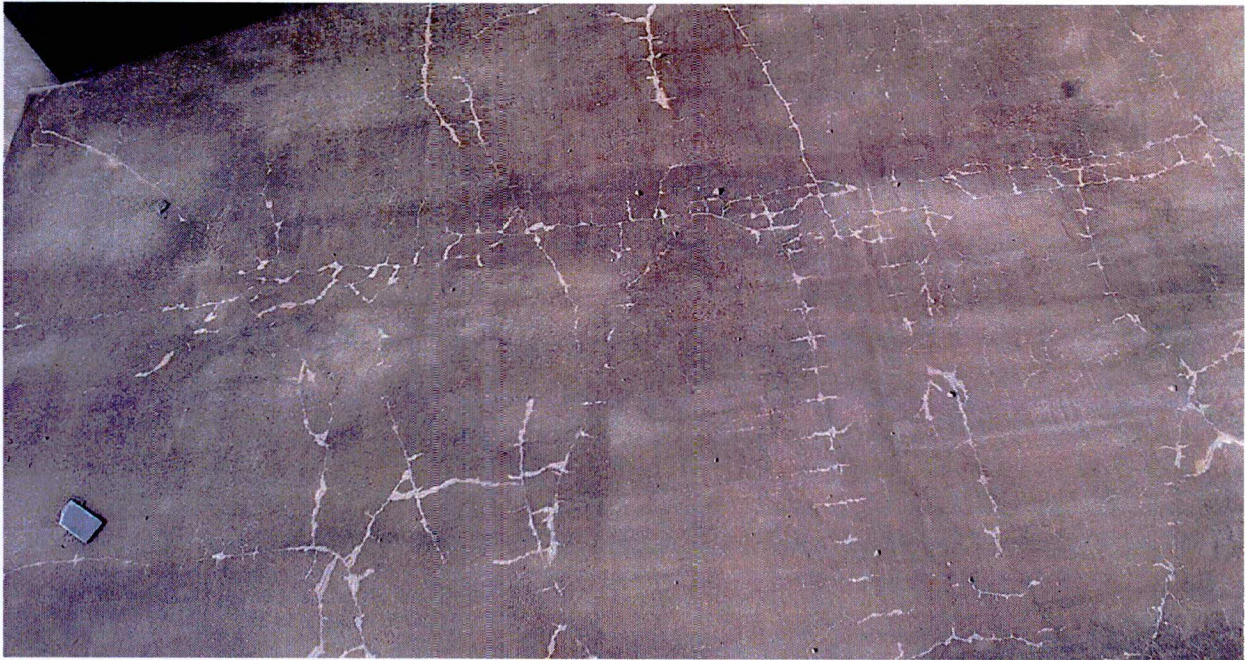
Cracking and Minor Spalding, Gantry Crane Roof
