Q-SDD-Engineering Survey & Interference Report for Building 704-7D, D-Area Maintenance Building

Prepared by: W.B. Griffin Date: 11/3/2020
W.B. Griffin
EC&ACP Engineering
Environmental Compliance & Area Completion Projects

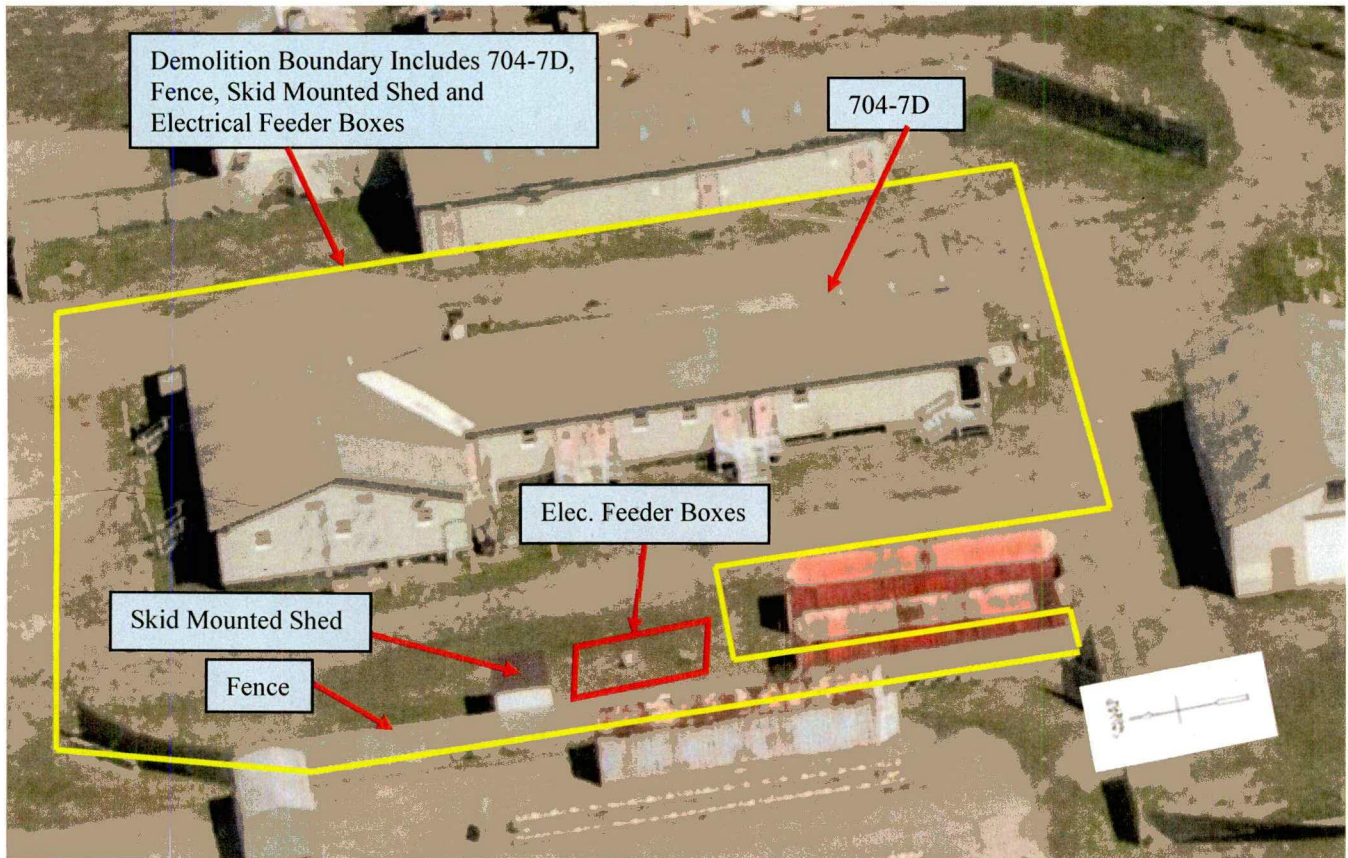
Figure 2: Aerial View of 704-7D and Surrounding Buildings/Facilities

- The area is partially fenced as shown in Appendix A, Figure 2.

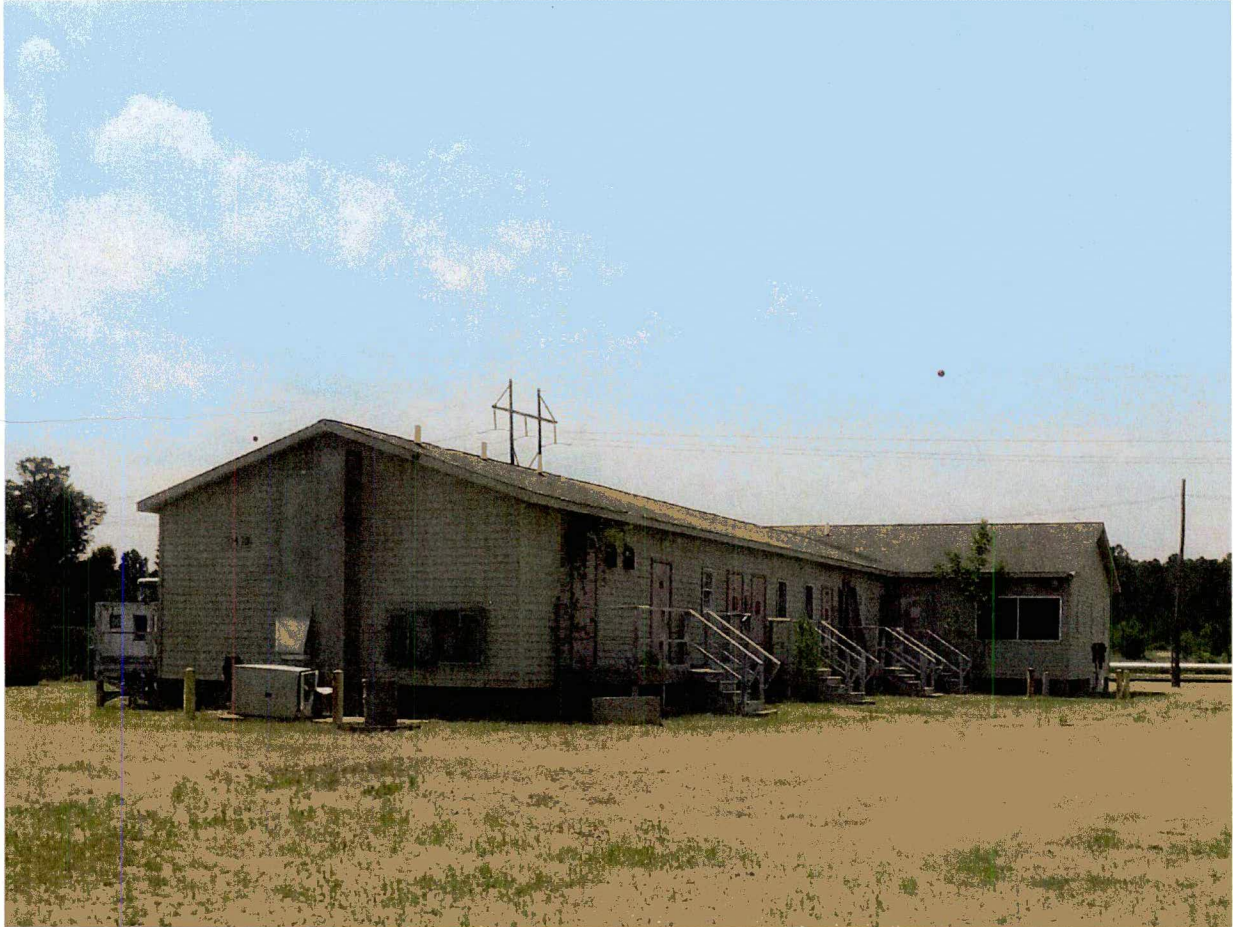
Figure 3: Building 704-7D Photo

Based on visual inspection on June 3, 2020, the structure as defined in References 5.1 and 5.2 is in poor to fair condition and has been determined to be unsafe to enter due to the deteriorated condition of the floors. It has also been determined there is no potential for an unplanned collapse of the structure either due to forces of nature and/or vibrations created by movement of heavy equipment in proximity to the building.
