Manual: C3
 Procedure: ER-IDS-019-063
 Revision: 3
 Effective Date: 10/25/2016
 Type-Class: Form
 Page: 1 of 87

R-AREA OPERABLE UNIT REACTOR BUILDING AND DISASSEMBLY BASIN FIELD INSPECTION CHECKLIST

R-Area Operable Unit Reactor Building and Disassembly Basin

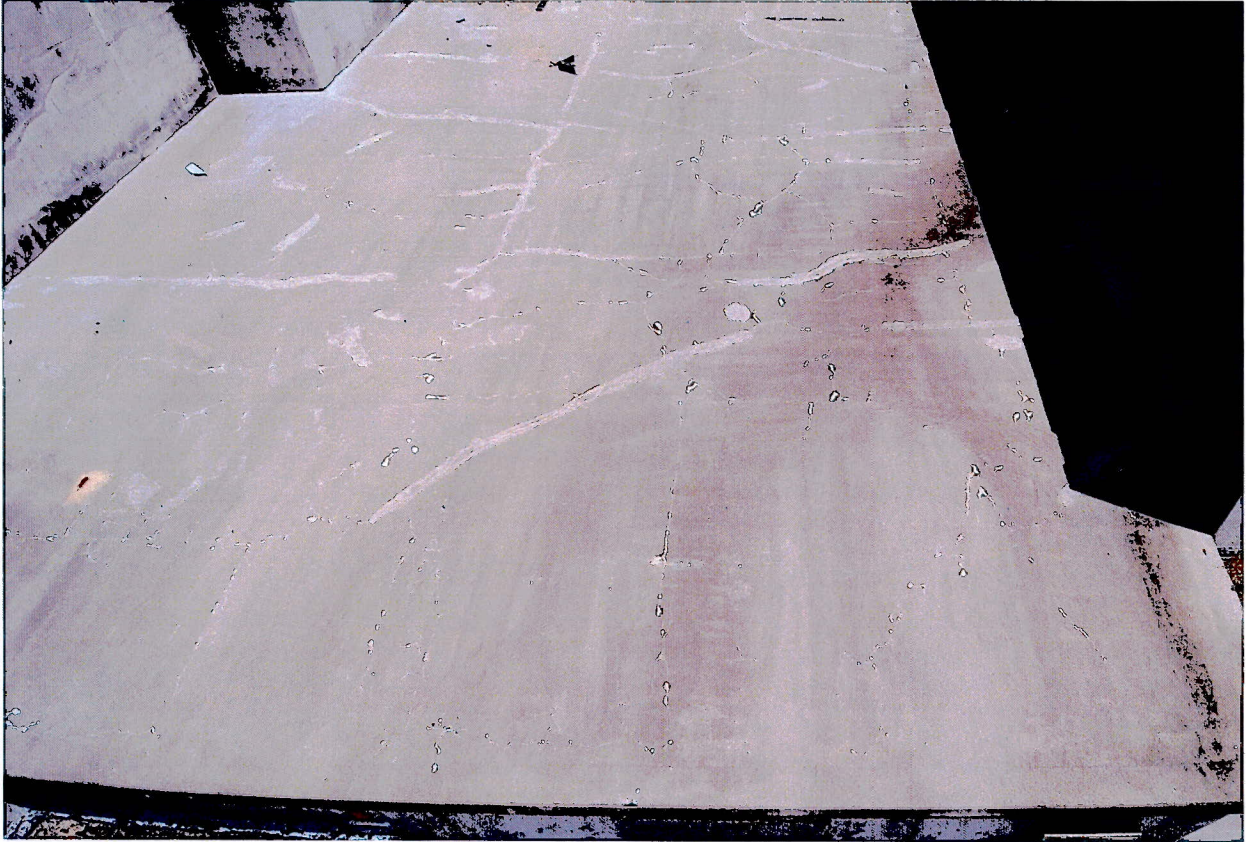
The 2018 inspection utilized an Unmanned Aerial System for the inspection. Video footage is stored on a data disk in EC&ACP Document Control. No further degradation of the reactor and associated roofs was observed. Vegetation growth continues and has exacerbated issues with standing water. Cracks were noted in the concrete walls next to the disassembly basin that were added as part of the closure but are currently within acceptable limits.

Cracking, Gantry Crane Roof

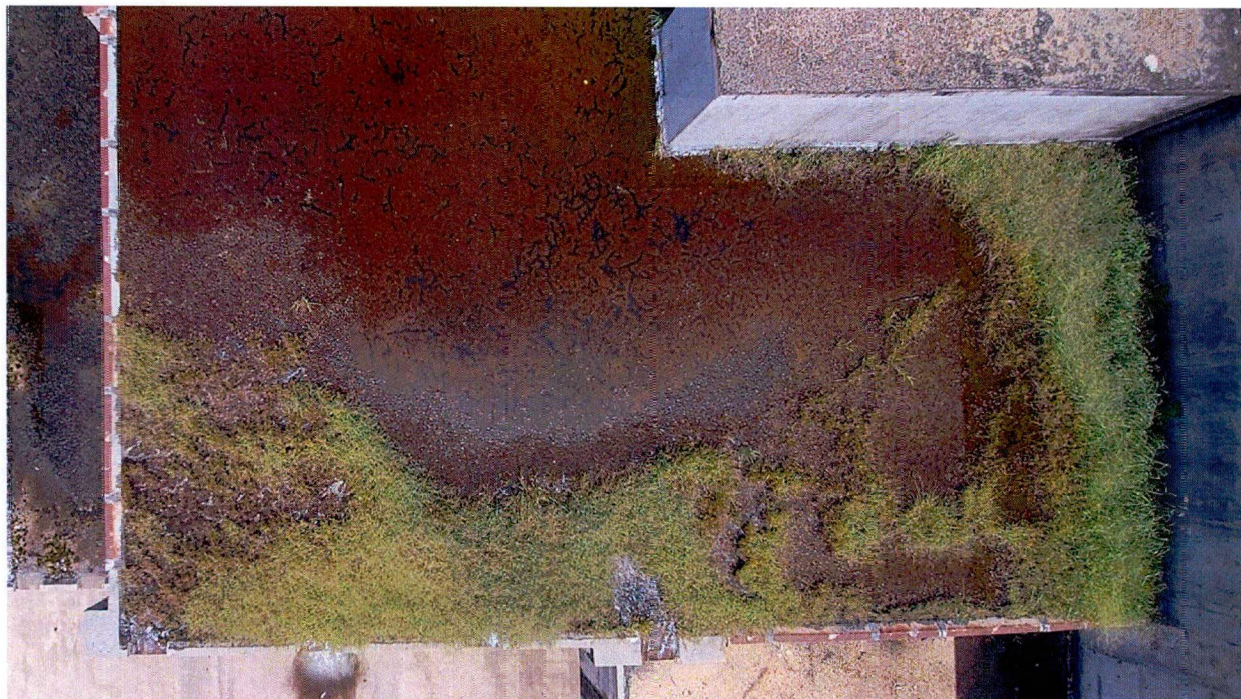
Vegetation

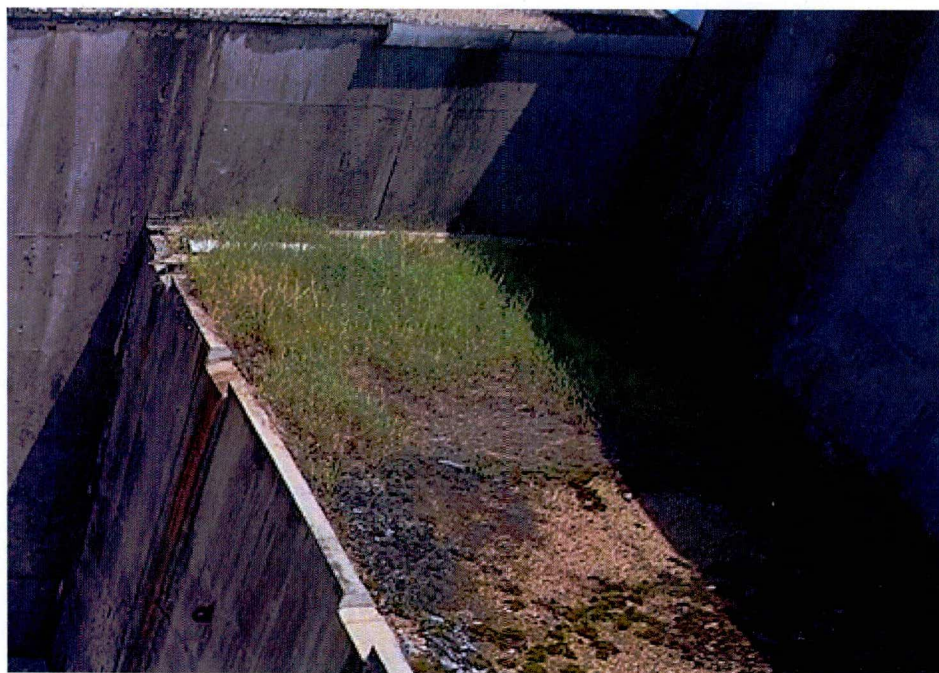
Vegetation

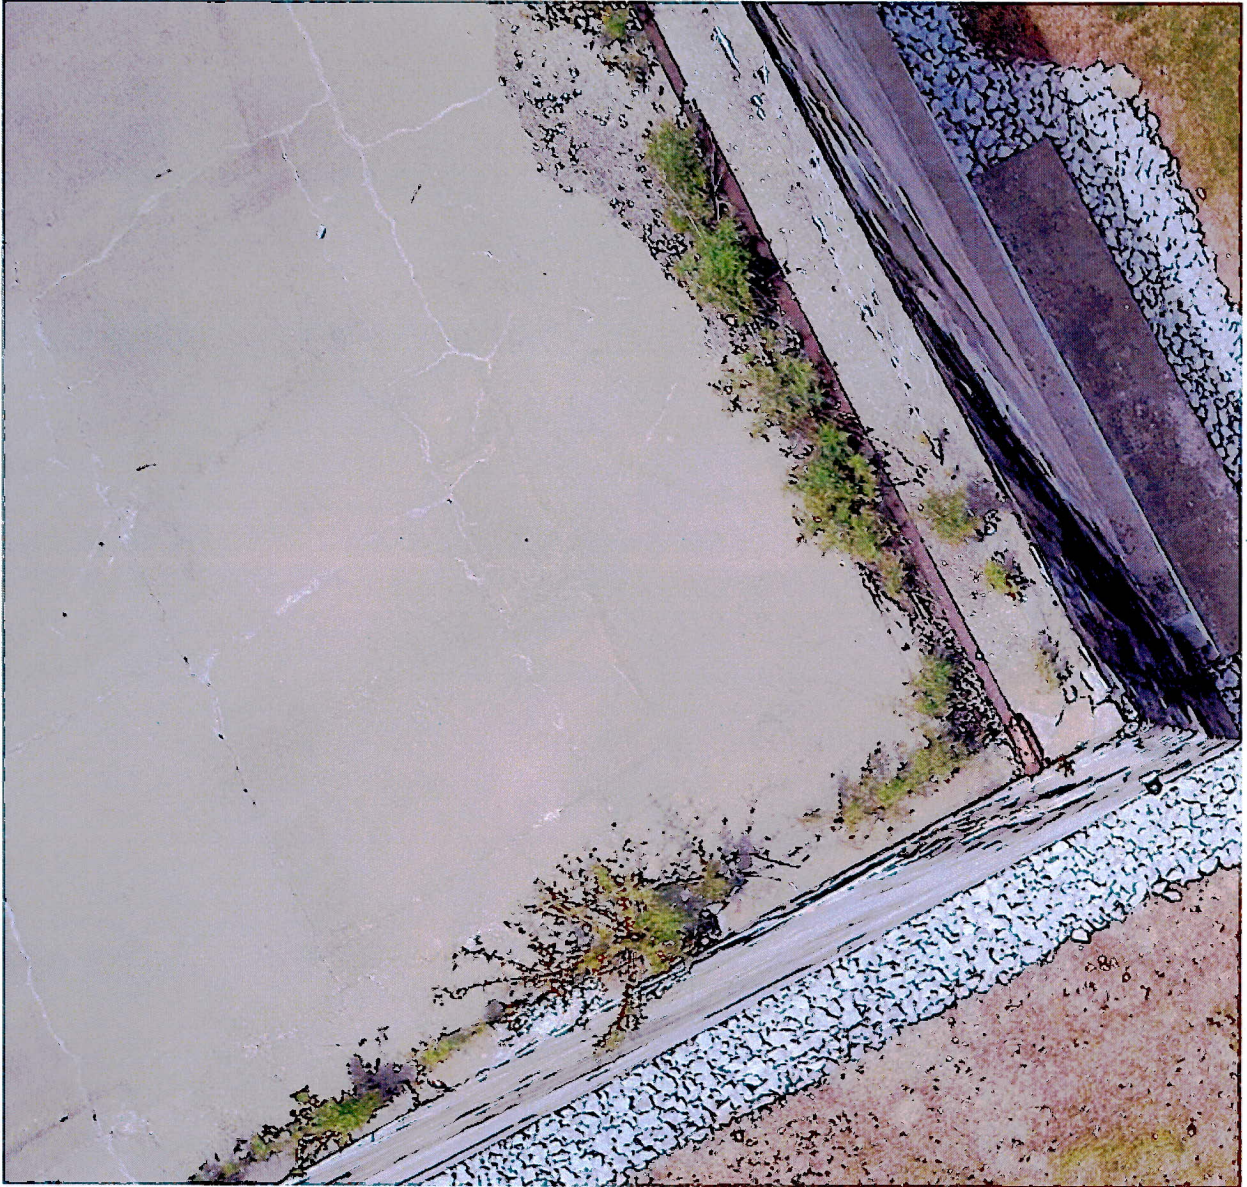
Vegetation

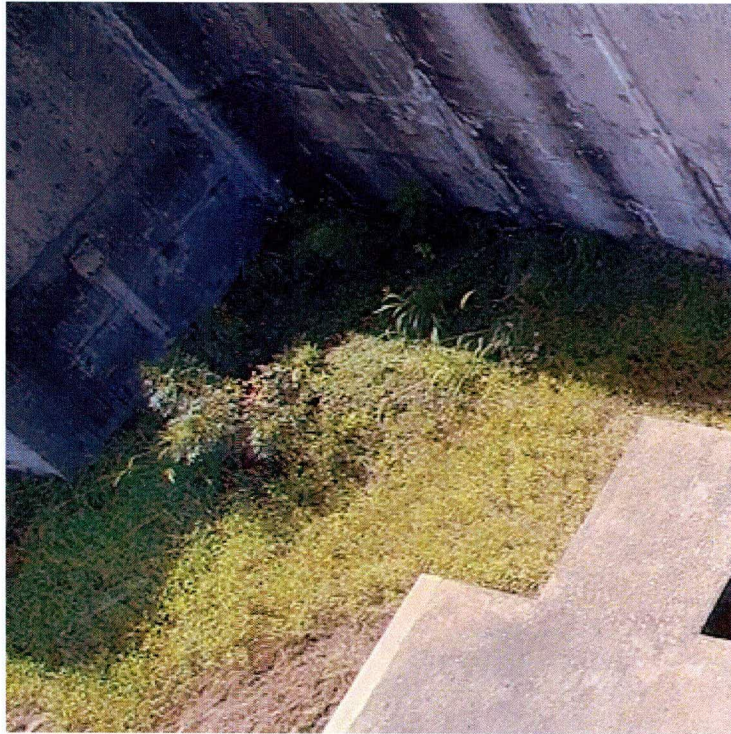
Vegetation

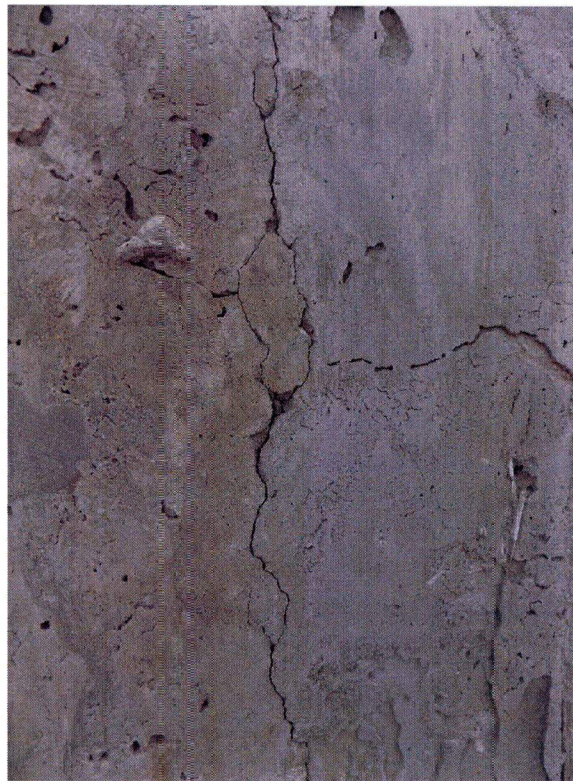
Cracking, 105-R Concrete – Dissassembly Side
