Q-SDD-F-00006**S&M Inspection Report for Building 221-1F, A-Line****February 8, 2022**

1. G-SMPL-F-00006, Rev. 1, dated 08/30/2016, "Surveillance and Maintenance (S&M) Plan Building 221-1F, A-Line"

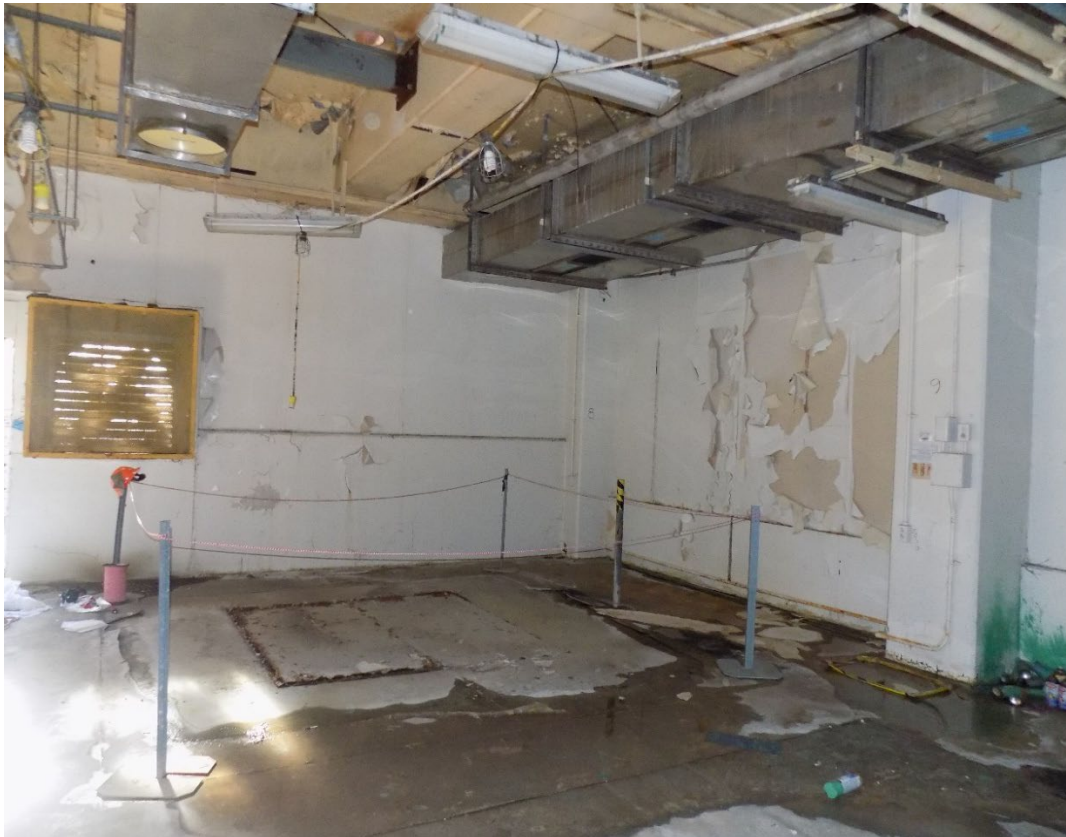
Photo 01: This image shows the general condition of the first floor in Zone 5.0, Room 100. Moisture can be seen on the floor as well as staining patterns from previous moisture collection. Due to the humid conditions and lack of ventilation; peeling paint was found throughout the area. The hinges surrounding the plate on the floor show corrosion. There appears to be no additional deterioration since the previous S&M Inspection in 2020.

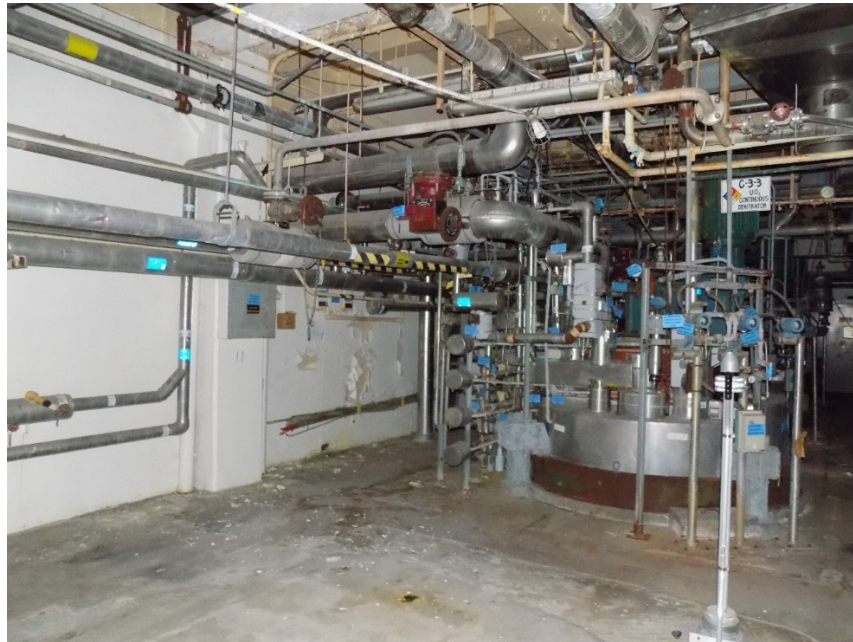
Photo 02: This image shows the general condition of the Denitrator Reactors located on the first floor in Zone 5.0, Room 104. There appears to be no change since the previous S&M Inspection in 2020.

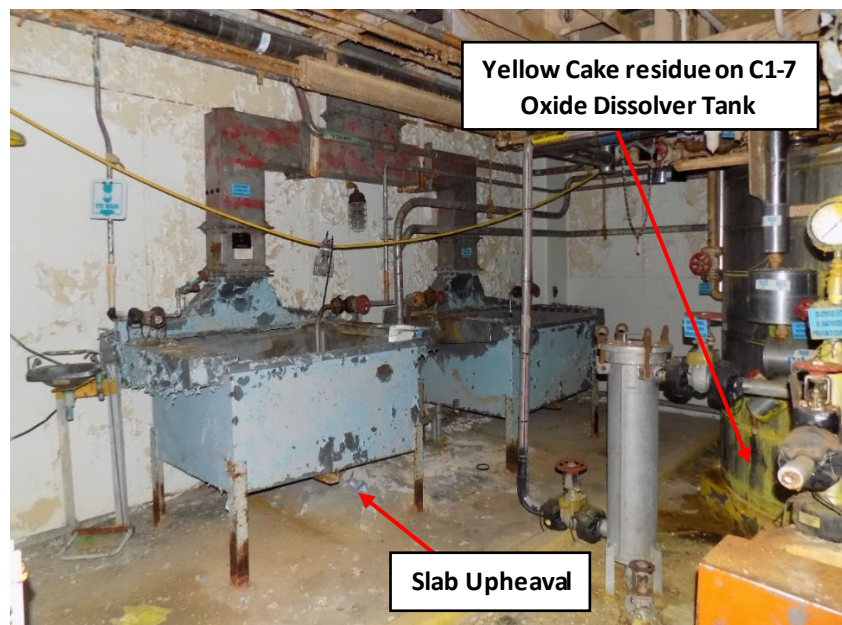
Photo 03: This image shows the decontamination sink on the left and the rinse sink on the right on the first floor in Zone 5.1.2, Room 103. The photo shows an upheaval of the slab on grade concrete beneath them. There appears to be no additional upheaval since the previous S&M Inspection in 2020. This is not a structural or a personnel safety concern since it is a slab on grade and the area is protected by a rope barricade with warning signs. The C1-7 Oxide Dissolver Tank located right of the sinks shows yellow cake residue. Residue has not increased since the previous S&M Inspection in 2020.

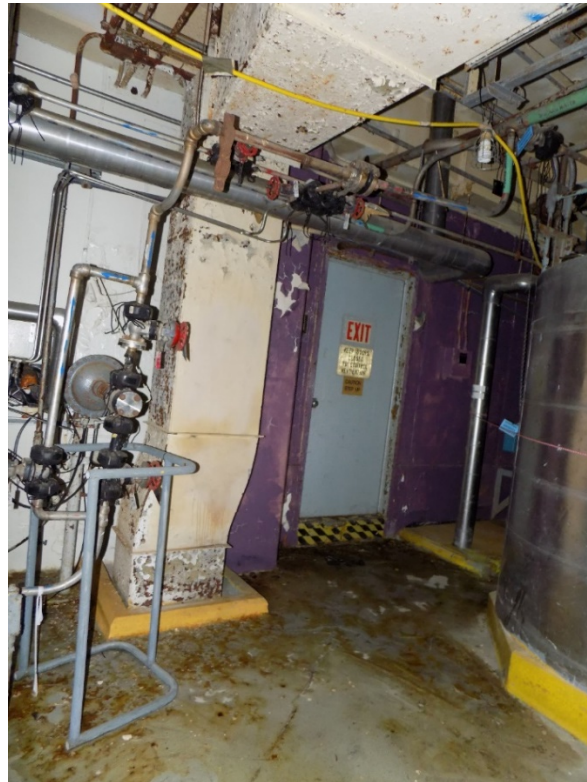
Photo 04: The above photo shows the typical condition of the concrete floor on the second floor in Zone 5.2.2, Room 208. There is moisture on the floor with the source appearing to be from the doorway. The moisture has caused staining on the floor. There appears to be no additional staining or degradation of the concrete since the previous S&M Inspection in 2020.

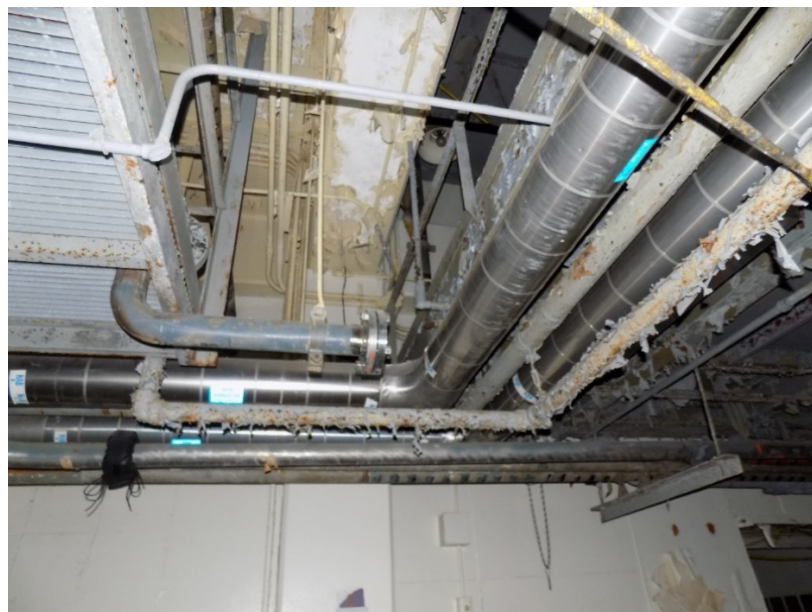
Photo 05: The photo above is a typical example of the deterioration of the paint coating around the pipes and the paint on the ceilings on the first floor.

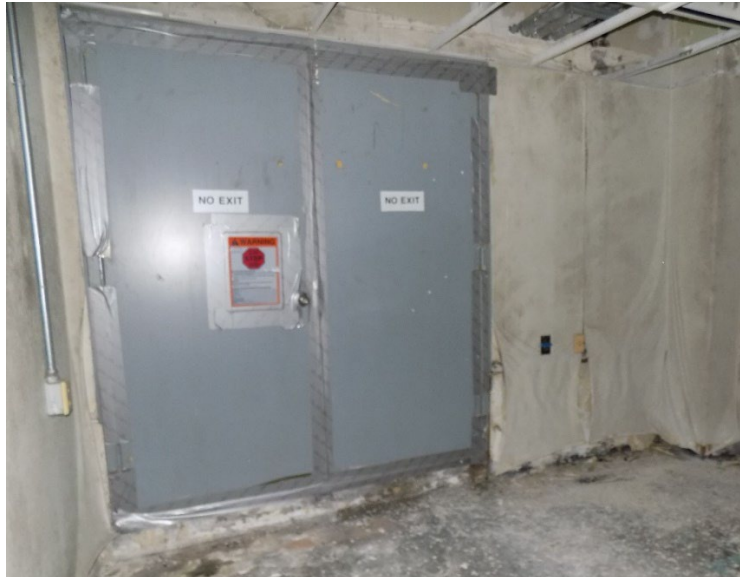
Photo 06: The photo above shows the exit doors on the north end of the second floor of A-Line. The tape around the door edges is secure and the “No Exit” signs are clearly posted.

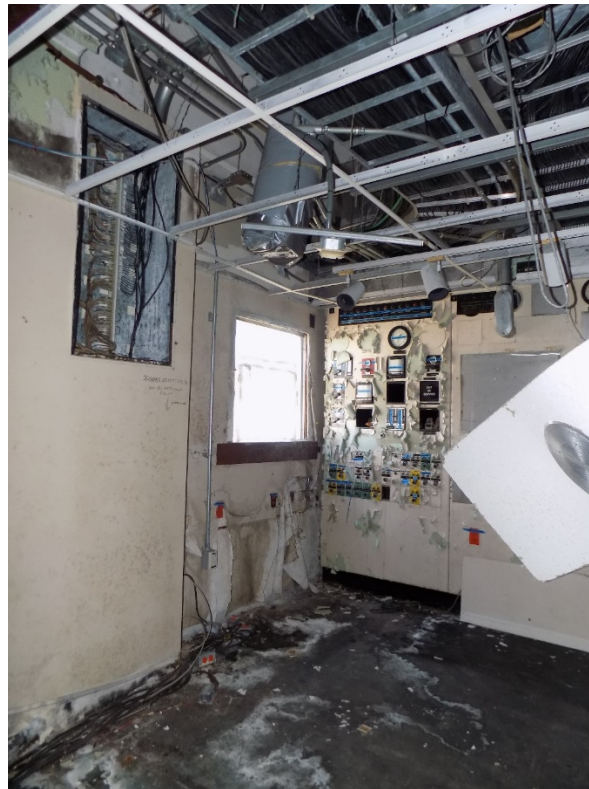
Photo 07: The photo above shows the general condition in Room 206, Zone 5.2.1. It shows an example of the amount of mold present on the walls and floor. The window could have been the source of the moisture causing the mold. There appears to be no additional mold growth in the area since the previous S&M Inspection in 2020.

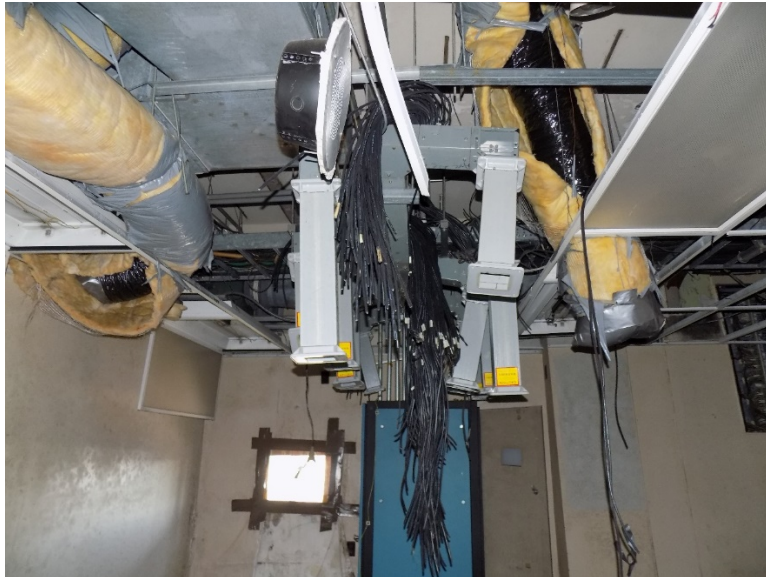
Photo 08: The photo above shows the condition of the ceiling in Room 206, Zone 5.2.1. The hanging wires were discovered during the 2020 S&M Inspection. There appears to be no additional deterioration of the ceiling since the previous S&M Inspection in 2020.

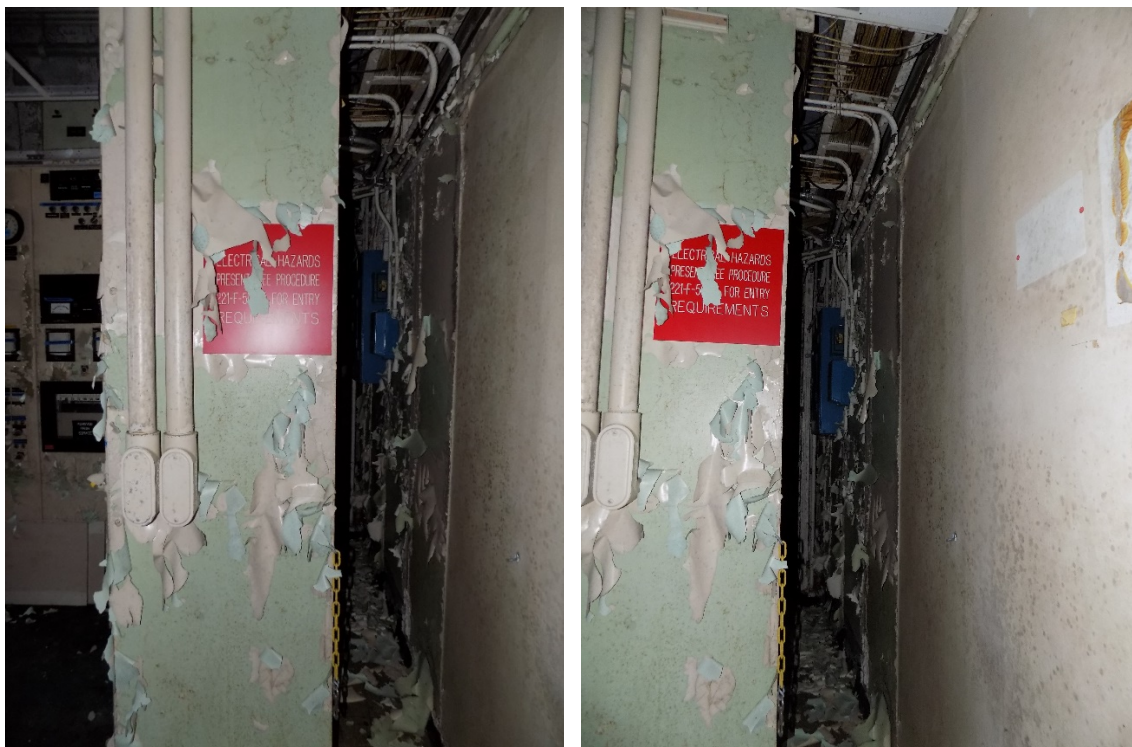
Photo 09: The photos above show the area behind the control panel in Room 207, Zone 5.2.1 (Control Room) and the extent of the peeling paint in that area. This condition is judged to be non-structural in nature.

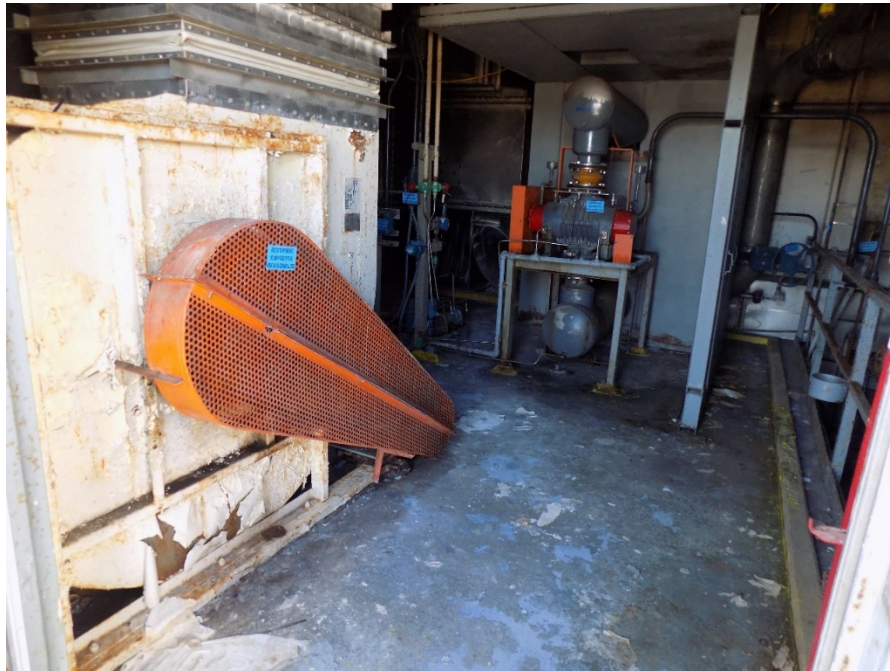
Photo 10: The above photo shows the general condition of the concrete and peeling paint on the third floor of A-Line in Room 302, Zone 5.3.2.

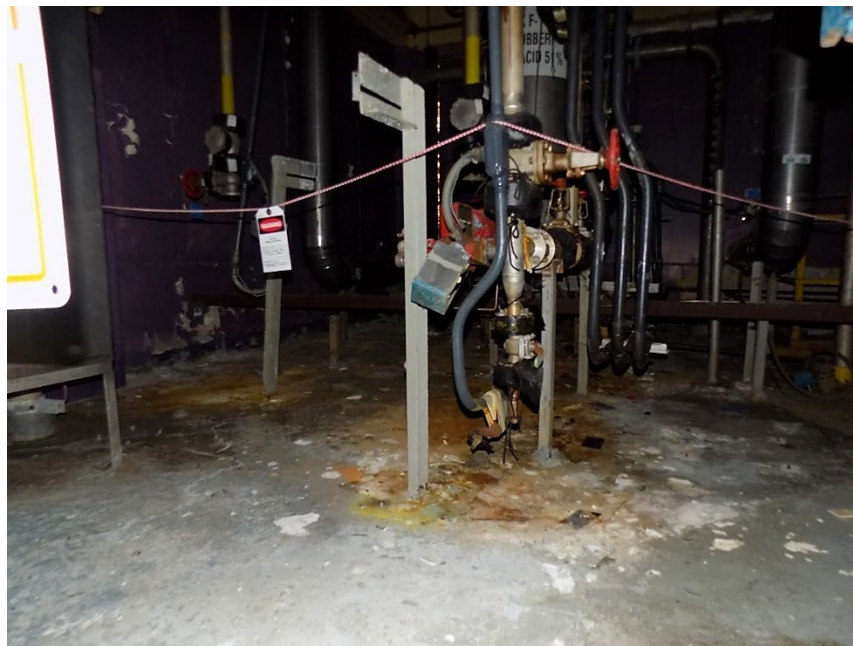
Photo 11: This photo shows a view of the acid spill on the third floor in the area of the Venturi Scrubber, F-1-1 (Room 302, Zone 5.3.2). The area is protected by a rope barricade with warning signs. There appears to be no additional degradation since the previous S&M Inspection in 2020.

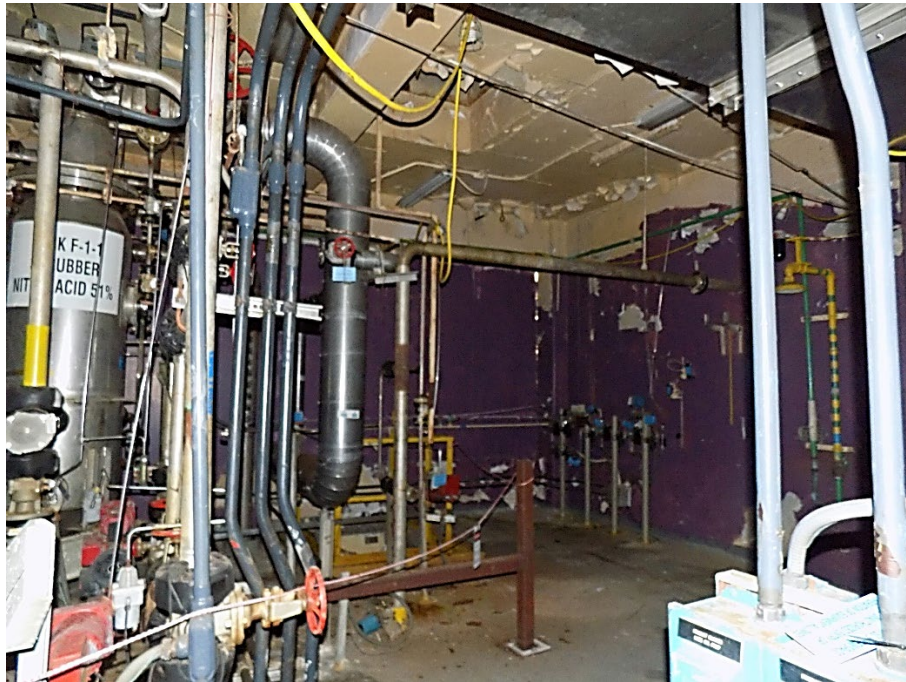
Photo 12: The above photo shows a typical example of the deterioration on the coating for fixed contamination on the third floor in Room 302, Zone 5.3.2. The deterioration does not appear to have worsened since the previous S&M Inspection in 2020.
