**Title: MONITORING OF CLOSED WASTE TANKS FOR HTF
AND FTF**

Closed Waste Tank Annual Inspection Checklist Cover Sheet

Inspection Year: 2019

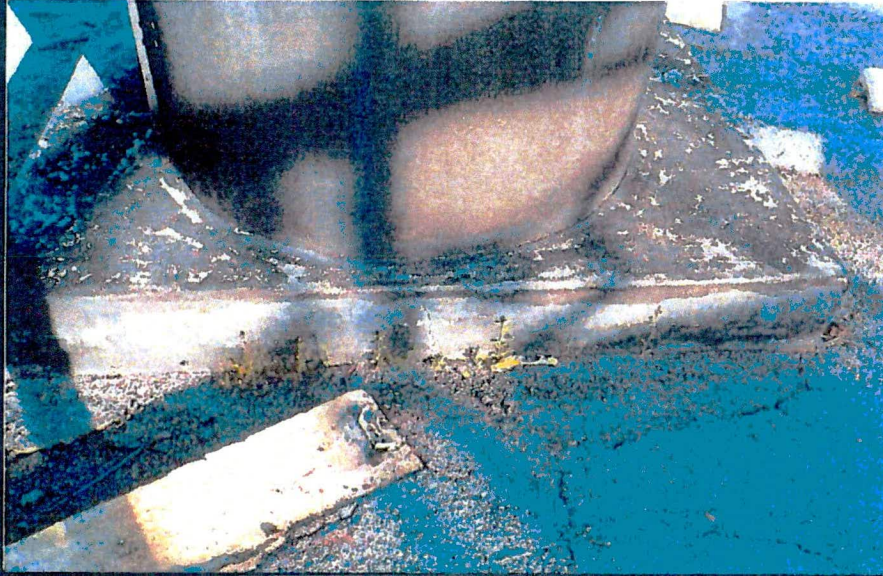
Tank 19, Northwest Riser, South Side

Comments:
 1. Three cracks noted on Tank 19 NW riser cap: W side, E side and S side
 2. Riser degradation unchanged
 BGM
