ENVIRONMENTAL COMPLIANCE & AREA COMPLETION PROJECTS (EC&ACP) STANDARD OPERATING PROCEDURES, VOL. I

Manual: C3
 Procedure: ER-IDS-019-073
 Revision: 1
 Effective Date: 08/30/2016
 Type-Class: Form
 Page: 1 of 3

A-AREA ASH PILE (788-A) STABILITY FIELD INSPECTION CHECKLIST

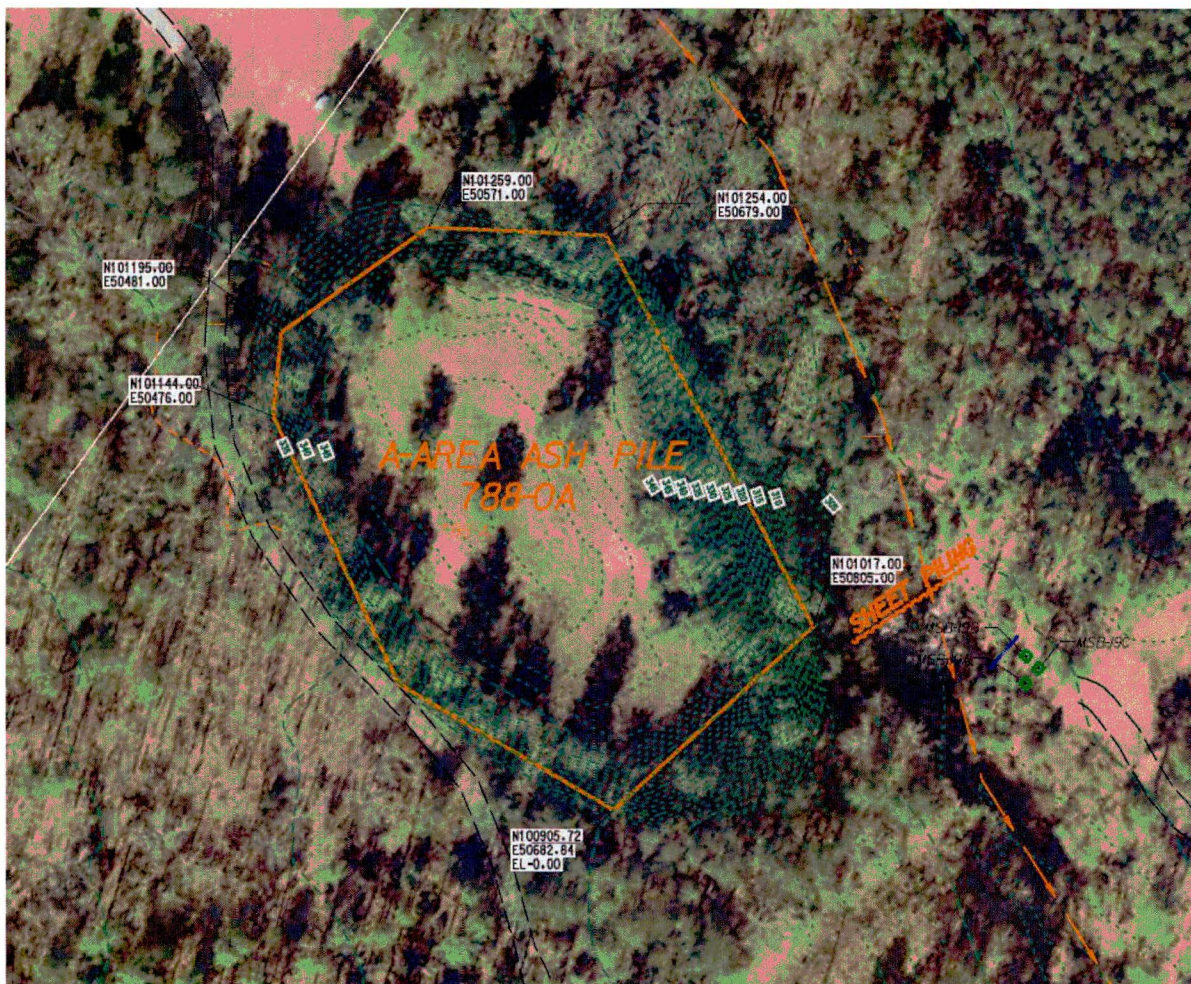
A-AREA ASH PILE (788-A)

Notes and Observation: SIGNS OF SOME ANIMAL TRAFFIC ON NORTH SLOPE OF ASH MOUND. THERE WAS NO SIGNS OF EROSION ON SLOPE.

COMPARISON OF A-ASH PILE STABILITY AFTER TROPICAL STORM IRMA. ALTHOUGH THERE WAS GREATER THAN 4" OF RAINFALL IN A 24 HOUR PERIOD AND WIND GUSTS IN EXCESS OF 45 MILES PER HOUR AT SRS ON SEPTEMBER 14, 2017 NO CHANGES TO THE EROSION OF A-AREA ASH PILE OR TIM'S BRANCH TRIBUTARY BANK WERE OBSERVED DURING A FIELD VISIT ON SEPTEMBER 13, 2017.
