**ENVIRONMENTAL COMPLIANCE & AREA COMPLETION PROJECTS (EC&ACP) STANDARD
OPERATING PROCEDURES, VOL. I**
Manual: C3
Procedure: ER-IDS-019-071
Revision: 3
Effective Date: 12/21/2021
Type-Class: Checklist
Page: 1 of 3
D-AREA BUBBLE TOWER COVER FIELD INSPECTION CHECKLIST
WORKING COPY

D-area Bubble Tower Cover Field Inspection Checklist

D-Area Bubble Tower Cover

578 D-AREA BUBBLE TOWER COVER

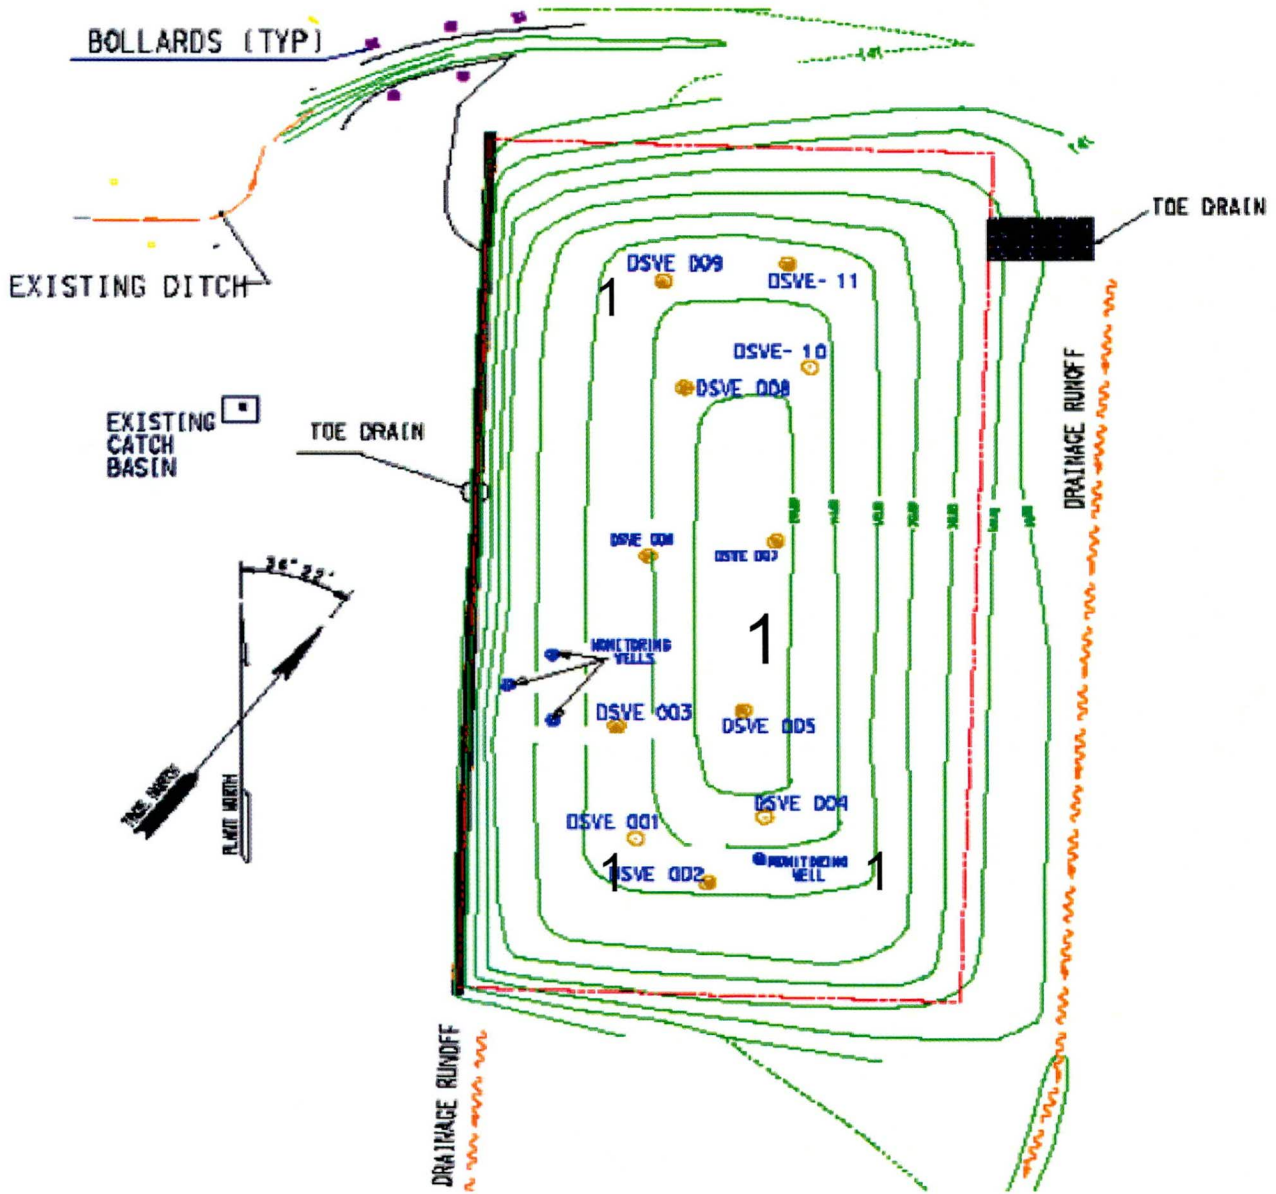
NOTES: 1= Active ant mounds on soil cover. Applied 1lb. of Extinguish ant bait.

Maintenance Item Corrected
 Applied Extinguish pesticide
