**ENVIRONMENTAL COMPLIANCE & AREA COMPLETION PROJECTS (EC&ACP) STANDARD
OPERATING PROCEDURES, VOL. I**
Manual: C3
Procedure: ER-IDS-019-041
Revision: 4
Effective Date: 01/11/2022
Type-Class: Checklist
Page: 1 of 3
D-AREA ASH BASIN (DAB) (488-D) FIELD INSPECTION CHECKLIST
WORKING COPY

D-Area Ash Basin (DAB) (488-D) Field Inspection Checklist

D-AREA ASH BASIN (488-D) MAP

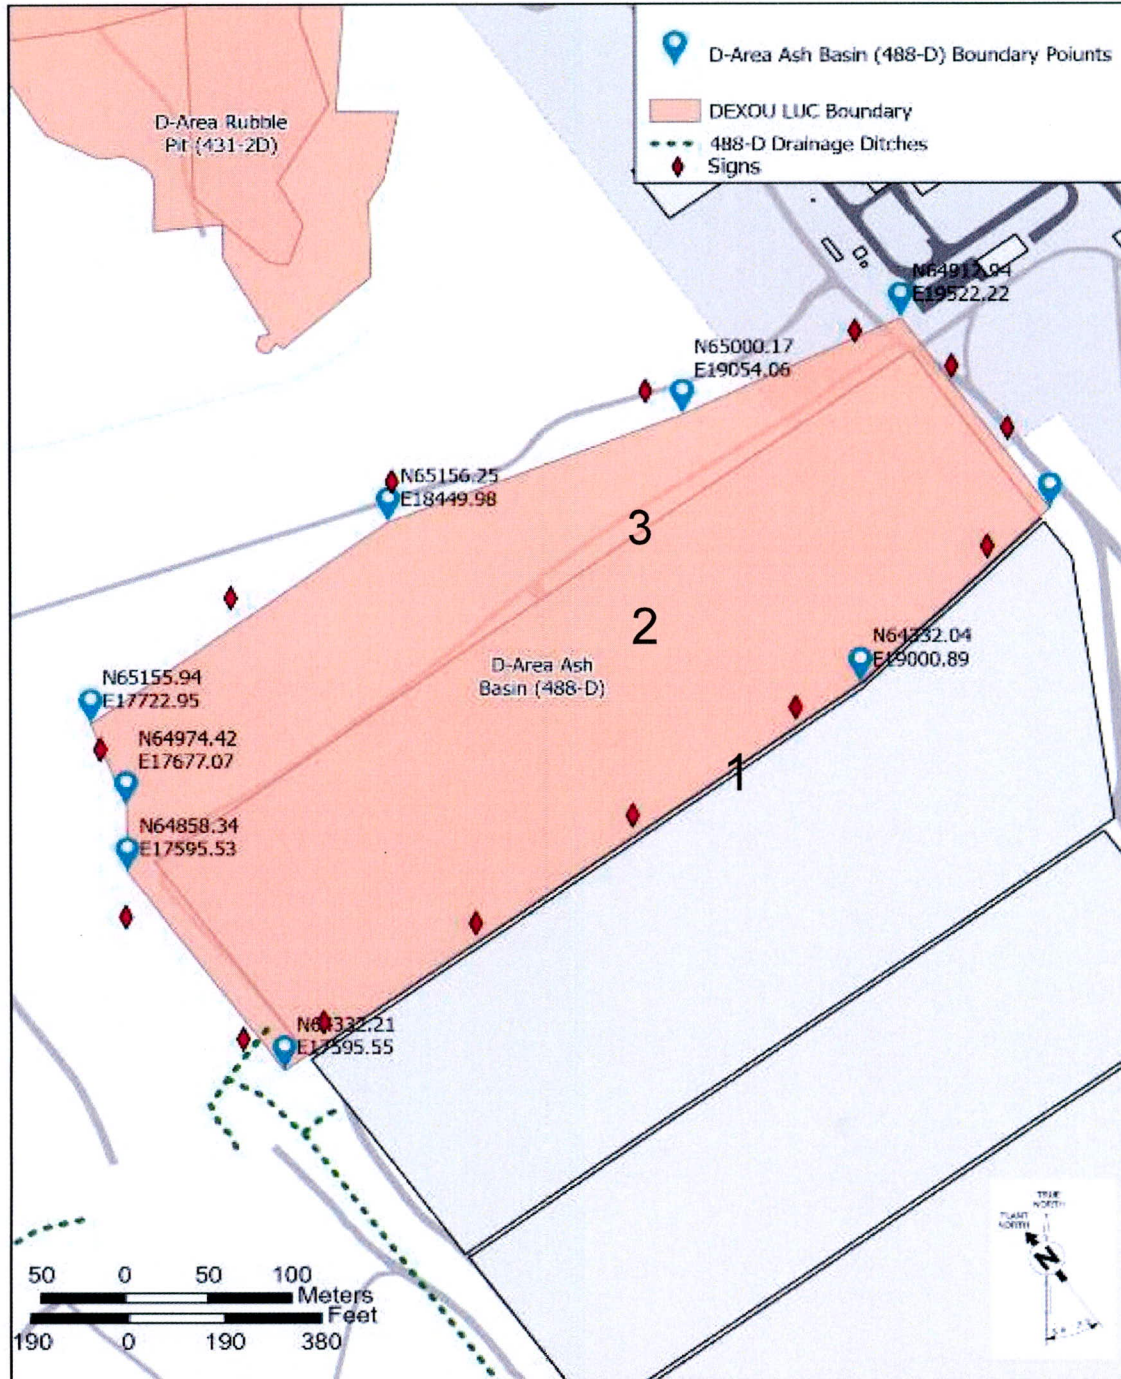
A = Satisfactory X = Unsatisfactory (Explanation required)		A or X	Observation/Corrective Action Taken
4.	VERIFY that the integrity of drainage systems and required land grading for proper drainage is maintained and that they are free of excessive erosion, sediment buildup, and any debris restricting water flow.	X	Broken PVC piping plug on drainage system See Map Note: 1 Reference Maintenance Register: PC-2022-00132

9.	VERIFY that signs of burrowing animals on the D-Area Ash Basin (488-D) are not present.	X	Carry over item: Excessive hog damage on the North slope and has continued across the entire cap. The USFS is currently performing repairs. See map note: 3 Reference Maintenance Register: PC-2017-00118

10.	Other. Active Ant Mounds	X	Active ant mounds on soil cover See map note: 2 Reference Maintenance Register: PC-2022-00133

NOTES: 1=Broken PVC piping plug on drainage system. Post Closure Maintenance replaced plug.
2= Active ant mounds on soil cover. Applied 10 lbs. of Extinguish ant bait.
3=Carry over item: Excessive hog damage on the North slope and has continued across the entire cap. The USFS is currently performing repairs.

Post Closure Maintenance replaced broken PVC piping plug on drainage system located on the South side

Applied Extinguish Ant Bait
