**ENVIRONMENTAL COMPLIANCE & AREA COMPLETION PROJECTS (EC&ACP) STANDARD
OPERATING PROCEDURES, VOL. I**
Manual: C3
Procedure: ER-IDS-019-063
Revision: 4
Effective Date: 1/08/2020
Type-Class: Checklist
Page: 1 of 3
**R-AREA OPERABLE UNIT REACTOR BUILDING AND DISASSEMBLY BASIN FIELD INSPECTION
CHECKLIST**
WORKING COPY

R-Area Operable Unit Reactor Building and Disassembly Basin Field Inspection Checklist

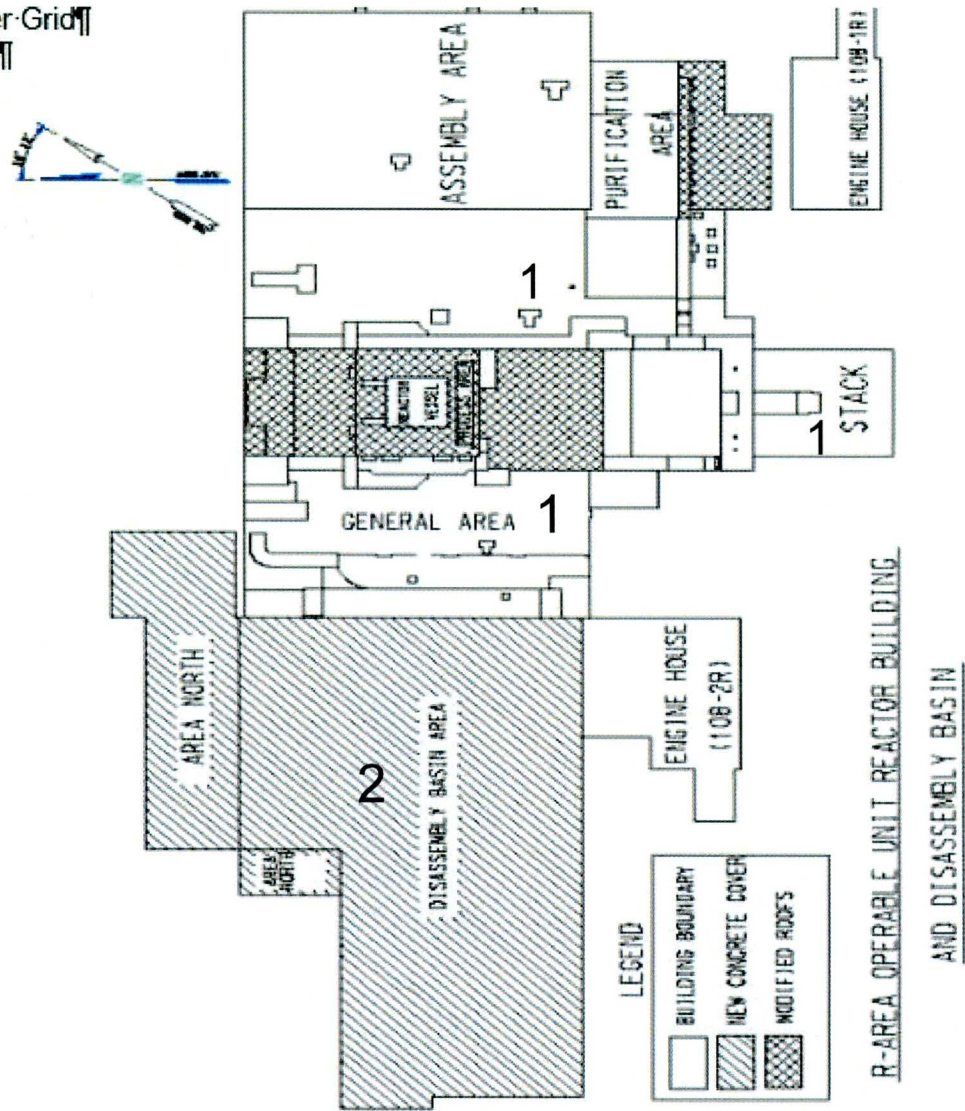
Map of R-Area Operable Unit Reactor Building and Disassembly Basin

NOTES: 1= Roofs are functioning as intended. Non-woody vegetation exist and hinders drainage. Efforts will be made to remove

Vegetation. 2= Carry over item: Several areas of caulking in expansion joints need repair. Work package for repair is in development.
