**Title: MONITORING OF CLOSED WASTE TANKS FOR HTF
AND FTF**

Work Order Title: MONITORING OF CLOSED WASTE TANKS FOR HTF AND
FTF

Closed Waste Tank Annual Inspection Checklist Cover Sheet

Inspection Year: 2020

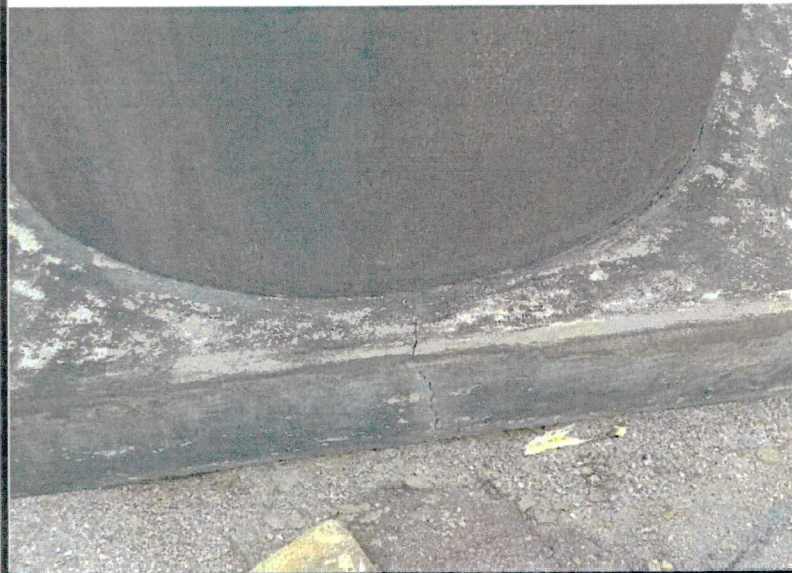
Tank 19, Northwest Riser (Crack on South Side)
