**ENVIRONMENTAL COMPLIANCE & AREA COMPLETION PROJECTS (EC&ACP) STANDARD
OPERATING PROCEDURES, VOL. I**
Manual: C3
Procedure: ER-IDS-019-020
Revision: 6
Effective Date: 11/23/2020
Type-Class: Checklist
Page: 1 of 4
**METALLURGICAL LABORATORY HAZARDOUS WASTE MANAGEMENT FACILITY (HWMF) POST
CLOSURE FIELD INSPECTION CHECKLIST**
WORKING COPY

Metallurgical Laboratory Hazardous Waste Management Facility (HWMF) Post Closure Field Inspection Checklist

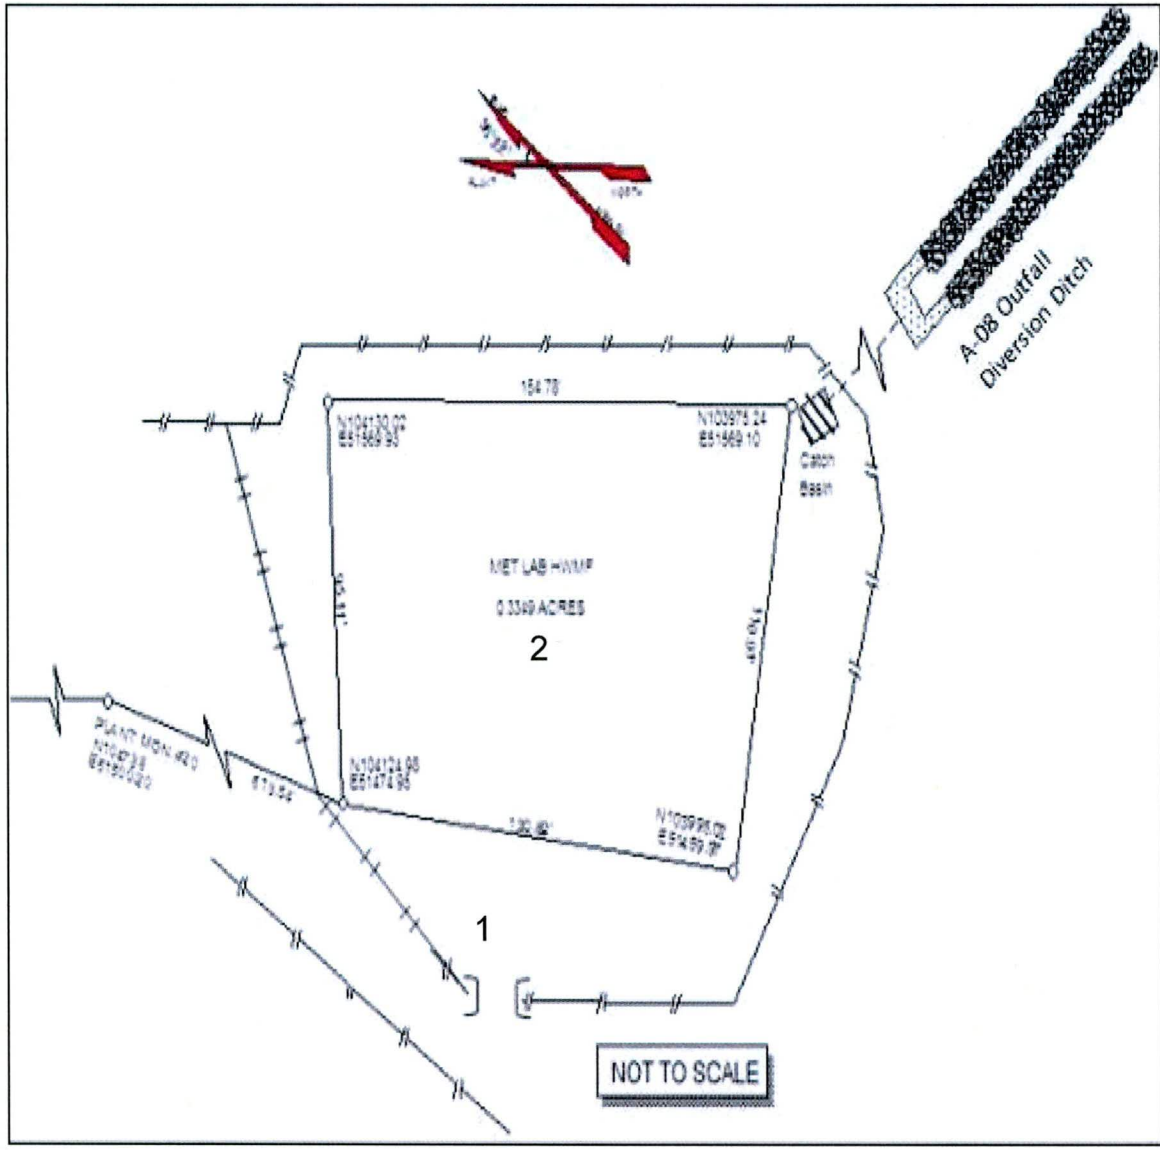
Map of Metallurgical Laboratory HWMF

A = Satisfactory X = Unsatisfactory (Explanation required)	A or X	Observation/Corrective Action Taken
3. VERIFY fence is in good condition (e.g., shows no signs of serious wear, no vegetative growth) and unattended gates are locked.	X	Bottom piece of frame work tubing on the entry gate is rusted through See Map Note:1 Reference Maintenance Register: PC-2021-00070

4. CHECK the soil cover and side slopes for signs of erosion, depression (subsidence) and evidence of burrowing animals.	X	Active Ant Mounds on Soil Cover See Map Note: 2 Reference Maintenance Register: PC-2021-00071

NOTES: 1=Bottom piece of frame work tubing on the entry gate is rusted through. Post Closure Maint. will repair gate with a new piece of frame work tubing.

2=Active Ant Mounds on soil cover. Applied .25 lbs. of extinguish ant bait.
