**ENVIRONMENTAL COMPLIANCE & AREA COMPLETION PROJECTS (EC&ACP) STANDARD OPERATING PROCEDURES, VOL. I**

Manual: C3  
 Procedure: ER-IDS-019-077  
 Revision: 1  
 Effective Date: 03/27/2018  
 Type-Class: Checklist  
 Page: 1 of 3

**D-AREA ASH BASIN (488-2D) AND ASH LANDFILL (488-4D) INTERIM FIELD INSPECTION CHECKLIST**

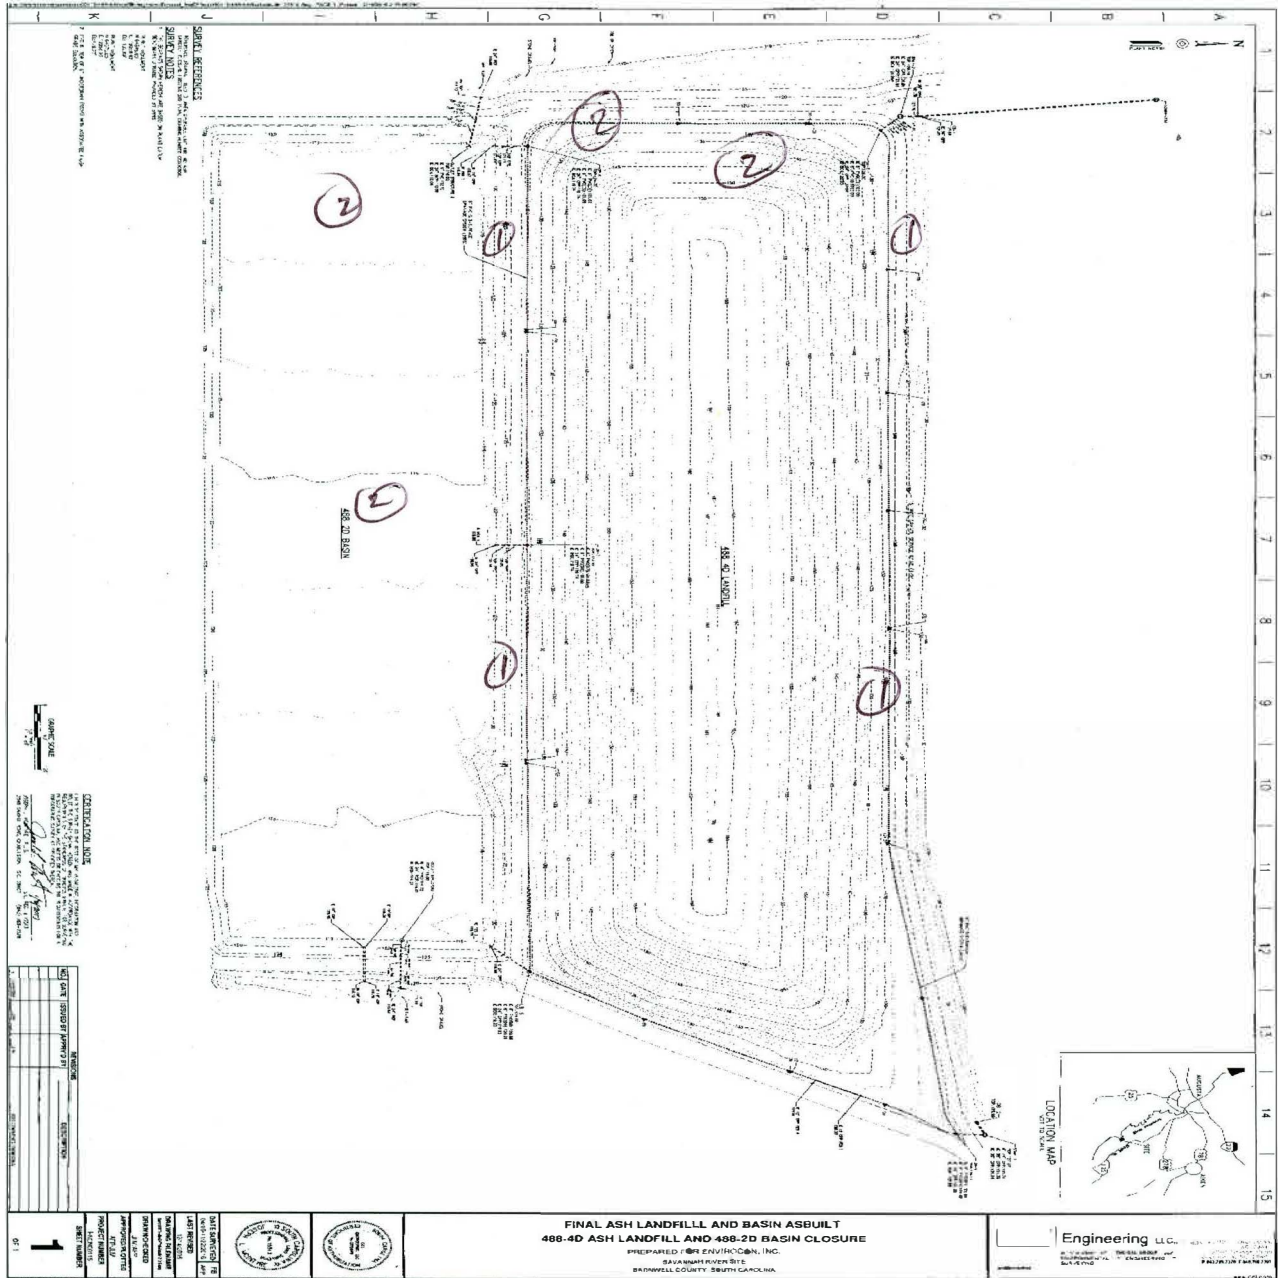
D-Area Ash Basin (488-2D) and Ash Landfill (488-4D) Map

| A = Satisfactory | | A or X | Observation/Corrective Action Taken |
|---|---|---|--|
| 6. | Verify the soil cover at D-Area Ash Basin (488-2D) and Ash Landfill (488-4D) has no signs of unacceptable erosion or depressions (subsidence). | X | CARRY OVER ITEM: SPOTS OF EROSION ON THE SIDE SLOPES OF 488-4D. SEE MAP NOTE: (1). REF. MAINT. REGISTER PL-2017-00094 |
| 7. | Verify signs of burrowing animals on the D-Area Ash Basin (488-2D) and Ash Landfill (488-4D) are not present. | X | HOGS ROOTING ON THE SIDE SLOPES + DRAINAGE DITCH OF 488-4D. MINOR HOE DAMAGE ON THE FLOOR OF 488-2D. SEE MAP NOTE (2). REF. MAINT REGISTER PL-2018-00091 |

NOTE: (1) = CARRY OVER ITEM: SPOTS OF EROSION ON THE SIDE SLOPES OF 488-4D. USFS WILL MAKE REPAIRS.  
 (2) = HOGS ROOTING ON THE SIDE SLOPES + DRAINAGE DITCH OF 488-4D. MINOR HOG DAMAGE ON THE FLOOR OF 488-2D. USFS WILL MAKE REPAIRS. CPL 8-7-18
