Manual: C3
 Procedure: ER-IDS-019-073
 Revision: 2
 Effective Date: 09/09/2021
 Type-Class: Checklist
 Page: 1 of 86
CPC 2/15/22

A-AREA ASH PILE (788-A) STABILITY FIELD INSPECTION CHECKLIST

Review of A-Area Ash Pile Stability Inspection 2022 vs 2021

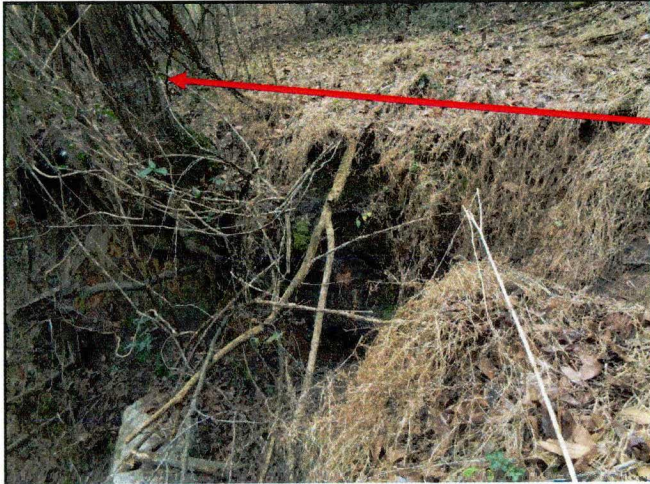
2021

This tree has fallen off the eroded bank downstream of the sheet piling

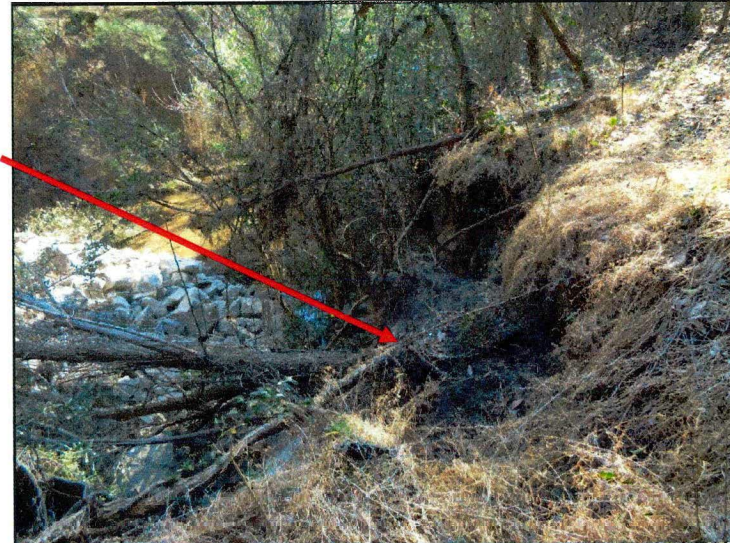
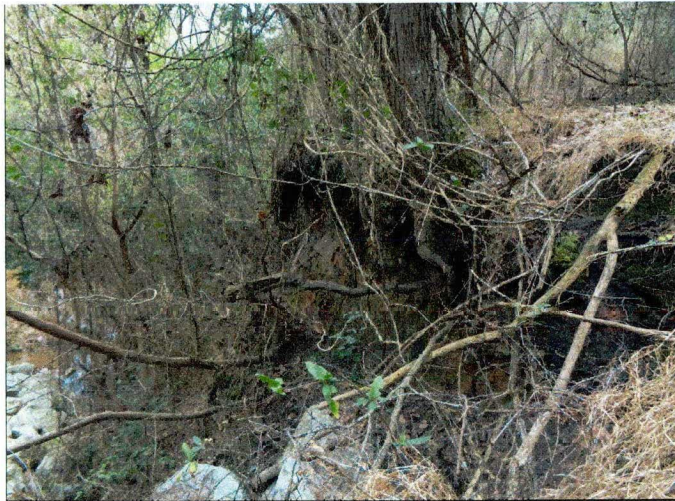
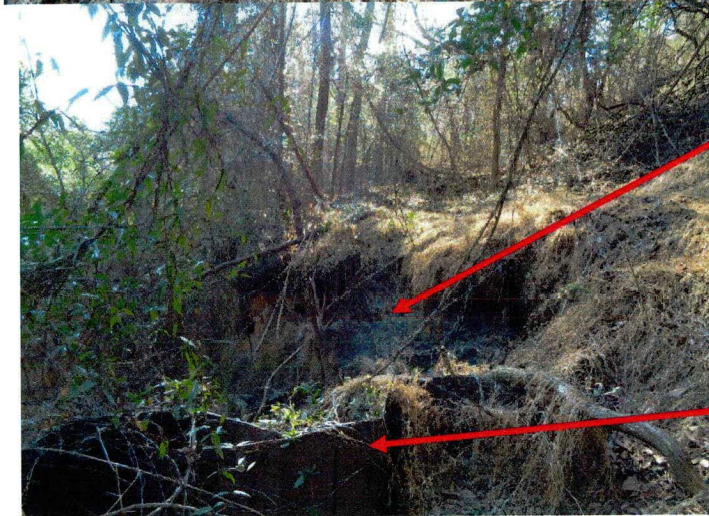
2022

Small amount of ash is on the bank slope where the tree roots were.

Not an exact matching view – Picture is taken from the opposite side of Tim's Branch Tributary looking toward the Ash Pile

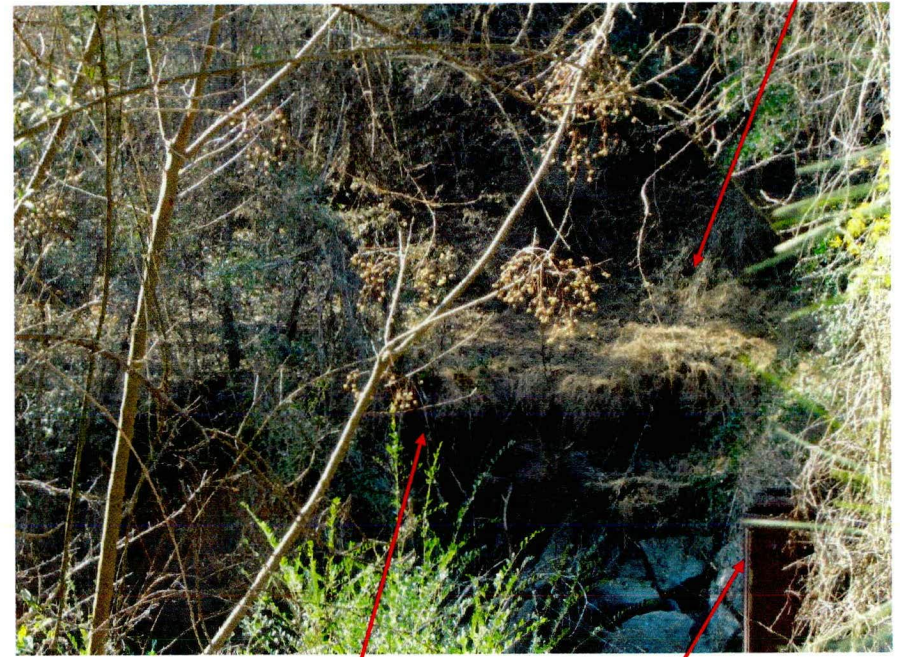
2022

The toe of the ash pile is very close to the sheet piling

Area where tree fell
