P-AREA OPERABLE UNIT REACTOR BUILDING AND DISASSEMBLY BASIN FIELD INSPECTION
CHECKLIST

P-Area Operable Unit Reactor Building and Disassembly Basin

SRNS-E3520-2017-00008-SM, Revision 1

105-P ACTUATOR TOWER ROOF SLAB FLAW AT THE SOUTHEAST CORNER

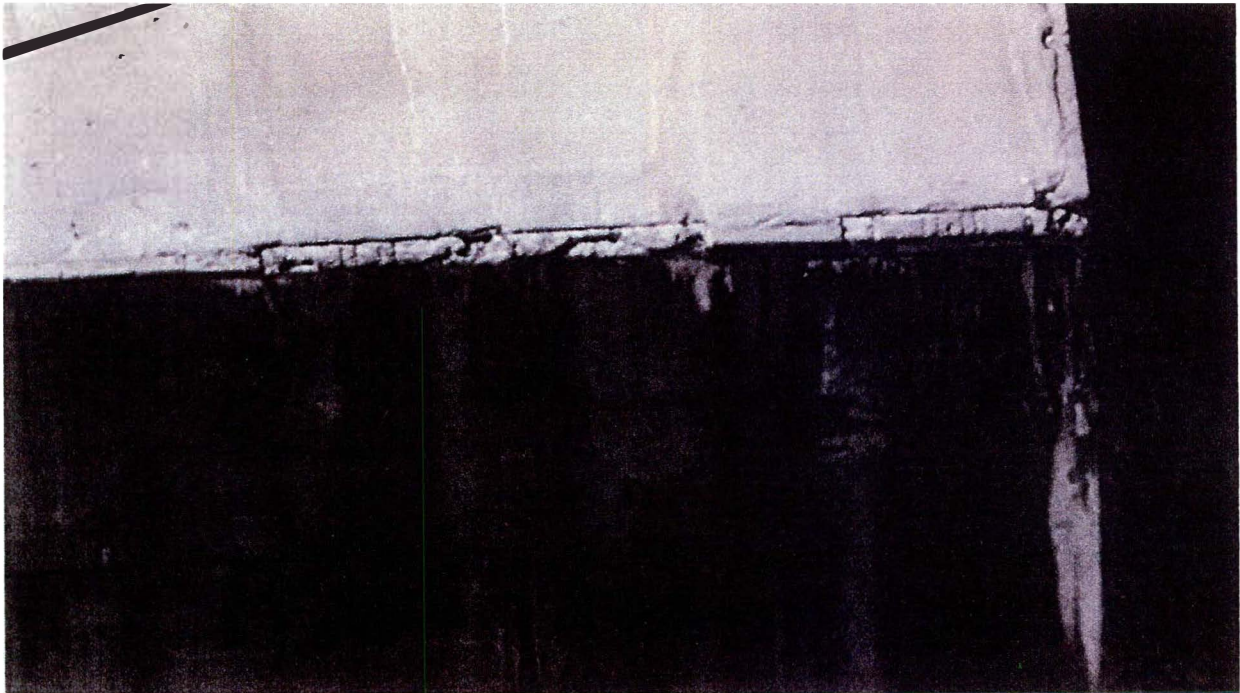
Photo 1: Concrete Edge Degradation

Condition of the roofs remained the same since last inspection. There was no further deterioration at the edge of concrete roof were stack was located and the flaw on the high hat (See Attached Memo). Vegetation growth is present at various areas on the roof. The sediment should be removed to eliminate and prevent vegetation. Some spots exist on the roof that cause the potential for pooling water. A crack on the process room cap appears to be widening and should continue to be monitored. The crack on the north face below the actuator has no change. Please see pictures for further details.

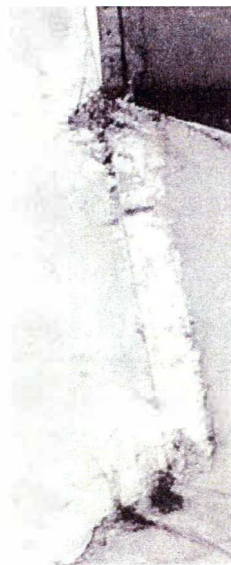
Figure 2: Vegetation

A = Satisfactory X = Unsatisfactory (Explanation required)	A or X	Observation/Corrective Action Taken
1. Verify roads are accessible to 105-P Reactor Building and Basin.	A	
2. Verify 105-P Reactor Building Complex roofs are functioning and free of woody vegetation. Submit inspection reports to Cognizant Technical Function to review and evaluate functionality of roofs. (REFER TO Note 3).	X	VEGETATION GROWING ON ROOF. SEE MAP NOTE (D). REF. MAINT. REGISTER PC-2017-00090

NOTES: ①- VEGETATION GROWING ON ROOF. ACP IS CURRENTLY DEVELOPING A WORK PACKAGE TO CLEAN SILT, SAND, DEBRIS AND REMOVE VEGETATION.
② SEVERAL AREAS OF CAULKING IN EXPANSION JOINTS NEED REPAIR ACP WILL DEVELOP A WORK PACKAGE TO REPAIR CAULKING JOINTS ON THE DISASSEMBLY BASIN COVER
SEE ATTACHED CTF REVIEW BLOMMENTS

Vegetation, silt, sand and debris needs to be removed from the roof of the Reactor Building.

Applied herbicide to vegetation on the roof with a Drone. Per CTF evaluation the silt, sand and debris on the roofs does not appear to be causing any detrimental effects to the functionality of the roofs.

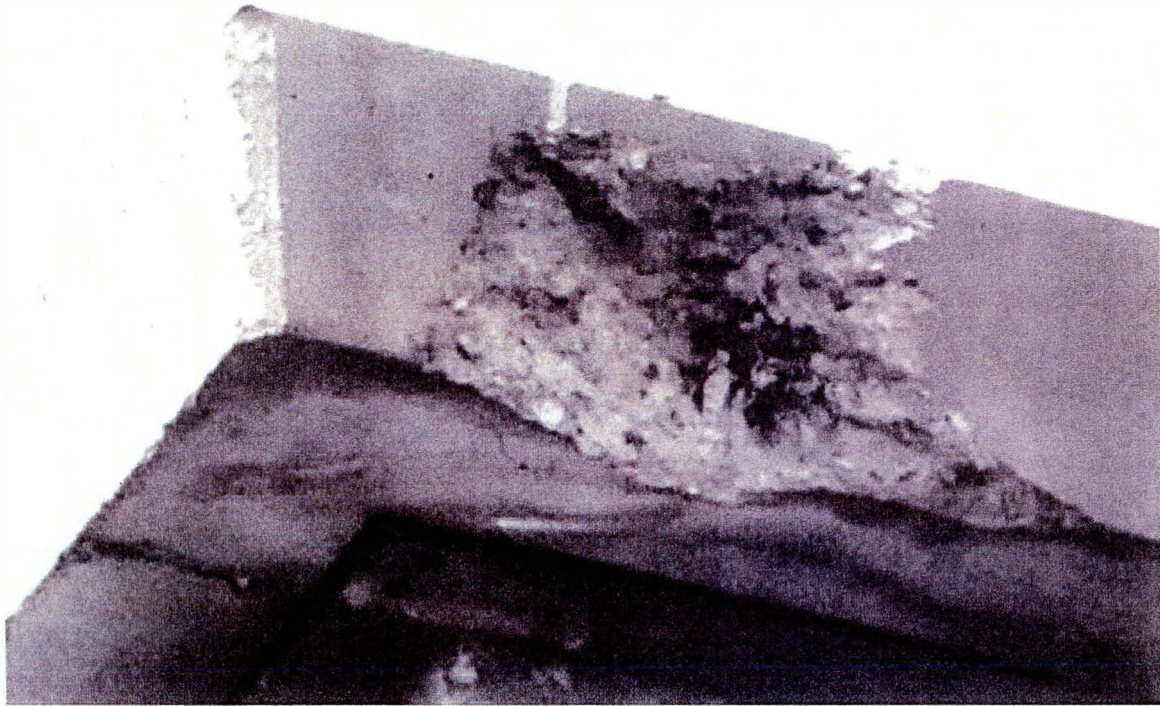
Image DSC 0009

1. The flaw is near the southeast corner, on the east side in the edge of the 12" cap slab overhang.
2. One of the epoxy-coated rebars is exposed. The bar is clean with no cement paste on it. From the edge detail on Drawings C-CC-P-00023 & 00024 it is seen the exposed bar is a #6 hooked bar that was intended to have 3" of concrete cover. There is no corrosion visible on the bar.

3. Given the location of the exposed bar, it is expected there are at least two bent bars (one each way) embedded between the flaw and the corner.
4. A crack starts at the top of the flaw and runs vertically down the thickness of the slab, turns at the bottom of the slab across the corner at approximately 45 degrees and appears to turn up vertically on the south side of the slab. There are other crack branches seen as well. There is some efflorescence seen on the bottom of the slab along the crack.

5. There appears to be a foreign substance in the flaw where the bar disappears near the top of the slab. The substance looks like a wad of grass or frayed rope.

6. The surface of the flaw appears to vary. The upper right portion in Photo DSC 0009 (attached) is clearly a break. The aggregate is fully exposed or split. The flaw near the exposed bar has a coating of cement paste over the aggregate; however there is no paste visible on the exposed bar.

The observations of the surface texture indicate the flaw is a void in the concrete that had a thin veneer on the surface. The thin veneer was likely stripped away when the forms were removed, leaving the void exposed. Thus, the flaw is deemed a product of construction, which is corroborated by the attached "105-P Aerial Taken 9-14-12", showing the flaw was present a year after the slab was constructed.

The crack across the corner is an indication the corner was subjected to an impact, perhaps during removal of the scaffolding and forms used during installation. Given the bars embedded in the projecting portion of the corner, it is not likely the corner will fall off. This is further assured by the presence of effervescence on the bottom of the slab along the crack. The slab has Integral Crystalline Waterproofing (ICW) in the concrete mix to seal cracks should they form after the slab has hardened. Thus, it is thought the cracks are annealing over time.

The presence of this flaw in the edge of the overhang does not threaten the underlying Actuator Tower. There is no indication the flaw will allow water to get into the building. The exposed rebar would be vulnerable to corrosion without the epoxy coating; however, the coating protects the bar for a time.

Note the cracking across the underside of the overhang corner, exposed epoxy coated bar (depth 3"), aggregate exposed near the surface but not near the bar and the foreign material near the top of the exposed bar..

Continue to surveille the flaw on an annual basis for signs of degradation. If it is seen the exposed bar is corroding, or if the corner is degrading further it would be prudent to consider applying a repair mortar with corrosion inhibitor.

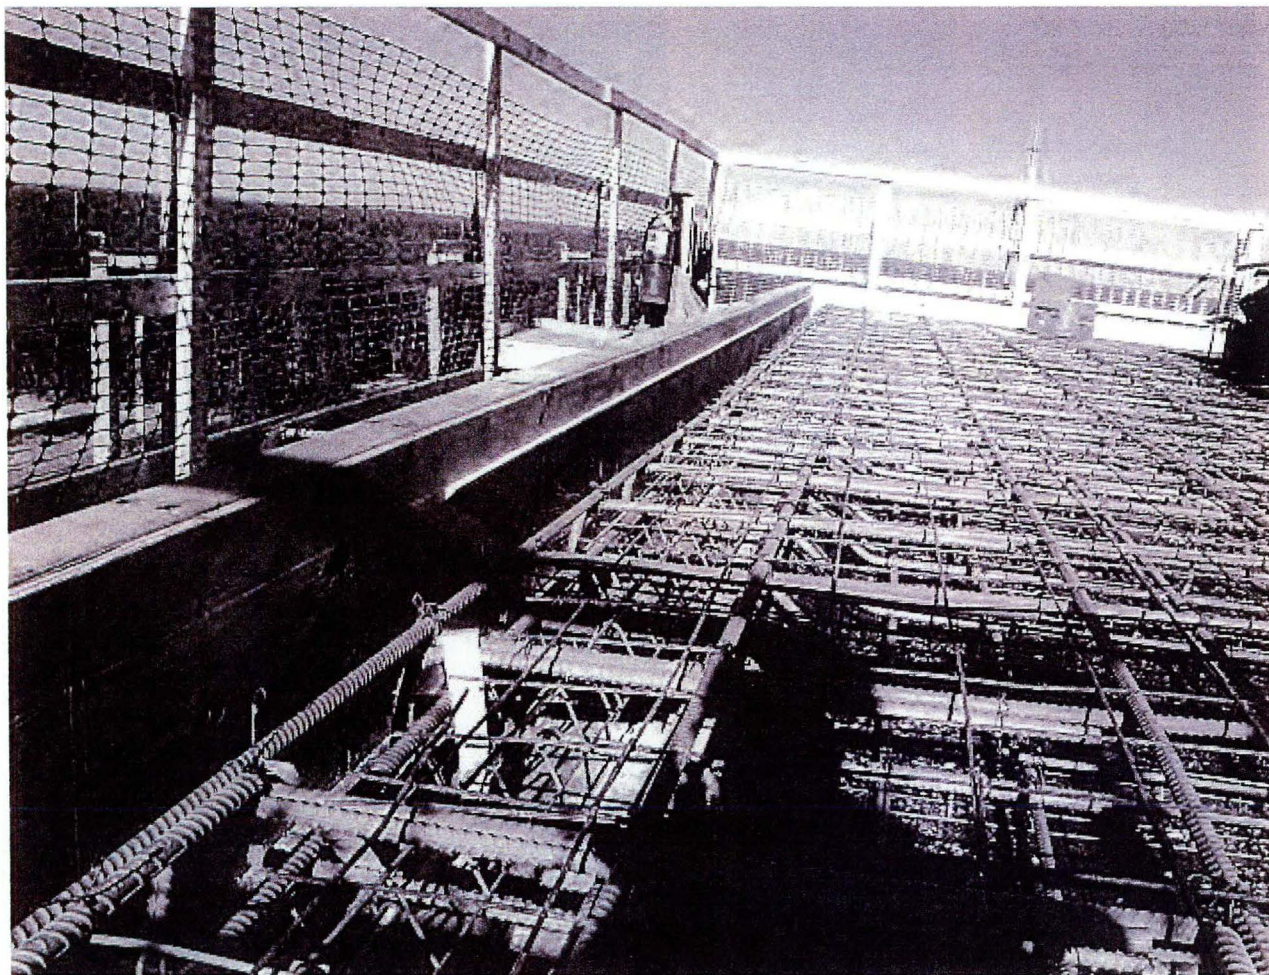
105-P Actuator Tower Roof Prep

Note the clear distance between the edge bars and the form is approximately 3" and the bars are coated with epoxy. No explanation for the welded wire mesh on top of the reinforcing grid.

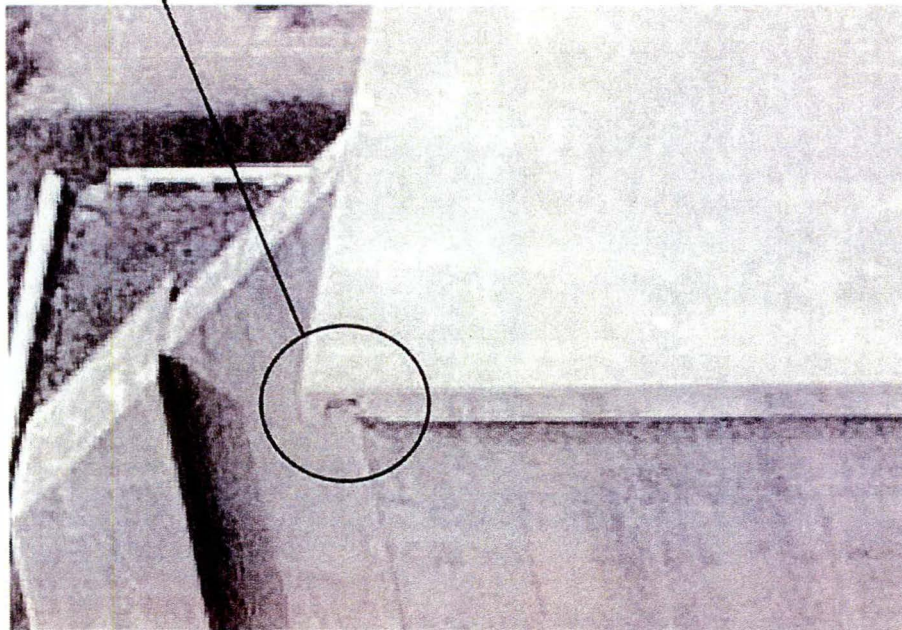
7. The "105-P Aerial Taken 9-14-12" (attached) shows this flaw was visible one year after the slab placement in 2011.

Aerial taken September 14, 2012 showing flaw was present one year after construction
