**ENVIRONMENTAL COMPLIANCE & AREA COMPLETION PROJECTS (EC&ACP) STANDARD OPERATING PROCEDURES, VOL. I**

Manual: C3  
 Procedure: ER-IDS-019-028  
 Revision: 4  
 Effective Date: 08/13/2018  
 Type-Class: Checklist  
 Page: 1 of 4

**SANITARY LANDFILL (BLDG. 740-G) FIELD INSPECTION CHECKLIST**

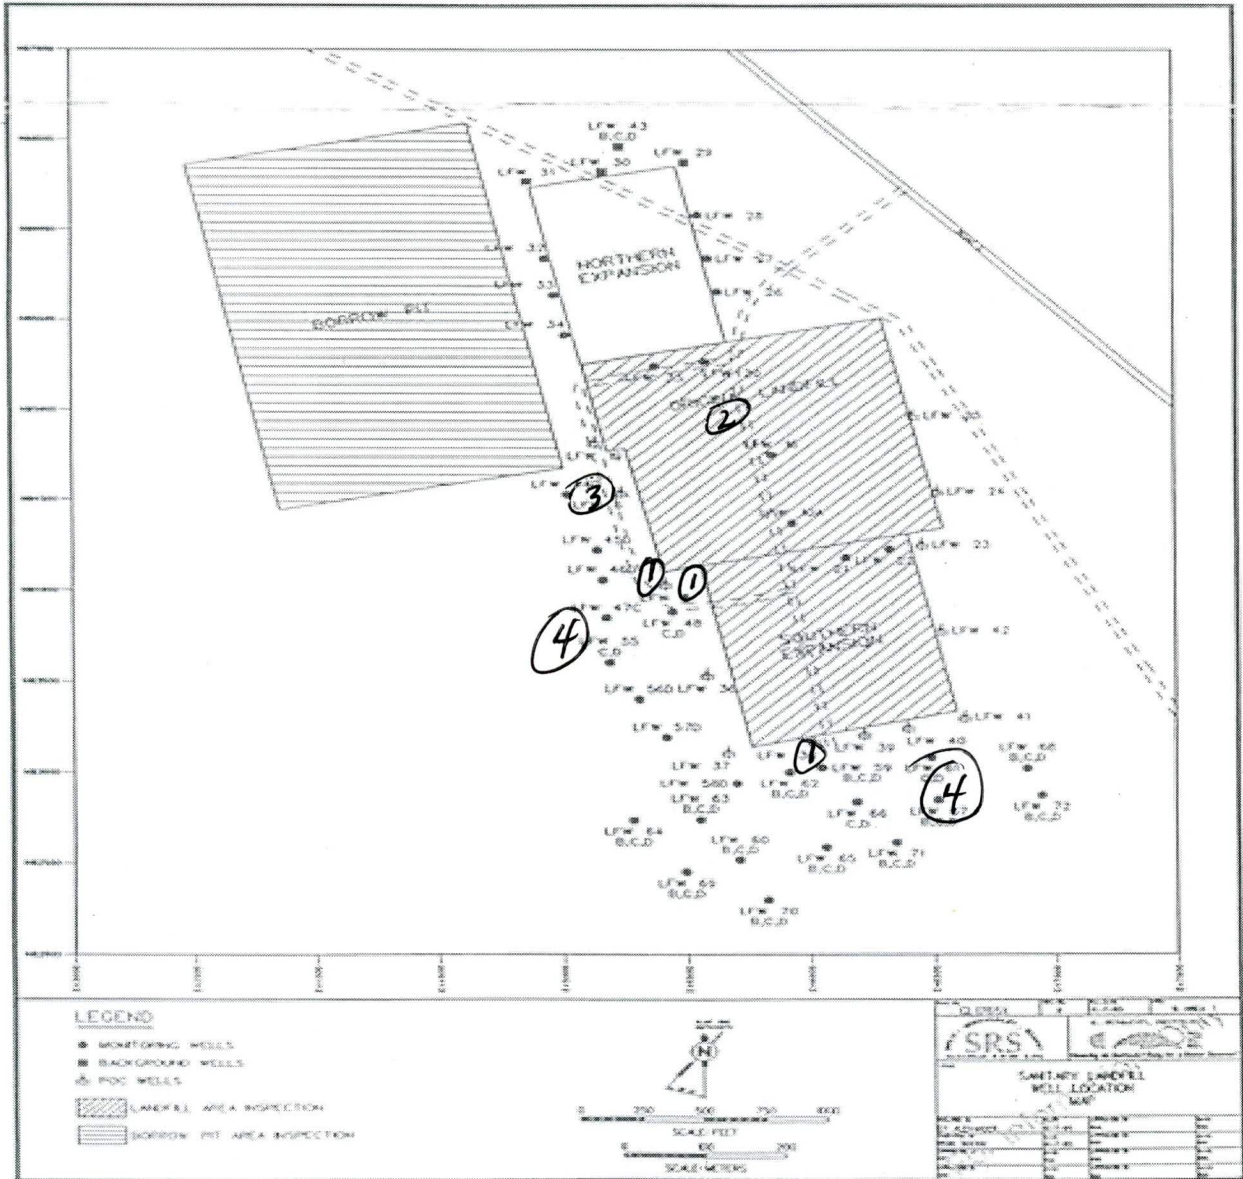
Map of Sanitary Landfill (Bldg. 740-G)

5. Inspect soil cover for signs of erosion, abnormal soil cracks, ponding, or depressions (subsidence).	A	
6. Inspect for signs of burrowing animals.	X	ARMADILLO'S DIGGING IN SEVERAL AREAS ON CAP. SEE MAP NOTE (2). REF. MAINT REGISTER PC-2018-00128

8. Inspect integrity of drainage system for presence of excessive erosion, sediment build-ups, slumping of banks, and any debris restricting water flow.	X	CARRY OVER ITEM: VEGETATION NEEDS TO BE REMOVED FROM THE OUTLET DRAINAGE PIPE LOCATED ON THE WEST SIDE. SEE MAP NOTE (3)

9. Inspect integrity of catch basins, including inlet/outlet drainage structures. Basins shall be cleaned every 2 years or when Inspector or Post Closure Manager determines capacity of basin has been reduced by greater than 50 percent.	X	CARRY OVER ITEM: OUTLET DRAINAGE DITCHES NEED VEGETATION REMOVED ON THE SOUTH + WEST CATCH BASINS. SEE MAP NOTE (4) REF. MAINT REGISTER - PC-2018-00046

NOTES: ① GAP IN BOTTOM OF FENCE AT THE OUTLET DITCH TO THE SOUTH CATCH BASIN, ALSO SEVERAL ARMADILLO HOLES UNDER FENCE. USES WILL FILL HOLES WITH REP-RAP. REF. MAINT REGISTER PC-2018-0012?

② = ARMADILLO'S DIGGING IN SEVERAL AREA'S ON CAP. USES WILL REPAIR.

③ = CARRY OVER ITEM: VEGETATION NEEDS TO BE REMOVED FROM THE OUTLET DRAINAGE PIPE LOCATED ON THE WEST SIDE. USES WILL REMOVE VEGETATION. REF. MAINT REGISTER PC-2018-0045

④ = CARRY OVER ITEM: OUTLET DRAINAGE DITCHES NEEDS VEGETATION REMOVED ON THE SOUTH + WEST CATCH BASINS; USES WILL REMOVE VEGETATION.

⑤ = CARRY OVER ITEM: HOLE DAMAGE ON THE SIDE SLOPE OF THE WEST CATCH BASIN. USES WILL REPAIR WITH TOP SOIL, GRASS SEED + STRAW.

US Forest service will make repairs with top soil, grass seed and straw

US Forest service will make repairs.
