**ENVIRONMENTAL COMPLIANCE & AREA COMPLETION PROJECTS (EC&ACP) STANDARD
OPERATING PROCEDURES, VOL. I**
Manual: C3
Procedure: ER-IDS-019-048
Revision: 6
Effective Date: 01/27/2022
Type-Class: Checklist
Page: 1 of 3
**R-REACTOR SEEPAGE BASINS 904-57G, 904-58G, 904-59G, 904-60G, 904-103G AND 904-104G
FIELD INSPECTION CHECKLIST**
WORKING COPY

R-Reactor Seepage Basins 904-57G, 904-58G, 904-59G, 904-60G, 904-103G and 904-104G Field
Inspection Checklist

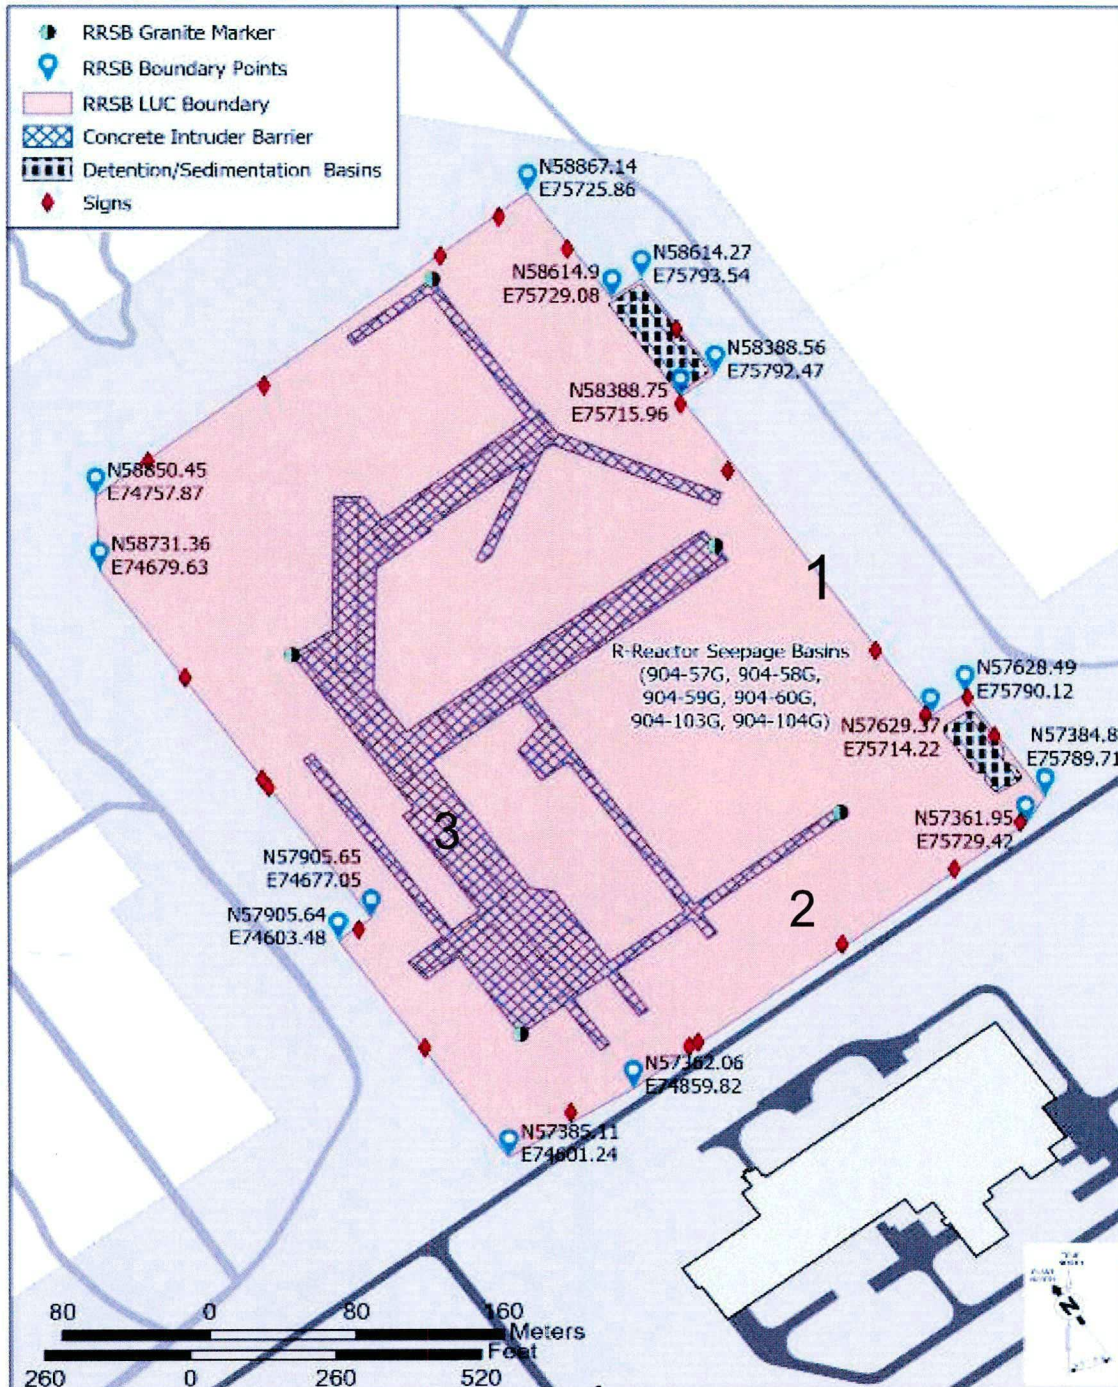
R-REACTOR SEEPAGE BASINS

A = Satisfactory X = Unsatisfactory (Explanation required)		A or X	Observation/Corrective Action Taken
3.	VERIFY fence is in good condition and locked (five locations).	X	Standing dead trees and vines at fence on the East fence line need removal See Map Note: 1 Reference Maintenance Register: PC-2022-00095

4.	CHECK asphalt cover for signs excessive cracking, depressions (subsidence), and burrowing animals.	X	Two cracks on the south side. See Map Note:2 Reference Maintenance Register: PC-2022-00096

5.	VERIFY no woody vegetation is growing through asphalt bioturbation barrier. REMOVE OR IDENTIFY as needed.	A	
6.	VERIFY there has not occurred excessive deterioration of concrete cover.	X	Concrete cover has areas of cracking and sealant in control joints is deteriorated See Map Note: 3 Reference Maintenance Register: PC-2022-00097

- NOTES:**
- 1=Standing dead trees and vines at fence on the East fence line need removal. USFS will cut and remove dead trees and clear vines from fence.
 - 2=Two cracks in the asphalt cover. The cracks will be filled with a repair sealant that engineering will specify.
 - 3=Concrete cover has areas of cracking and sealant in control joints is deteriorated. Construction will repair concrete and replace sealant in the control joints.
