**ENVIRONMENTAL COMPLIANCE & AREA COMPLETION PROJECTS (EC&ACP) STANDARD OPERATING PROCEDURES, VOL. I**

**P-AREA OPERABLE UNIT REACTOR BUILDING AND DISASSEMBLY BASIN FIELD INSPECTION CHECKLIST**

Inspected By		
Dylan Price (Print Name)	<i>Dylan Price</i> (Signature)	11-19-24 (Date)

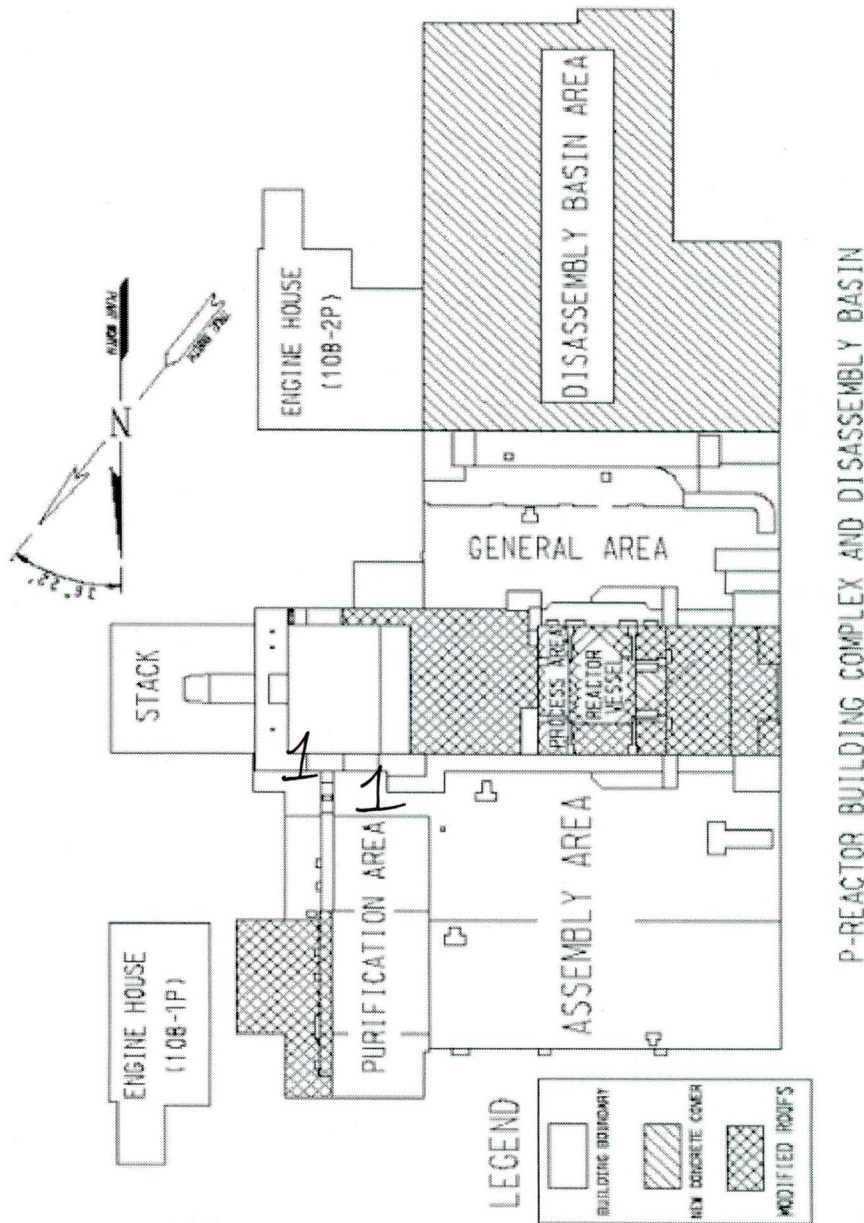
Map of P-Area Operable Unit Reactor Building and Disassembly Basin

NOTES: 1 - Vegetation on roof
