ENVIRONMENTAL COMPLIANCE & AREA COMPLETION PROJECTS (EC&ACP) STANDARD OPERATING PROCEDURES, VOL. I

Manual: C3
Procedure: ER-IDS-019-063
Revision: 4
Effective Date: 1/08/2020
Type-Class: Checklist
Page: 1 of 3

R-AREA OPERABLE UNIT REACTOR BUILDING AND DISASSEMBLY BASIN FIELD INSPECTION CHECKLIST

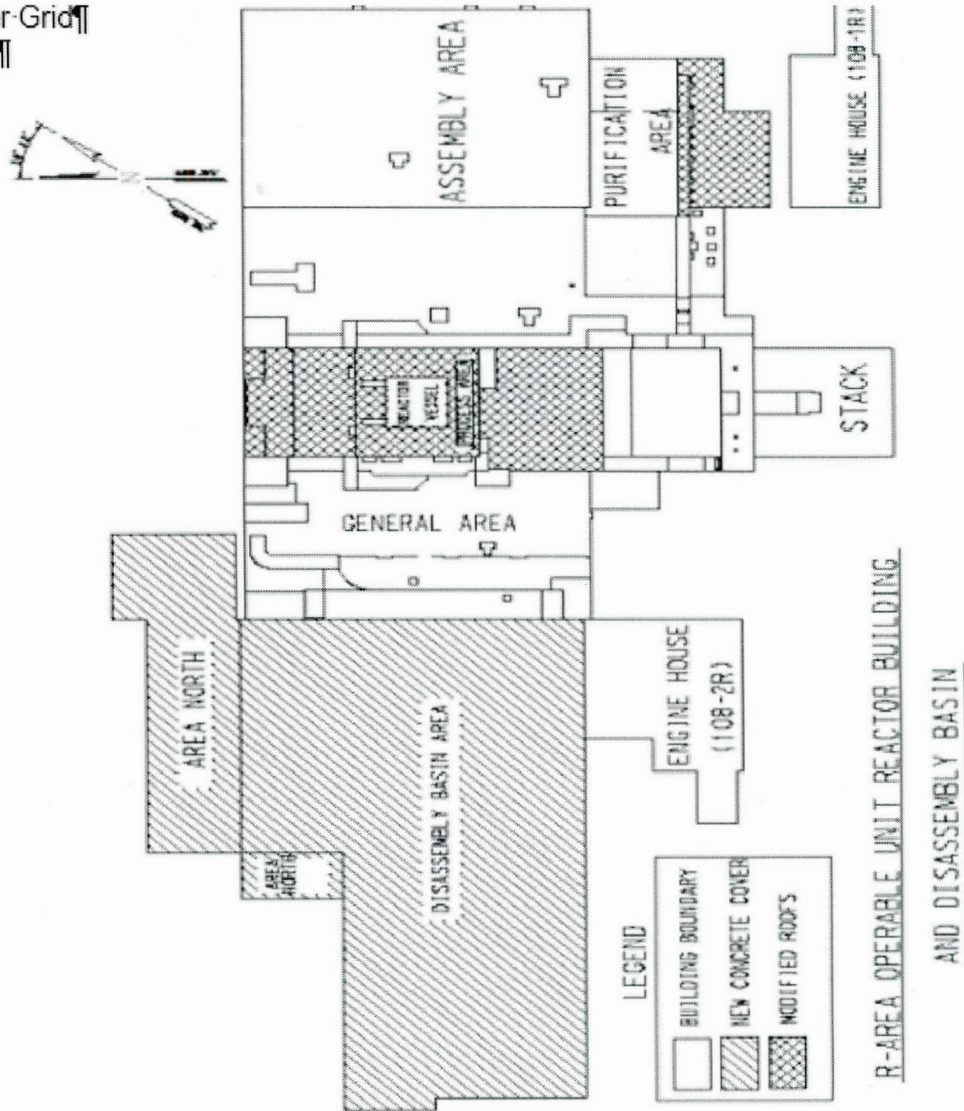
Map of R-Area Operable Unit Reactor Building and Disassembly Basin

NOTES: 1 - Small patches of vegetation exists on roof.

SRM will apply herbicide via drone during spring 2025
