# **Post-Construction Report/Corrective Measures Implementation Report /Remedial Action Completion Report for the G-Area Oil Seepage Basin (761-13G) Operable Unit (U)**

**SRNS-RP-2020-00022**

**March 2020**

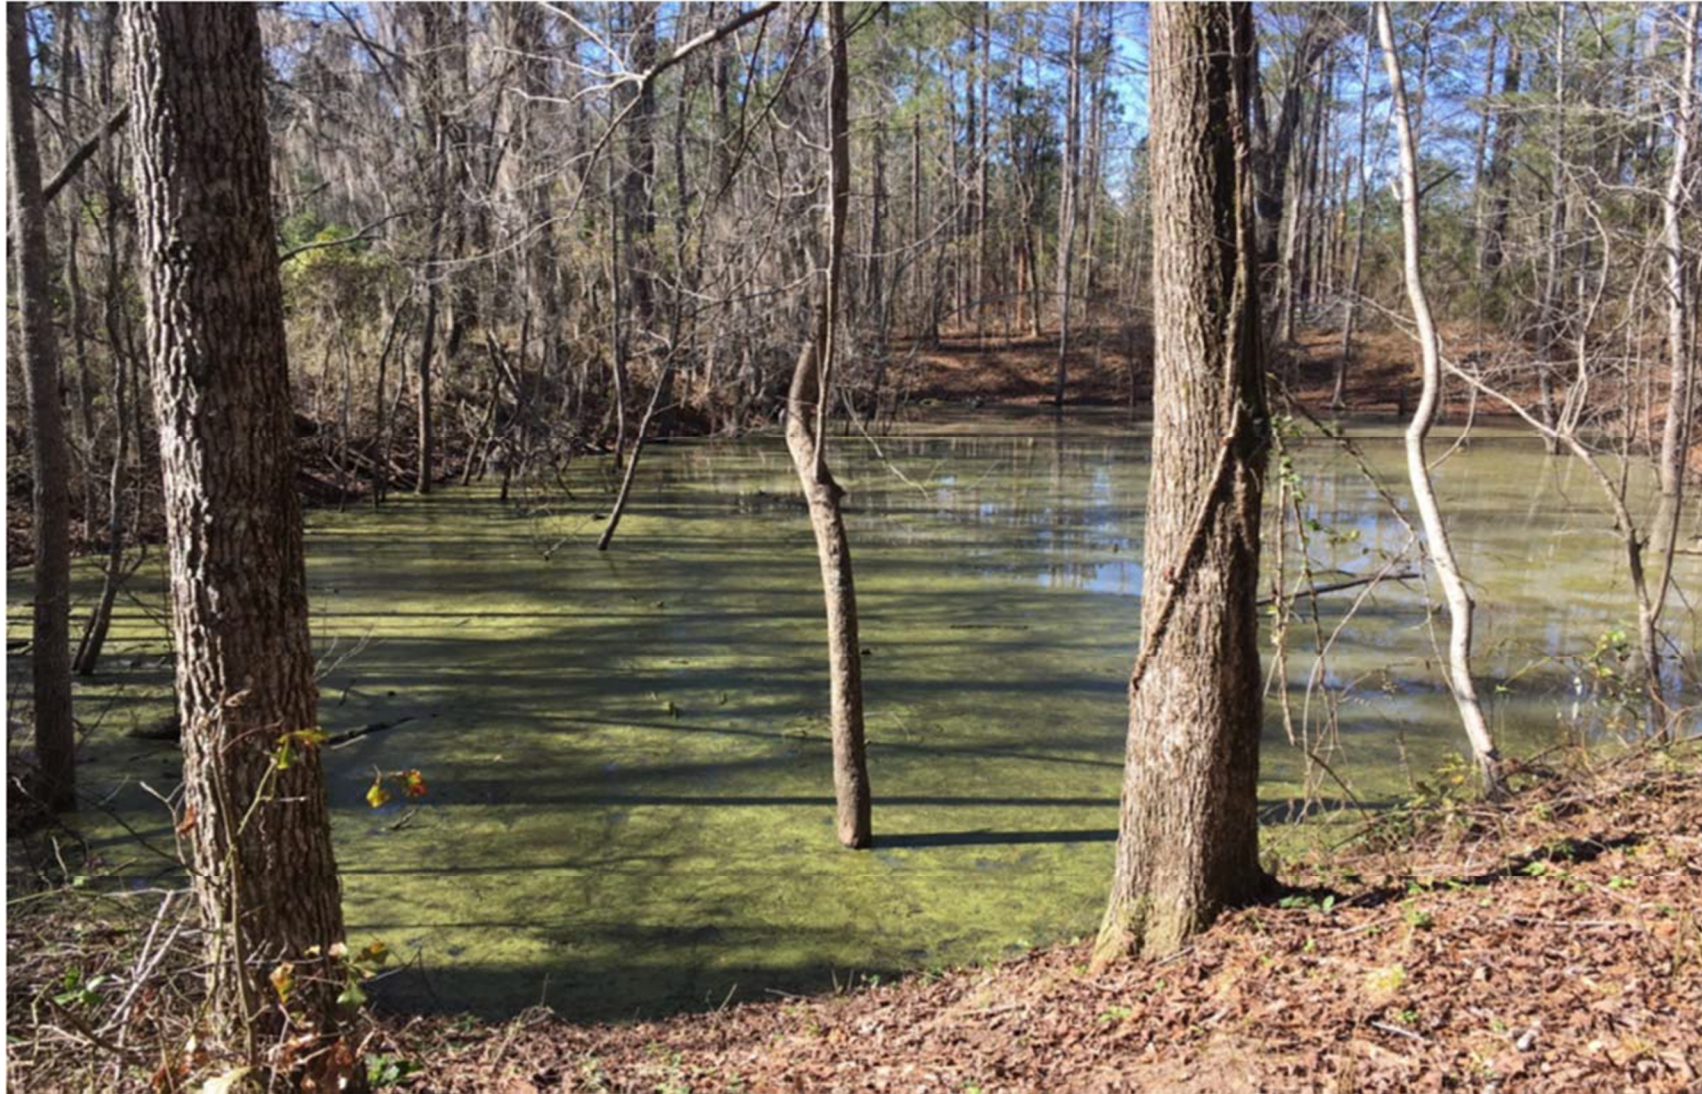
The GOSB OU is located southeast of N-Area (Central Shops) in relatively flat terrain, approximately (~) 54-meters (m) (180-feet [ft]) south of the railroad tracks, which run adjacent to Central Shops (Figure 1). The area surrounding the GOSB OU is wooded with heavy underbrush and contains no stressed vegetation or other visual indications of contamination (Figure 2).

**Figure 2. Photograph of the GOSB OU Pre-Construction (February 2017)**

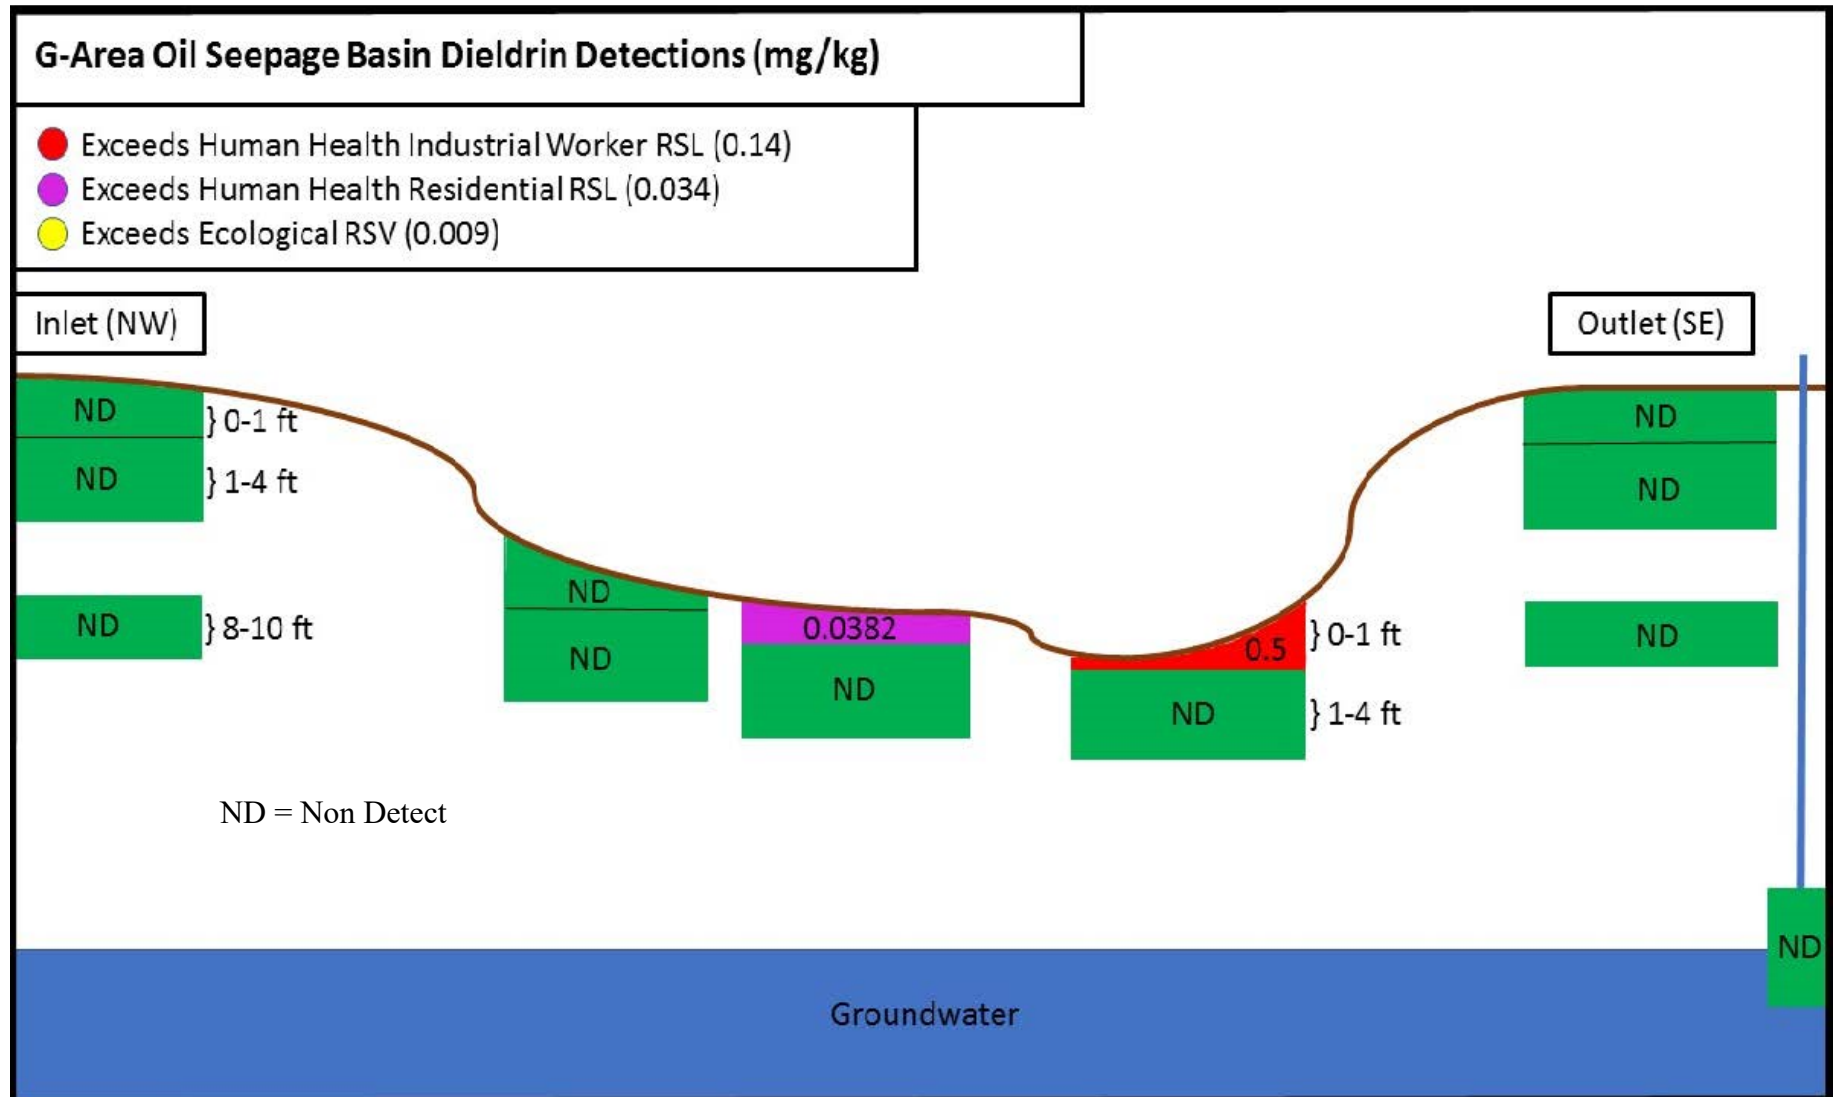
**Figure 5. Cross-Section of GOSB OU Dieldrin Detections - Soil, Sediment, and Groundwater**

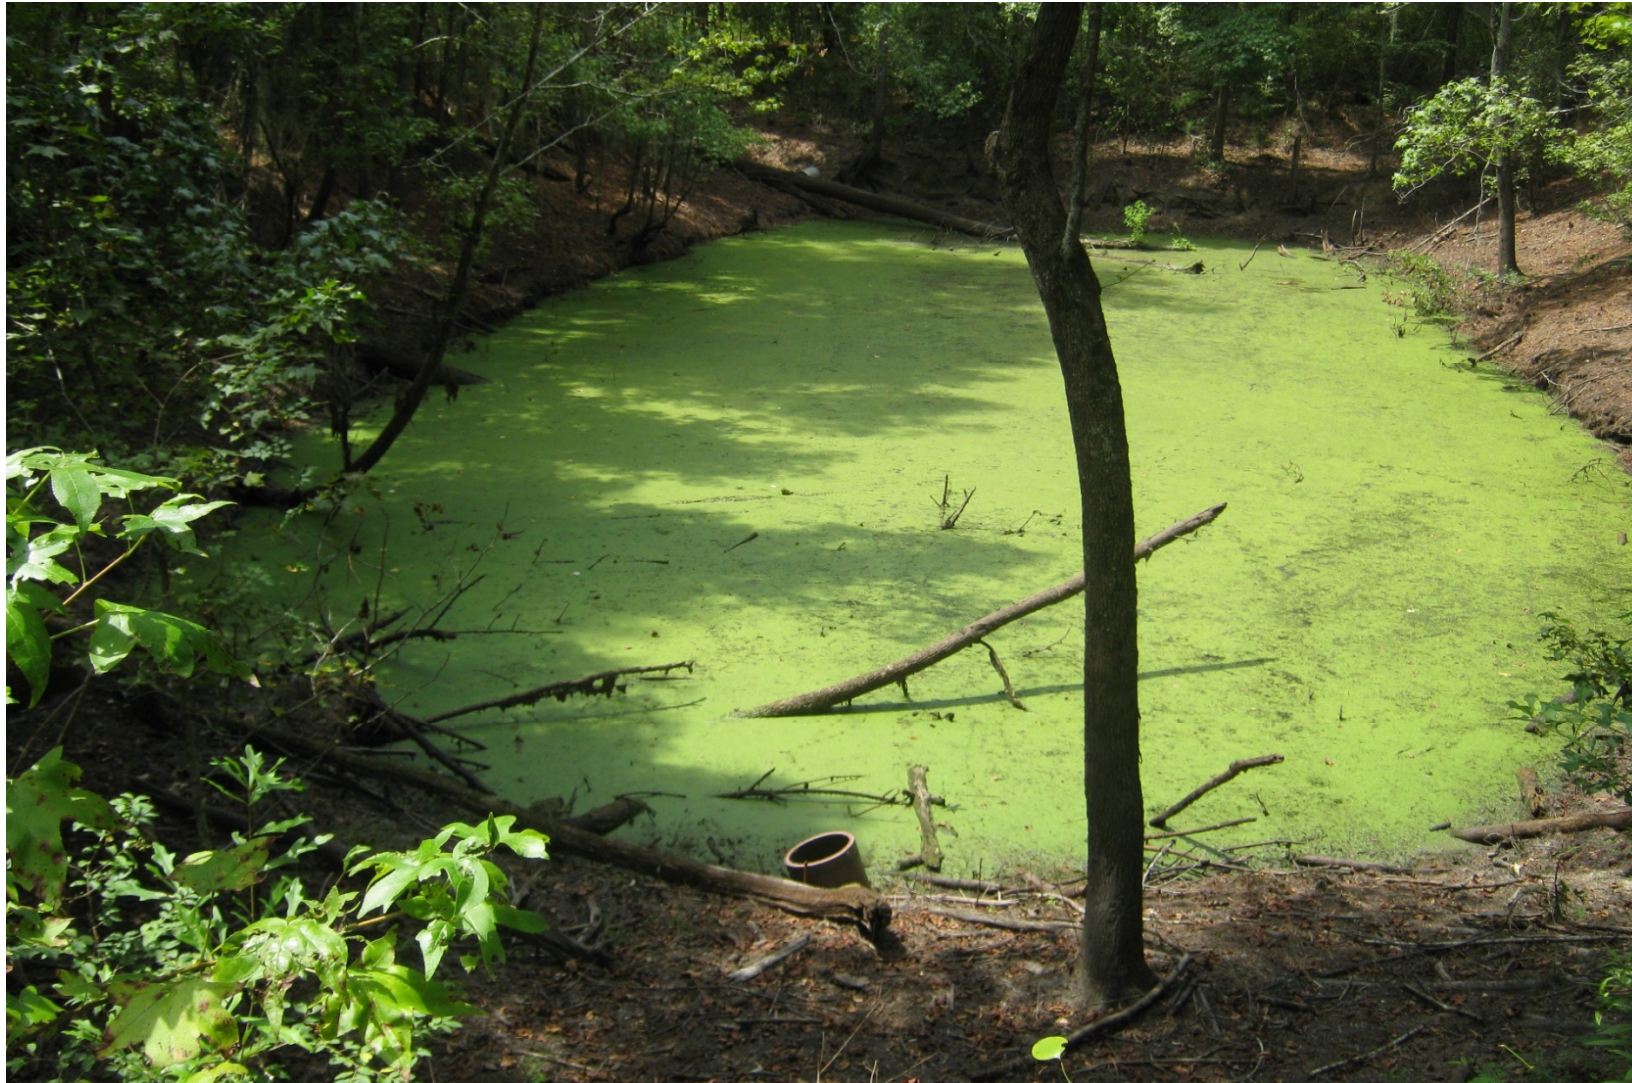
**Figure 8. GOSB OU Water Level Before Construction**

The design in the CMI/RAIP (SRNS 2019a) called for dewatering of the basin. At the time of the RA construction, it was determined that the water level was significantly reduced due to recent dry weather (Figure 8). The GOSB OU project team determined that the stone aggregate material would be sufficient to cover the remaining water. Therefore, no dewatering was required, and backfilling of the basin could begin.

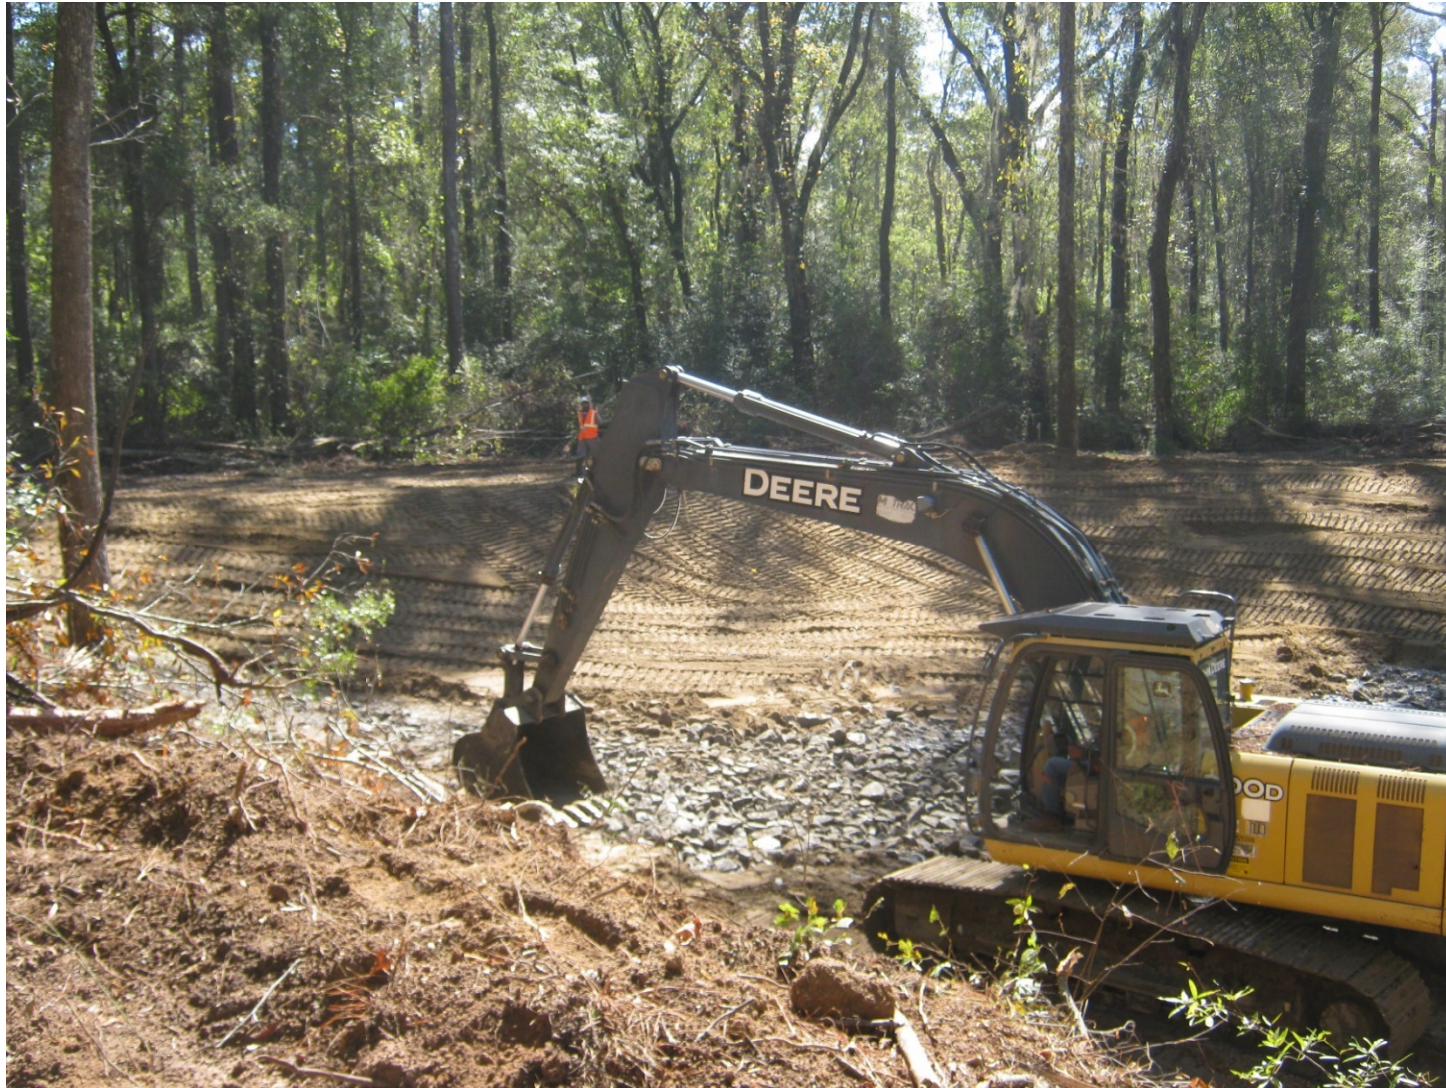
**Figure 9. Structural Stone Prior to Common Fill**

PMCS used a John Deere 200D LC excavator to place ~623 m<sup>3</sup> (815 yd<sup>3</sup>) of surge stone aggregate (7.6 cm [3 in.] average diameter) in the basin bottom to bridge the soft subgrade before backfilling with common fill. While laying stone in the south eastern side of the basin, construction personnel observed that the stone aggregate was displacing the soft, sludge-like bottom sediments. To mitigate this issue, the GOSB OU project team decided to use larger diameter stone aggregate to stabilize the sediments. The excavator was used to add 105 m<sup>3</sup> (137 yd<sup>3</sup>) of the larger stone (“rip-rap”) and then work the sediments into the voids. Approximately 2.1 m (7 ft) of stone aggregate was laid into the basin bottom to an elevation of 85.0-m (279-ft) above mean sea level. Following placement of the bridging material, PMCS backfilled the basin with ~2,896 m<sup>3</sup> (3,788 yd<sup>3</sup>) of clean common fill. The common fill was sampled and analyzed to verify that it met the requirements of clean common fill material per *SRS Fill and Soil Cover Material Verification Protocol* (WSRC 2003) (See Section 4.1). Fill material was spread in layers (maximum 30.5-cm [12-in.] thick) using a John Deere 550K bulldozer and compacted using a Hamm H 7i drum roller prior to compaction testing (Appendix C). The fill material was mounded and compacted as outlined in the CMI/RAIP design (SRNS 2019a). Figures 9-13 show construction activities.

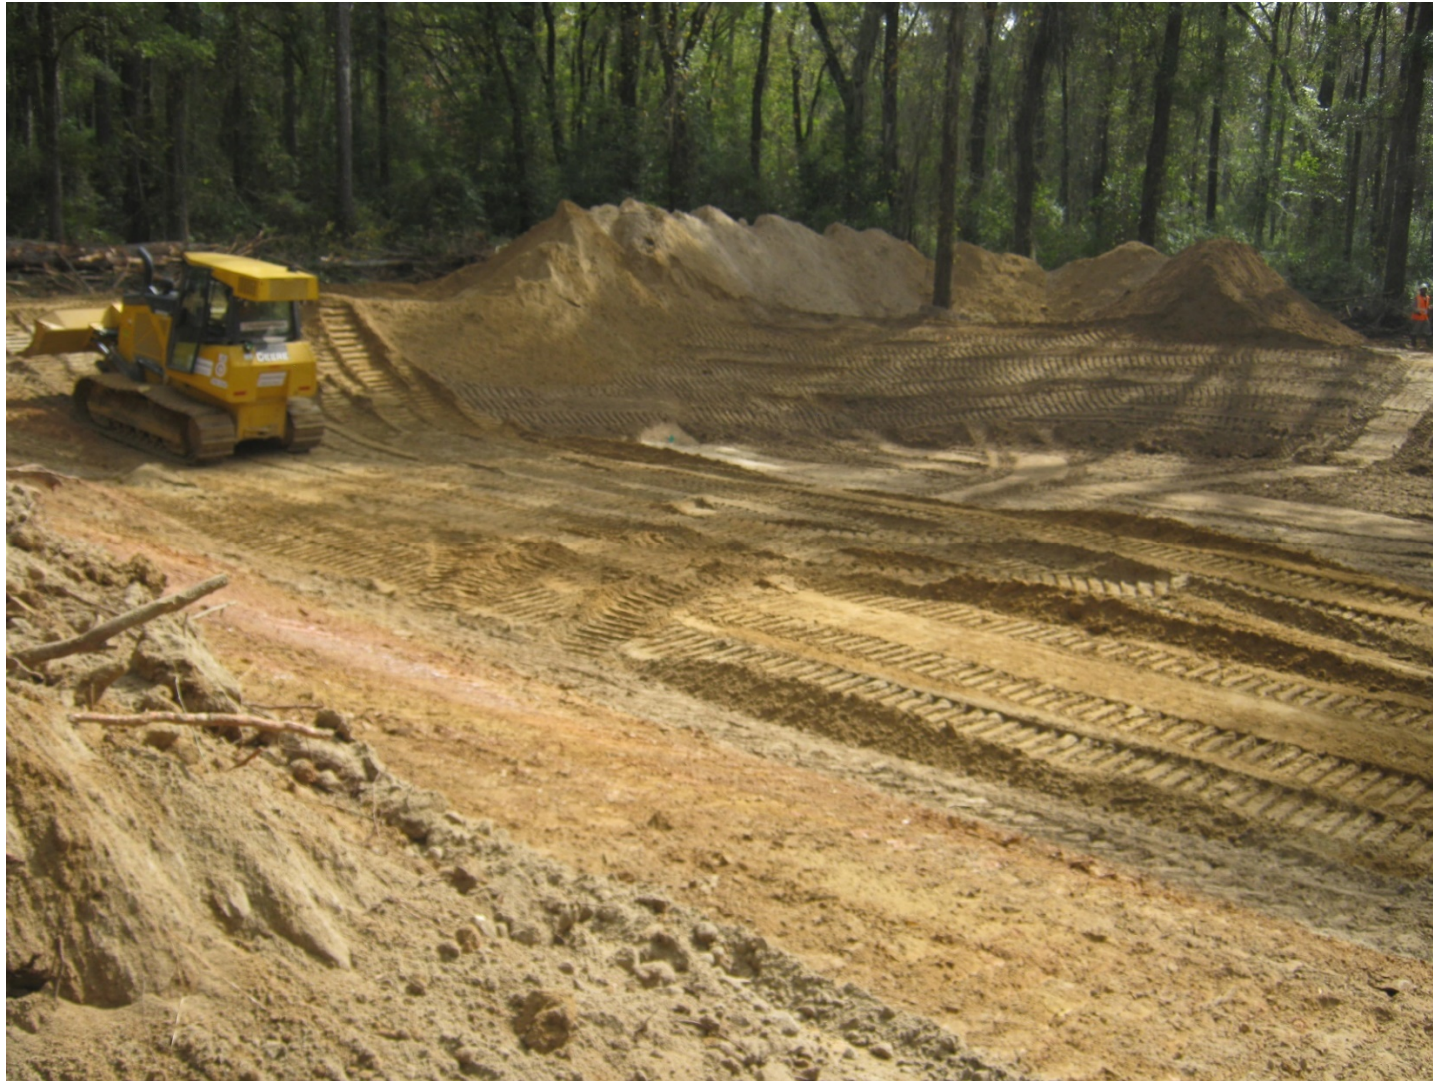
**Figure 10. Placement of Common Fill in Support of GOSB OU Closure**

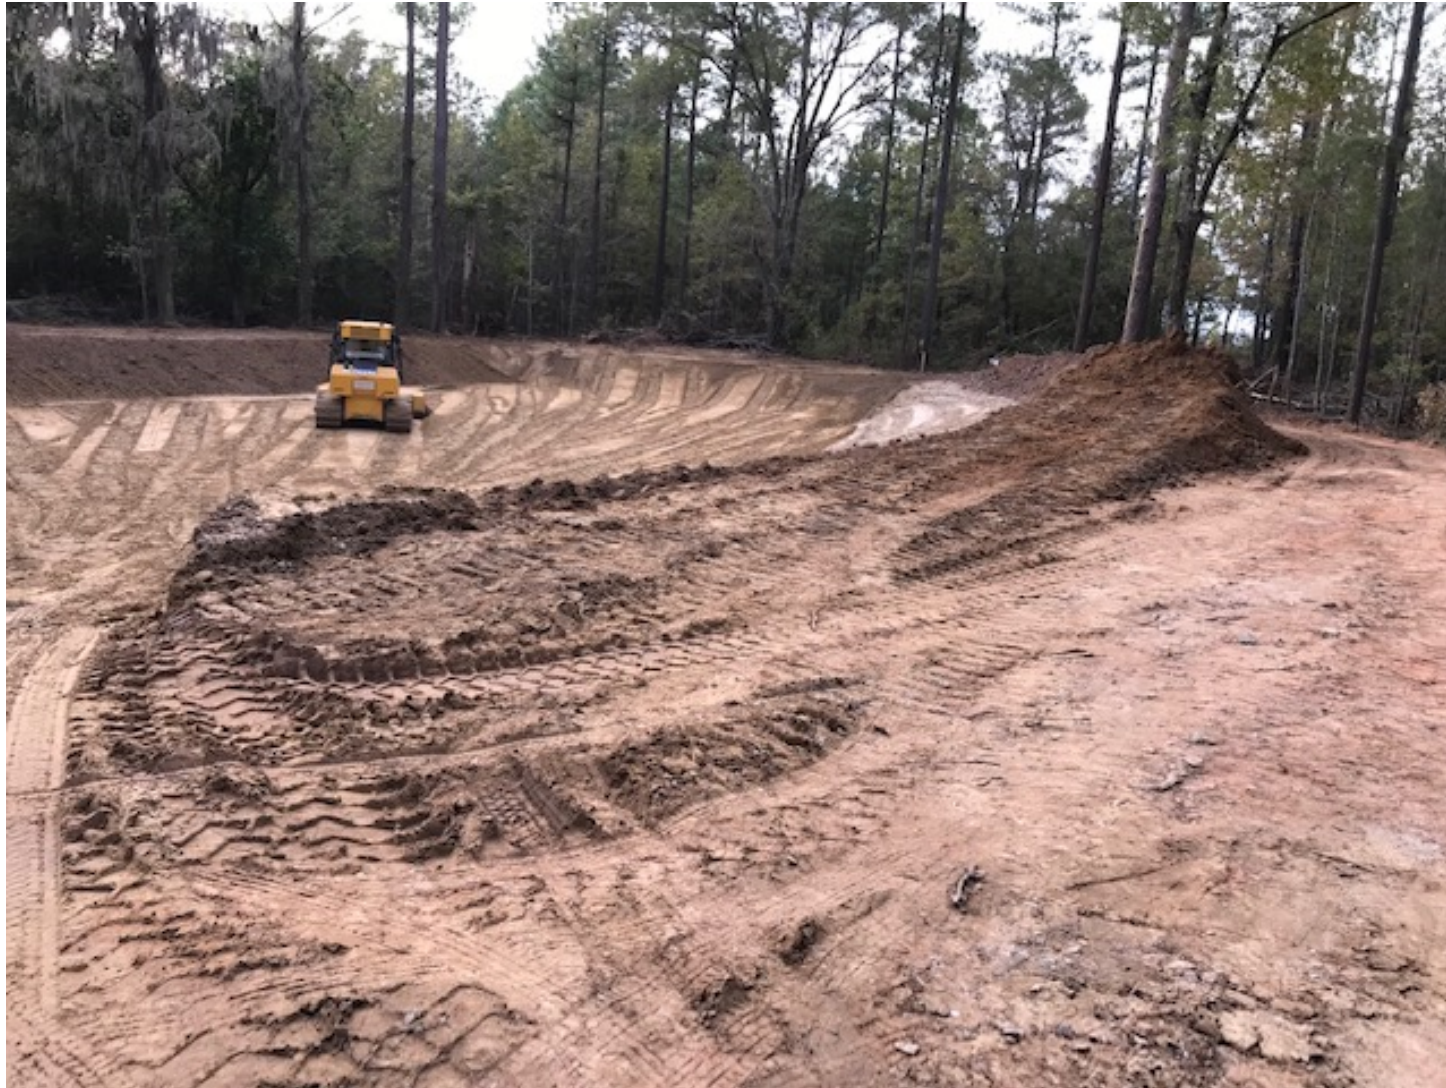
**Figure 11. Placement of Common Fill in Support of GOSB OU Closure**

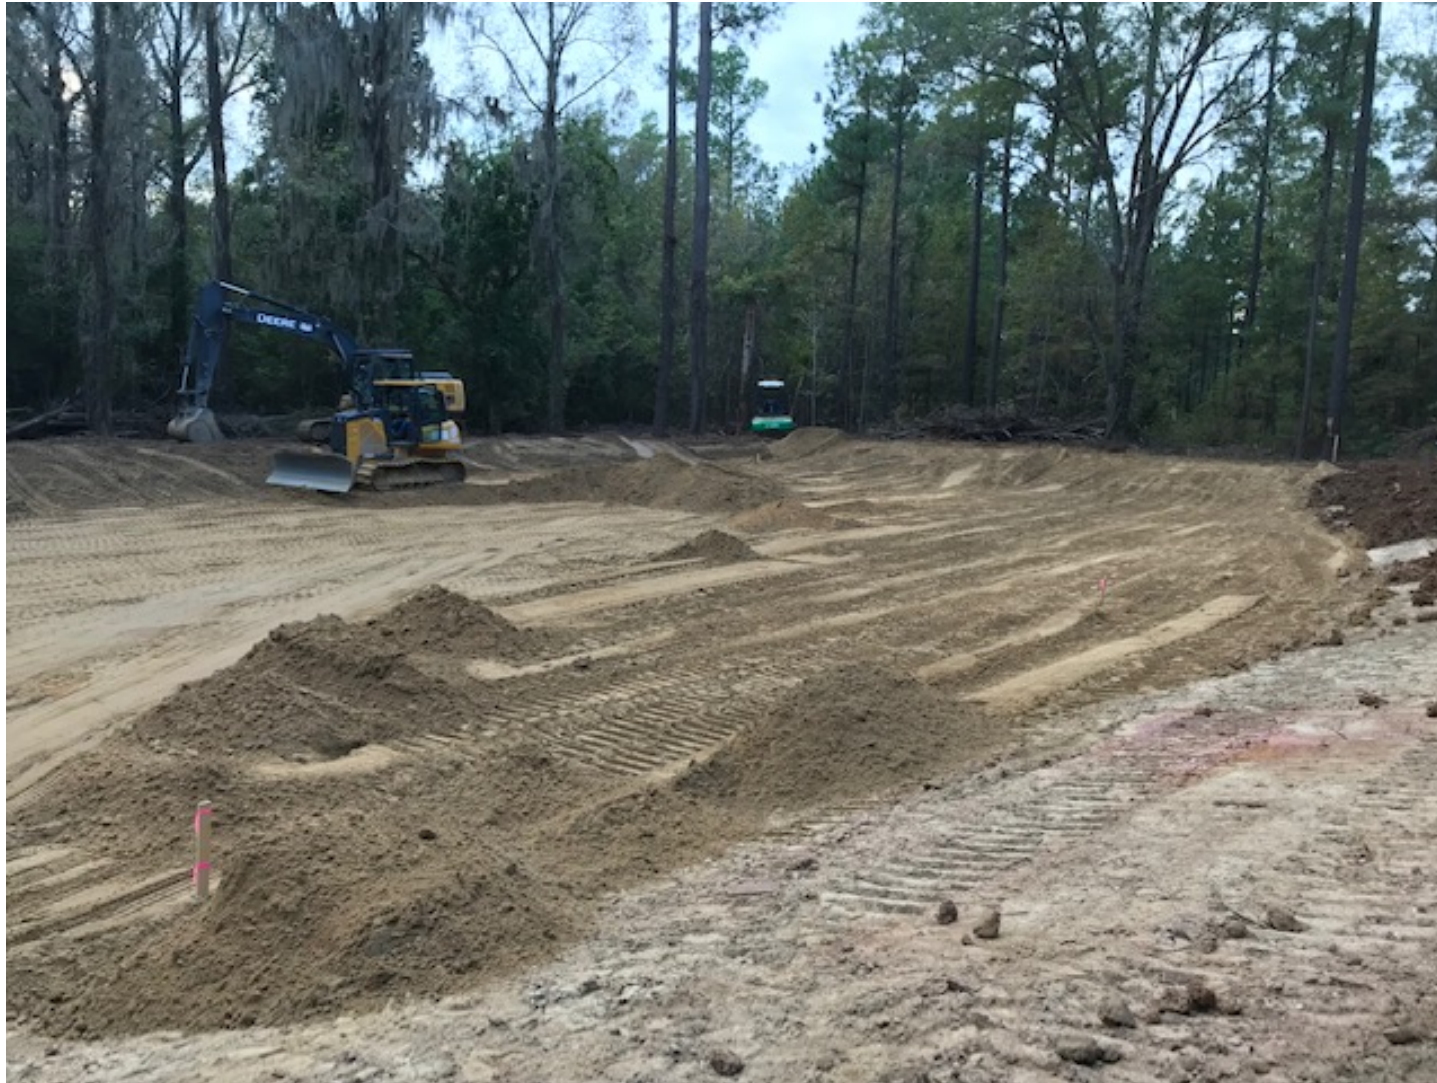
**Figure 12. Spreading and Compacting Common Fill in Support of GOSB OU Closure**

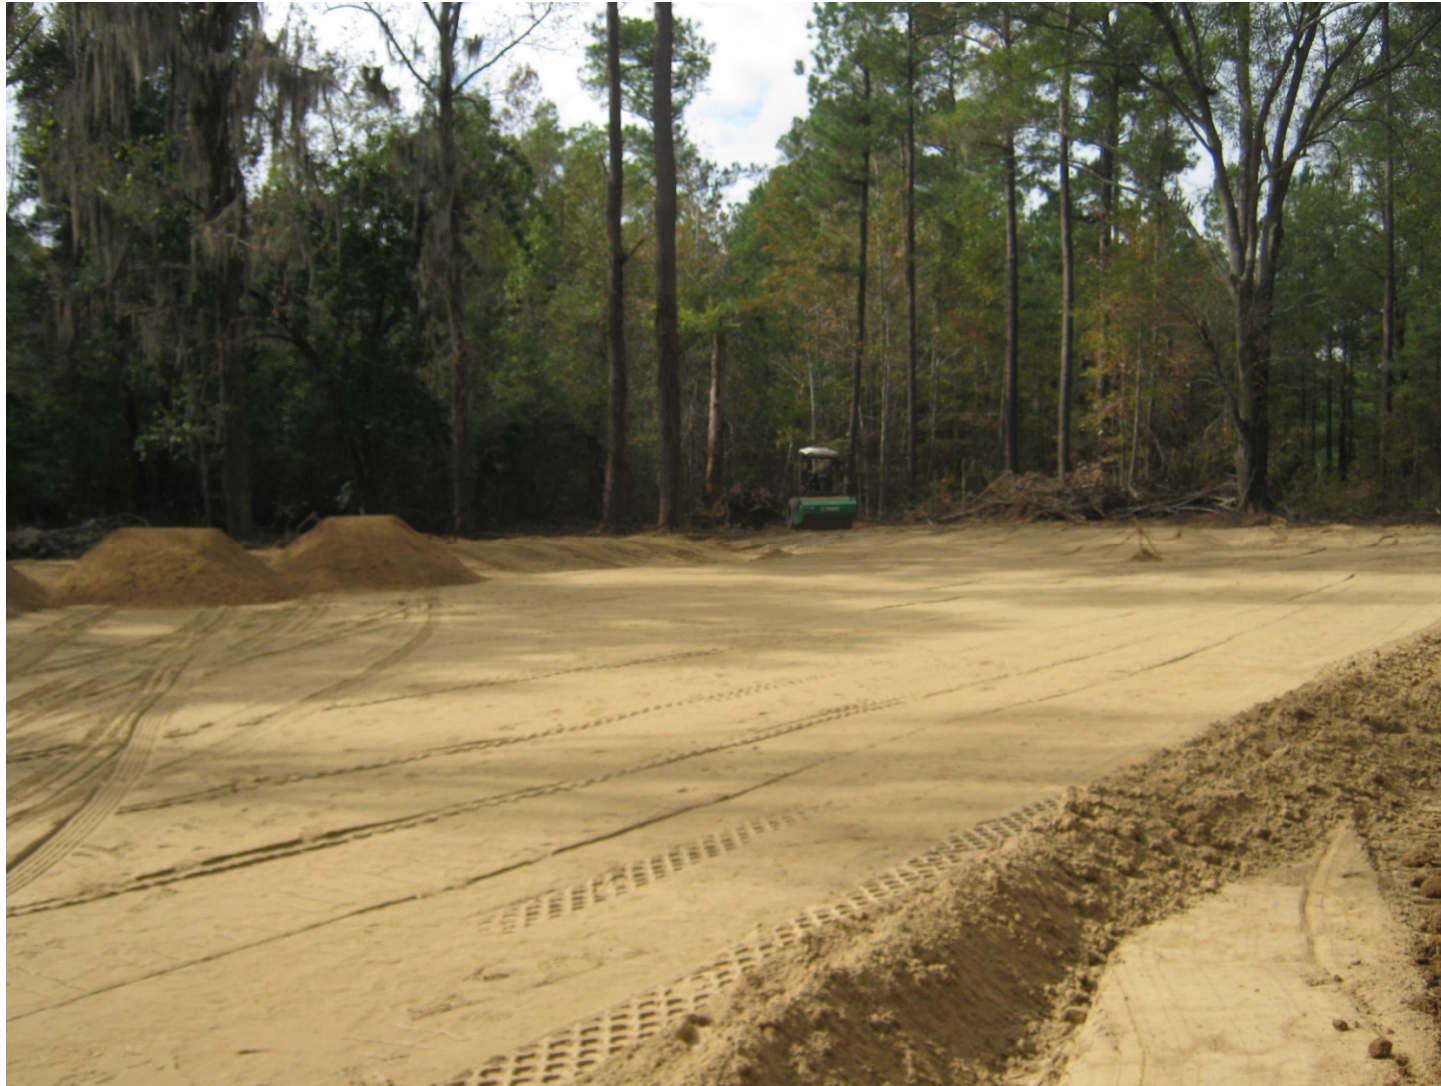
**Figure 13. Compacted Common Fill at GOSB OU Prior to Mounding**

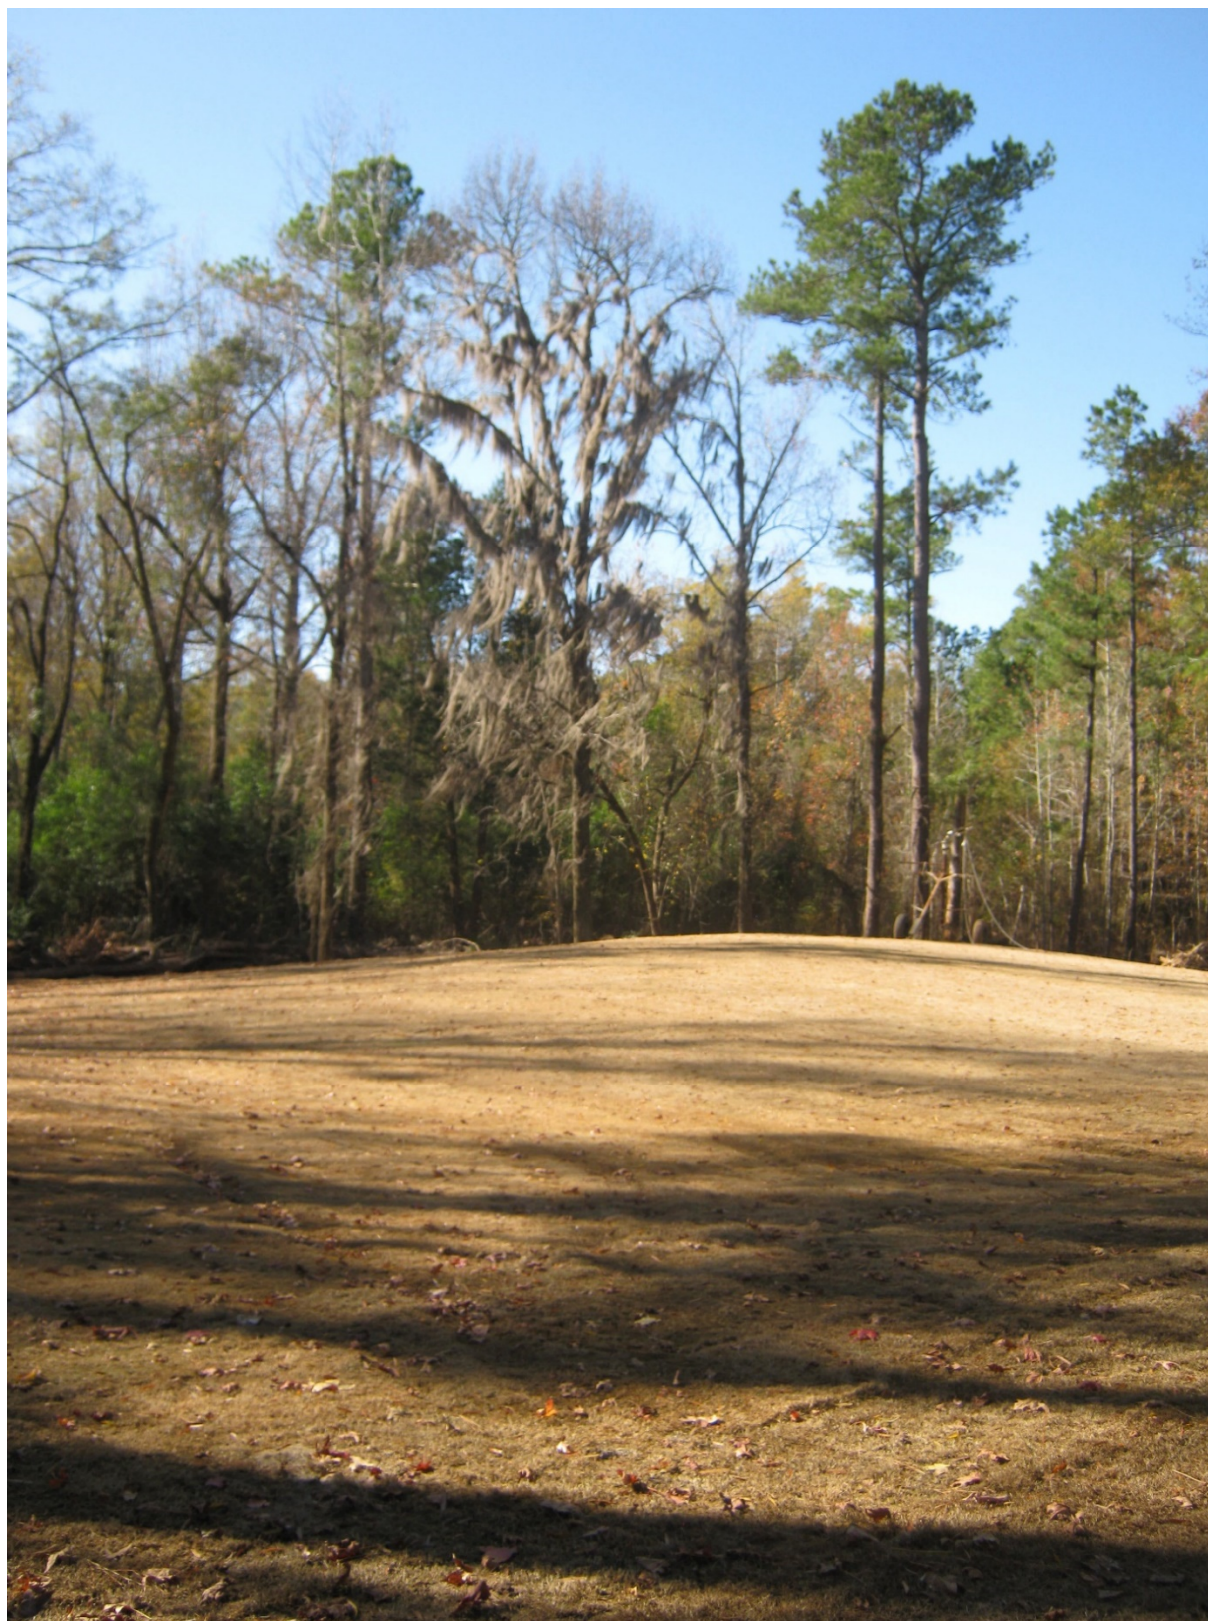
**Figure 15. Post-Construction Photograph of the GOSB OU**

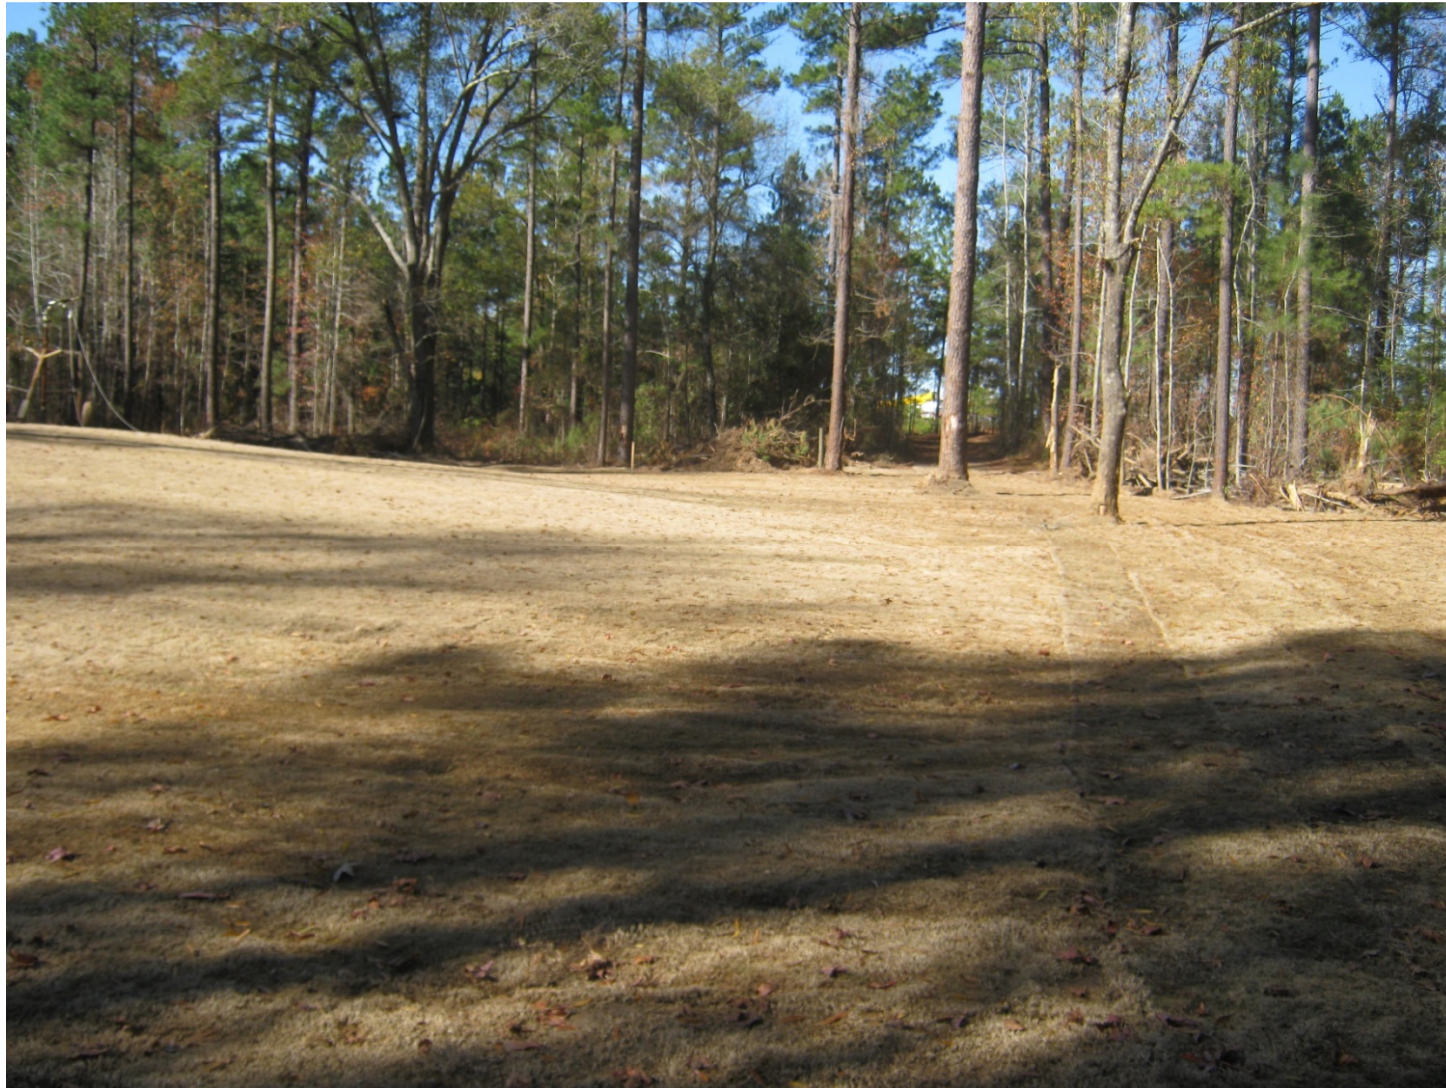
**Figure 16. Post-Construction Photograph of the GOSB OU**

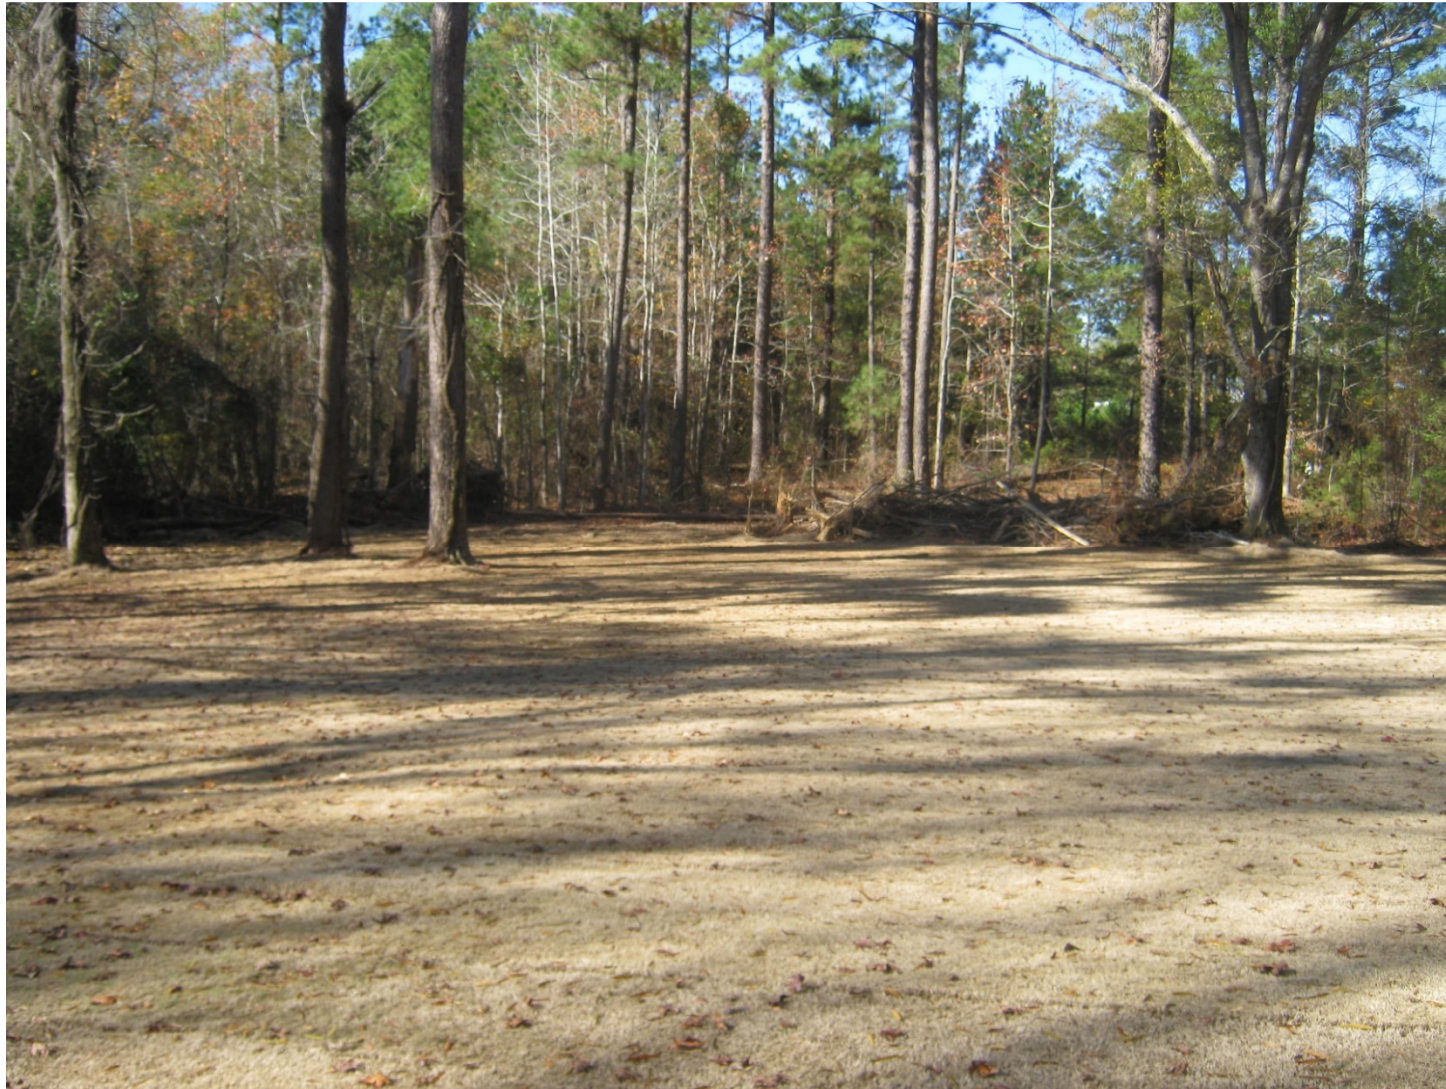
**Figure 17. Post-Construction Photograph of the GOSB OU**
